Visual Examination of Aluminum Containers for Extended Wet Storage of Non-Aluminum-Clad Spent Nuclear Fuel – FY21

June 2021

SRNL-STI-2021-00311, Revision 0

L.N. Ward
M. Trimm
C. Verst
S. Boland

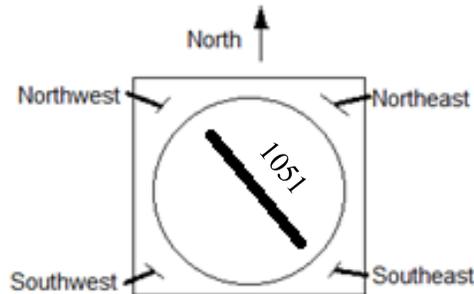
Comprehensive view of Lid Weldments Video Complete? – **First bundle. Fuel ID not visible from L camera (basin camera).

1st corner/ NE corner – 8:22am – Orange brown cobwebs on rack. Corrosion in very small nodules. Iron rust. Particulate increased as going down bundle. Camera image starting to snow at 8:30am from radiation. Impact limiter with orange brown sediment.

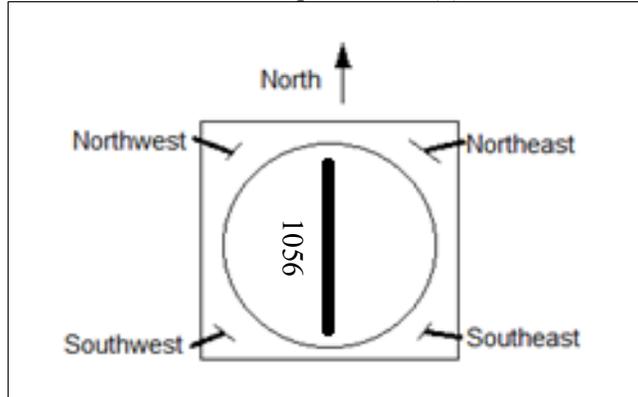
Comprehensive view of Lid Weldments Video Complete? - ****Cobwebs on lid, brown to orange to clear (translucent), bail weld intact. Reddish corrosion spots on lid (2).**

1st corner/ NE corner – 12:28pm – Mottled gray surface. Many spots. Some nodules following scratch. Pitting along same scratch with associated nodules. Lighter color, no mottling nearer to bottom of bundle. Particulate coming up due to corrosion removal (from bundle).

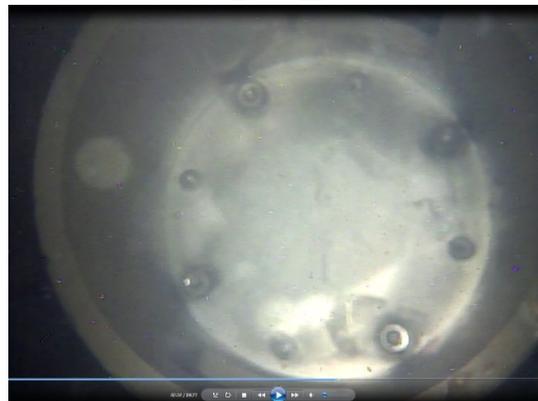
Bottom

In deploying the side view FF camera for viewing the bottom of the bundle, radiation effects to the camera were immediately noticeable. The camera still produced reasonably clear images of the bundle bottom without noticeable corrosion, discoloration, or deformation of the weld (Figure 3-2). The bolts for the OCP are visible and intact as well.

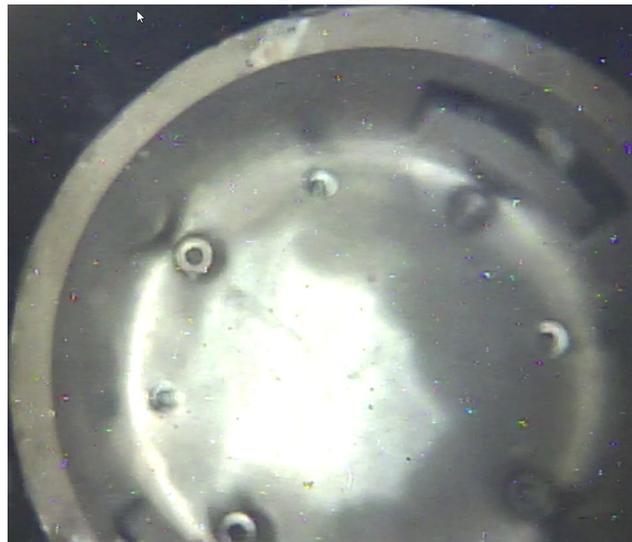
Bottom

examination. Slight pitting was noted, along with various scratches and circumferential scrapes with orange discoloration. This is most likely due to a steel piece causing the scrape and leaving behind some steel within the scrape that subsequently rusted on the aluminum bundle. Some scaling corrosion was noted near the bottom of the bundle. While there were items to note in every corner, this bundle had very little overall general corrosion. This also contributed to less particulate in the camera images, as the camera was not dislodging corrosion into the water. The bundle bottom looked clean, intact, and without any weld deformation or corrosion (Figure 3-3).
