SDU 7 Shotcrete Sample Characterization

C. A. Langton and K. A. Hill

July 2022

SRNL-STI- 2022-00296 Revision 0

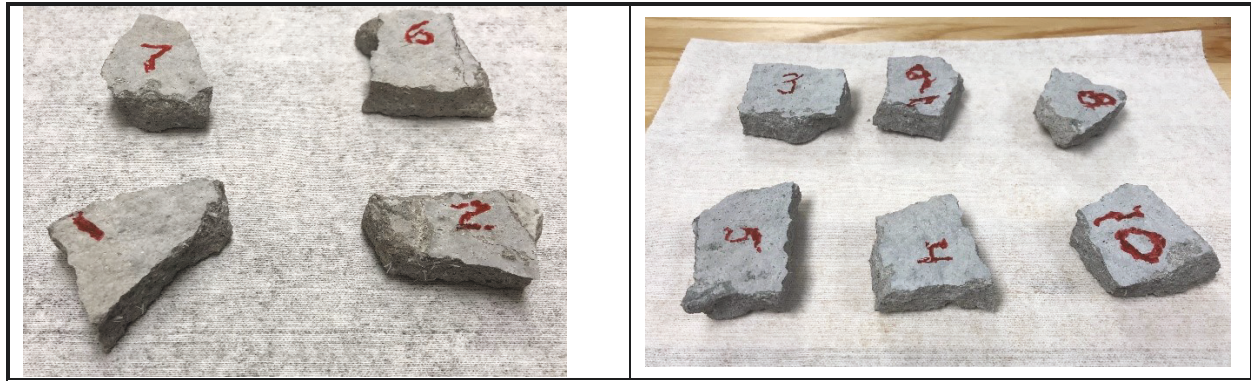
The first ten samples of delaminated SDU 7 Layer 8 characterized by SRNL were collected from pieces that had fallen onto the ground around the SDU. Subsamples of these Layer 8 pieces are shown in Figure 2-1. Characterization consisted of visual observations, mineralogy of the exposed and underlying surfaces of Layer 8, and ASTM C642 porosity, moisture sorption and density.

Figure 2-1. Subsamples of Layer 8 used for ASTM C642 property measurements.

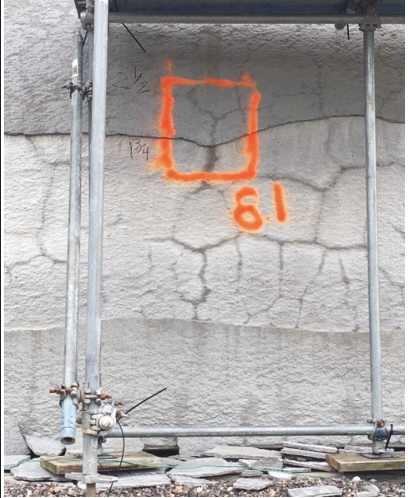
A third sampling event was performed to collect multilayer samples that contained map cracks. One sample was requested at location 8.1, shown in Table 2-3 was identified within working distance from the ground that had map cracking on the surface of Layer 8 where Layer 8 was firmly bonded to Layer 7. Several subsamples were analyzed from this sample 8.1 using computed x-ray tomography.

Sample Location	Survey GPR Results (Depth to Rebar Strand)	Maximum Drill Depth ($X \geq .25$ Survey GPR Results)	SDU 7 Layers 8 (outer) and 7 (penultimate Sample Locations)
8.1	2 .25	Before sampling

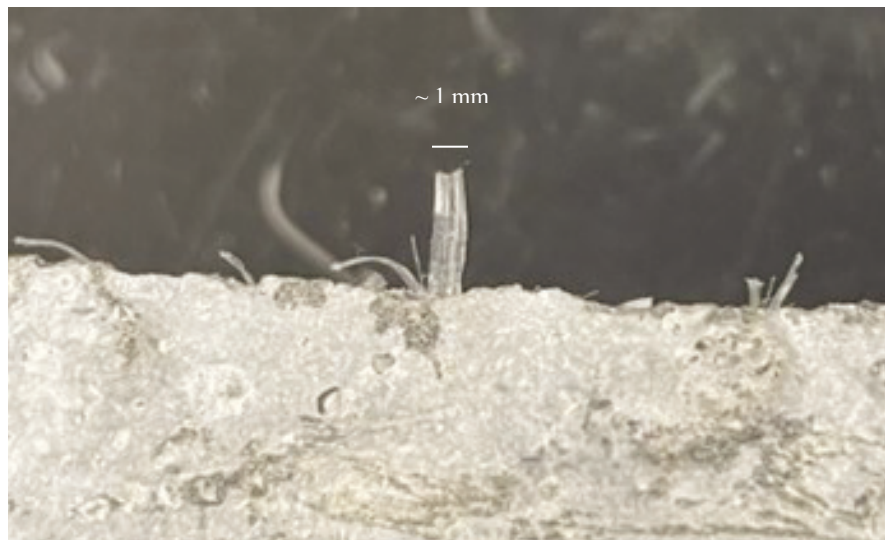
Several microfibers were pulled out of fractured surfaces of SDU 7 Layer 8 shotcrete. They appear to be self-defibrillating microfibers as indicated by “scoring” along the length of the fibers. See Figures 3-13 and 2-14. Overall, the bonding between the fibers and matrix was good. The significance of partial defibrillation may impact the susceptibility of the shotcrete to plastic shrinkage and /or placement properties. The type of fiber, dose, and method of incorporation into the shotcrete mix warrants reviewed to achieve the maximum benefit of the fiber addition.

According to ACI 506.1-21, one reason for adding microfibers to shotcrete mixes is to “minimize plastic shrinkage” [Nitschke and Winterberg 2016]. Macroscopic and microscopic examination of the fibers indicate that many fibers were not defibrillated, i.e., did not separate into smaller fibers or fiber bundles, during the mixing process. This does not appear to have impacted the overall shotcrete porosity and paste-aggregate bonding. However, it may have contributed cracking resulting from plastic shrinkage which occurs in fresh cementitious materials as the result of water loss due to evaporation from the surface after placing and before hardening. However even with a highed addition of microfibers more defibrillation, plastic shrinkage will occur if the evaporation rates is not controlled by dequate wet curing for a sufficient length of time.

Figure 3-13. Polypropylene self-defibrillating microfibers. Scoring seen on the fiber surface is typical of self-defibrillating fibers.
