Furniture Rack Corrosion Coupon Surveillance - 2012 Update

October 2012

Savannah River National Laboratory
Savannah River Nuclear Solutions, LLC
Aiken, SC 29808

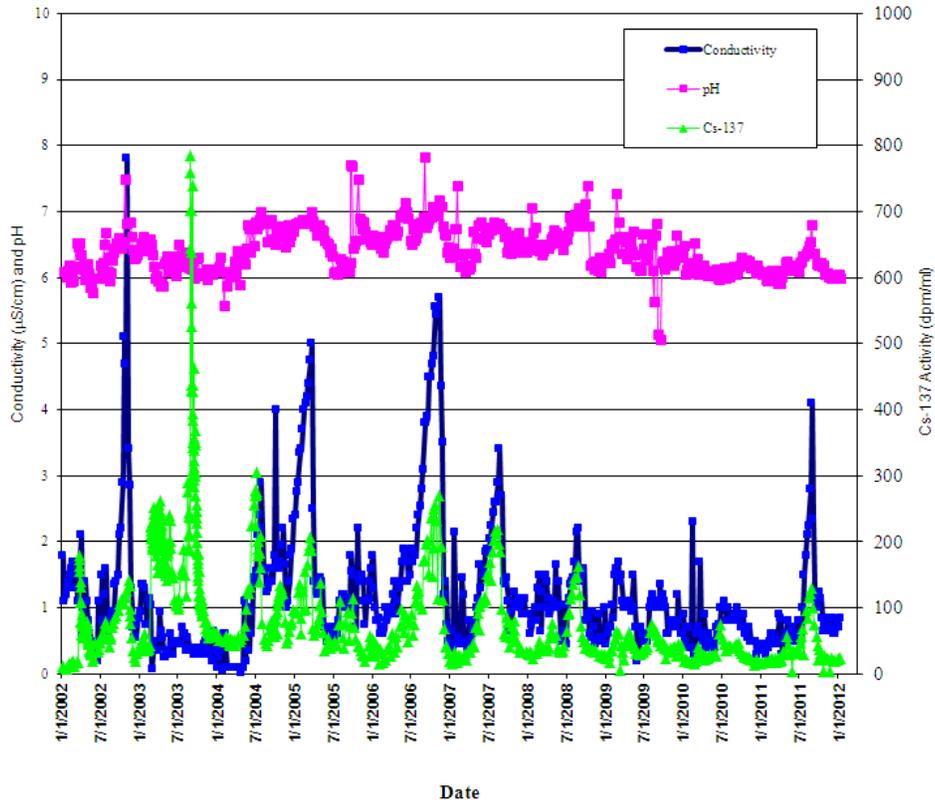
Figure 3-1 L Basin Water Quality Parameter Trends - Conductivity, pH and Cs-137 activity over the time period of 2001 through 2011

The L Basin water quality has been well controlled over the furniture rack coupon exposure. The L Basin Water Chemistry Control Program establishes limits to control the basin water activity and to minimize corrosion of the fuels, bundles, and associated handling and storage equipment. The pH and conductivity limits are: $5.5 \leq \text{pH} \leq 8.5$ and conductivity $< 10 \mu\text{S}/\text{cm}$ [6]. The basin water pH and conductivity fell within these limits. The data over the time period of 2001 to 2011 is given in Figure 3-1 along with the Cs-137 activity. The spikes in conductivity and Cs-137 activity correspond to the addition of fuels to the basin as well as operational activities such as maintenance to a deionizer valve and a change in the building AC. The Cs-137 limit, which was established at $< 500 \text{ dpm}/\text{ml}$, was exceeded only briefly in 2003 after the addition of failed fuels from RBOF [6].

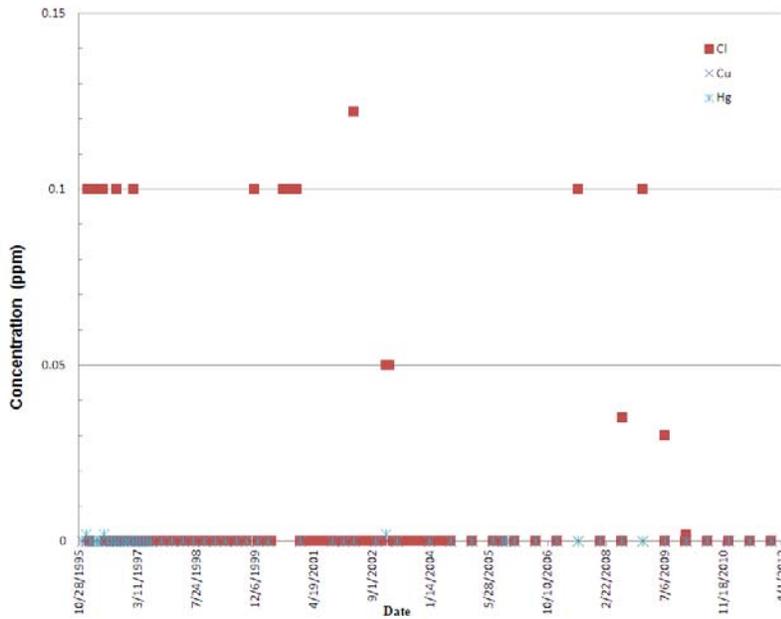
Figure 3-2 L Basin Water Quality Parameter Trends – Concentrations of Cl, Cu, and Hg over the time period of 1995 to 2012

Elemental species are also regulated by the L Basin Water Corrosion Control Program, including Cl ($\leq 0.1 \text{ ppm}$), Hg ($\leq 0.014 \text{ ppm}$), and Cu ($\leq 0.1 \text{ ppm}$). Over the years the furniture rack coupons were exposed in L Basin, the chloride concentration was the only species to meet or exceed its limit as shown in Figure 3-2. Most of the higher values were obtained during the early years of the exposure.

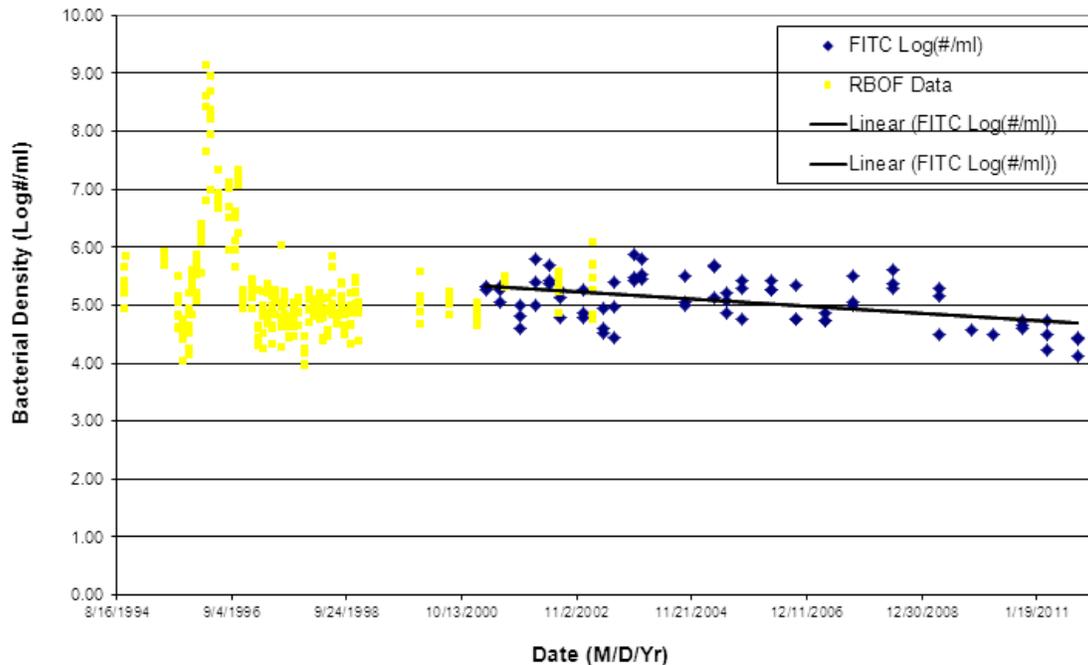
Figure 3-3 Total Bacterial Count Trend from 1994 to 2011

Total direct counts are made of both viable and non-viable bacteria present in a basin water sample. After a basin water sample is heat fixed to a slide and stained, the stained microbial cells are counted using a Zeiss epifluorescent microscope. Total direct counts in the L Basin, including both viable and non-viable bacteria have trended downwards since 2008 as shown in Figure 3-3. The average density of bacteria in the water samples since 2008 is less than half that average for the time period since 2001.

The pitting observed on the coupons does not appear to be related to microbiological factors. The number of bacteria in the basin has been on a continual decline since 2008 (Figure 3-3). The biodiversity has declined since 2006. However the average pit depths appear to be constant without any pits depths close to penetrating the full thickness of the coupons.

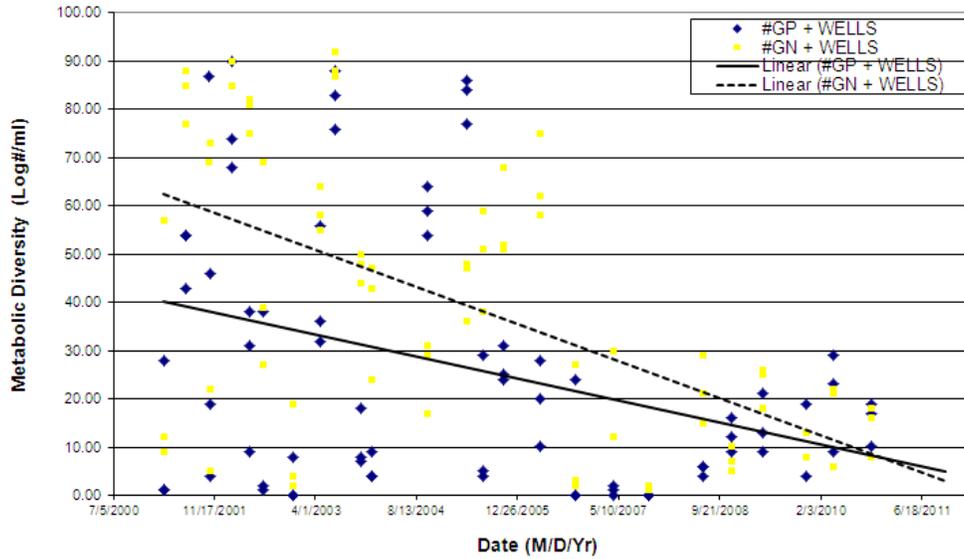
Figure 3-4 Metabolic diversity of L Basin water as measured using Biolog™ plates over the time period of 2001 through 2010

A measure of the microbial diversity is given by Biolog™ plates, which has shown a decreasing trend since its use initiated in 2001 as shown in Figure 3-4. The plates are used to differentiate aerobic bacteria between gram negative (GN) and gram positive (GP) species, which indicates a difference in the cell membrane structure. The plates have 95 wells with different organic substrates that will activate an indicator dye due to enzyme reactions of the microbes. A large number of positive wells indicate increased

physiological diversity and activity in the microbial population. Scrapings from pins exposed to the L Basin water were also used to inoculate the wells. Over ten years the metabolic diversity of bacteria in the water samples has decreased. The measured metabolic diversity reached minimum values from 2006-2008 but has increased some since then, although 2011 results are not included in Figure 3-4.

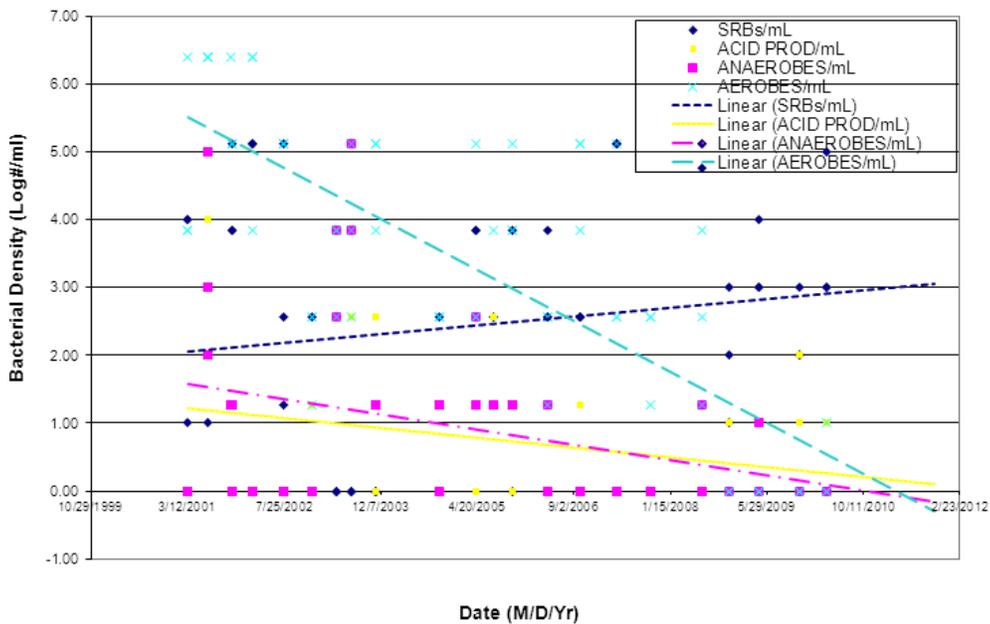
Figure 3-5 Bacterial density of viable bacteria in L Basin over the years of 2001 through 2010

Viable counts of aerobic, anaerobic, sulfate-reducing, and acid-producing bacteria were determined using the commercially available MICKit™. The results and trends of viable bacteria showed a decrease for all groups except sulfate-reducing bacteria which have increased by one order of magnitude over nine years of sampling. These trends are shown in Figure 3-5 through 2010.
