# **A Structural Impact Assessment of Flaws Detected During Ultrasonic Examination of Tank 15**

**B. J. Wiersma  
J. B. Elder**

Savannah River National Laboratory  
Materials Science and Technology Directorate

Publication Date: August 2008

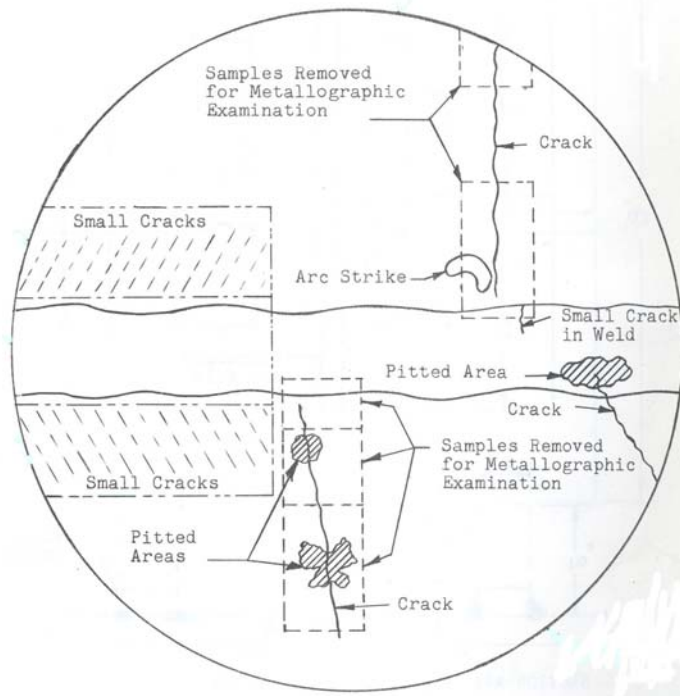
- Three cracks were visibly observed on one of the samples (see Figure 2), with two of the cracks being through-wall. The cracks were intergranular and essentially perpendicular to the horizontal weld.

**Figure 2. Drawing of interior surface of sample removed from Tank 16H.**

observation would explain why the two major cracks did not propagate into the weld and the numerous surface cracks did not extend into the narrow zone immediately adjacent to the weld.

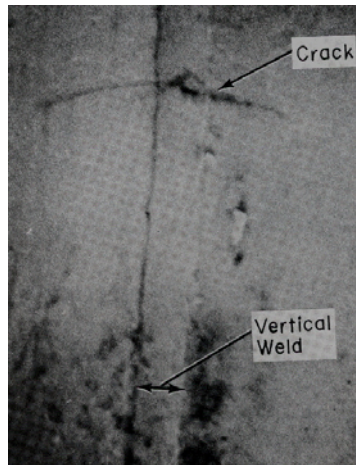
In June 1962, the vertical weld in the upper primary shell beneath inspection port 151 was sandblasted and then inspected with dye penetrant [12]. Ten large cracks were visible without magnification. The cracks were essentially perpendicular to the weld bead (see Figure 4). Four of the cracks were estimated to be between 4 to 6 inches long. The radiograph of the vertical weld and the photographs revealed exterior surface imperfections as well as internal weld beads. Although three of the cracks appeared to be associated with weld beads, most of the cracks showed no correlation with known fabrication blemishes. One crack appeared to be slightly curved, however, this crack was located next to a repair weld at the intersection of the vertical weld and the middle horizontal weld. All of the cracks appeared to be in a 3-inch zone next to the weld and therefore likely affected by fabrication residual stresses. One crack was observed near a repair weld at the intersection of the vertical and horizontal weld. The crack had an arc like appearance (see Figure 5).

Figure 4. Dye-penetrant testing of stress corrosion crack on vertical weld in Tank 16 [12].

In January 1974, the same weld was sandblasted and re-inspected with dye penetrant [14]. The cracks did not appear to have increased in size since the 1962 inspection. This result indicated that weld residual stresses were the primary crack driving force.
