**Failure Evaluation of Savannah River Site High-Level Waste Evaporator
242-25H – Part I
17366**

Author: T. Yamamoto
Savannah River Remediation LLC

ABSTRACT

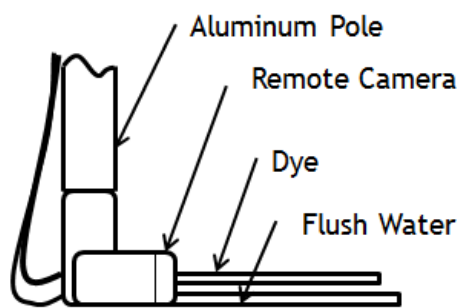
The majority of the north side of the evaporator from the middle of the evaporator down was sprayed with dye and washed. Additional enhanced visual inspections with dye penetrant were performed on the tube bundle looking where the tube sheet was welded to the vessel. There were no specific locations that indicated a leak from the enhanced visual inspection with the dye penetrant. Figure 6 shows all of the areas of interest where dye was applied and the chart gives a description of the individual locations.

Fig. 5. Figure on the left is the dye penetrant application unit with a dye and flush lance attached to a remote camera. Figure on the right is the top of the steam tube bundle with dye penetrant on the surface before flushing.

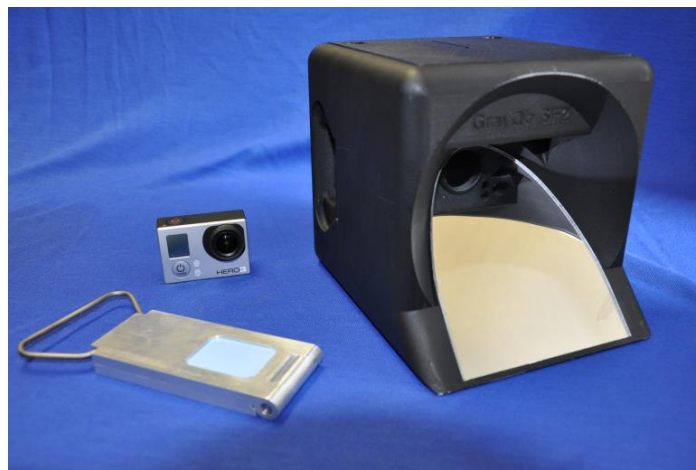
To aid in determining whether or not the leak was in the lower or upper section of the evaporator vessel, a Grey Qb was used to detect radioactive gamma hot spots. The Grey Qb, consisted of a 3D printed housing, a Go-Pro camera, and a tungsten shielded x-ray film shown in Figure 7. Around the Grey Qb was a shielded case with a shutter. The unit would be lowered into position and the shutter door would be raised exposing the x-ray film, while the Go-Pro camera took images. Once the exposure time was complete (~20 minutes), the shutter was closed and the unit retrieved. The x-ray film and the images were imported to software that overlaid the images to show areas with the highest exposure. Separate shots were able to be evaluated against one another, comparing the intensity values within the exposed image.

Fig. 7. Grey Qb Developed by SRNL.

The results from the Grey QB indicated that there was a very intense concentration of radioactive material in the lower section of the evaporator pot, and background radiation levels in the upper portion (See Fig. 8.). If a leak were to occur in the upper section of the evaporator near the tube bundle, one would anticipate an area with higher radiation levels that would indicate more intensely near the stiffening band that segregates the upper vertical section from the lower coned section. However, that was not observed in the image.

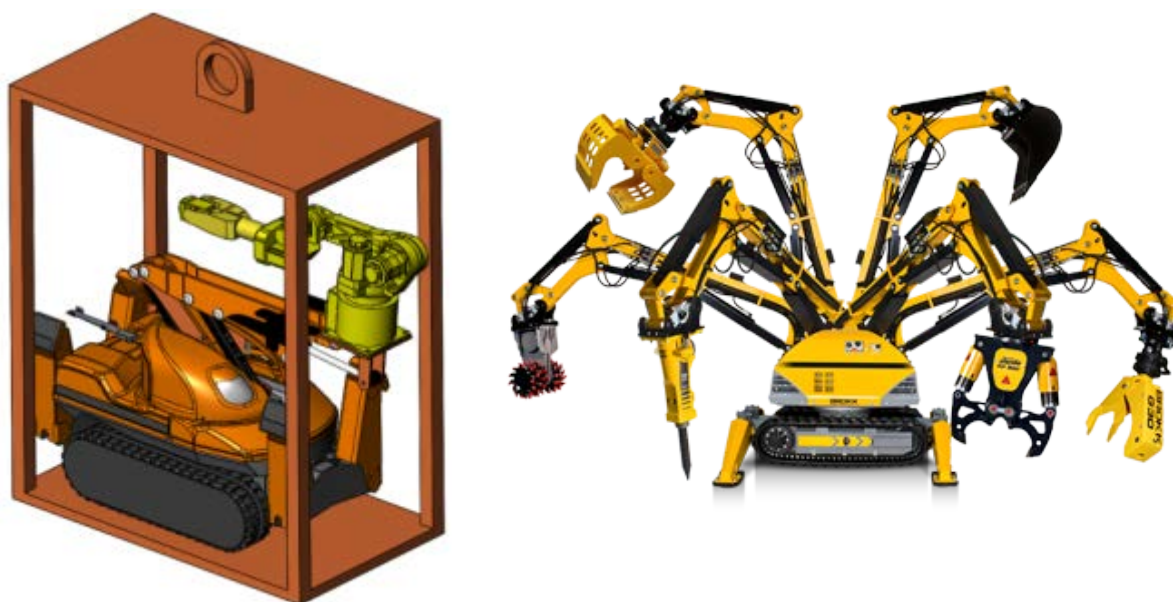
Fig. 10. Figure on the left shows a model of the BROKK 100 with the KUKA arm attached to the robot on the lifting mechanism that will lower and raise the unit out of the cell. Figure on the right shows a typical BROKK 100 with some of the other attachments that readily available for the BROKK if needed.

Development of remote equipment to cut the lagging and remove the insulation from the lower section of the evaporator is in progress. A BROKK 100 (remote excavator) with a KUKA machine assembly robot arm attached to a platform on the end of the BROKK will be used. The unit will be lowered into the cell via a crane platform with the BROKK positioning the arm close enough to the evaporator to remove the lagging and insulation. It is anticipated that the KUKA will be fitted with a plasma torch to cut pieces of the lagging. Once all or sections of the lagging are cut and removed from the cell. The robot will then be raised out of the cell and a separate end effector will be placed on the KUKA with a tool changer and multiple tools to remove the bulk of the insulation.

Once all of the insulation and lagging are removed from the evaporator vessel and the cell is cleaned, the vessel will be filled with water to see if the leak can be visually located. If the vessel needs to be heated, the steam lance or tube bundle will be utilized to add additional heat. It is anticipated that the leak site is going to be difficult to find, with the leak site anticipated to be very small due to the slow leak rate of approximately 378.5 liters/day (100 gallons/day). However, once the leak site is located, the local area around the leak will be further cleaned by remote equipment. This will aid in repairing the vessel. Remote equipment is currently being developed and designed for the repair.
