PVP2007-26362

EVALUATION OF THE FAILURE OF A RADIOACTIVE WASTE TRANSFER LINE JACKET

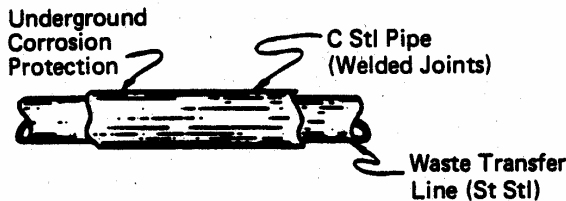
Figure 1. Cut-away drawing of SRS waste transfer line system.

A cut-away drawing of the most common pipe design for the SRS transfer system is shown in Figure 1. The core pipe is typically made of 304L stainless steel. The sizes of the core piping range between 1-3 inches in diameter. Core piping that was installed prior to 1988 was Schedule 40 wall thickness, while since then Schedule 10 has been allowed. The piping was designed according to ASME B31.3. The design pressure for the piping was 150 psig, although the operating pressure for the line is typically in the 100 psig range.
