# FY2005 and FY2006 Corrosion Surveillance Results for L-Basin

Savannah River National Laboratory  
Materials Science and Technology

Publication Date: September 2007

**DOCUMENT: WSRC-STI-2007-00692****Title: FY2005-2006 Corrosion Surveillance Results for L-Basin (U)****MS&T APPROVALS**

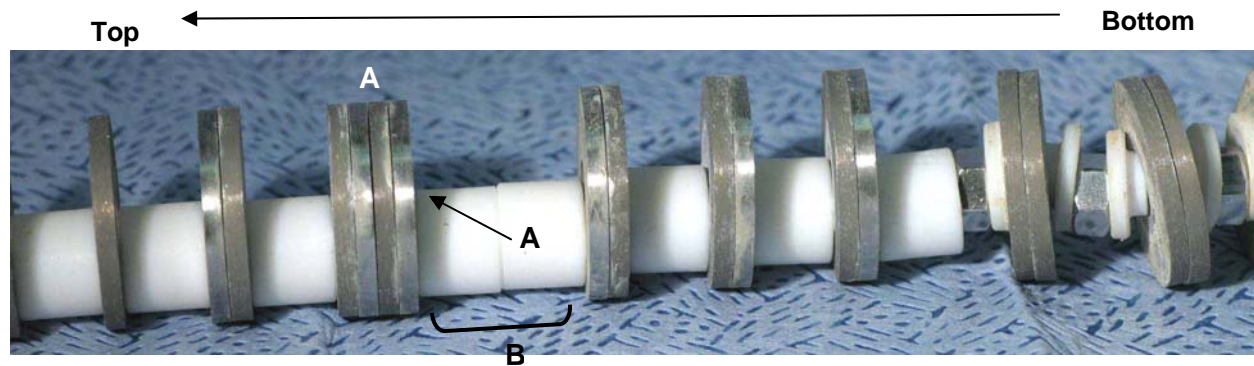
Figure A.3 Close-up of double set of galvanic coupons at position A with two PTFE spacers (B) on the right.

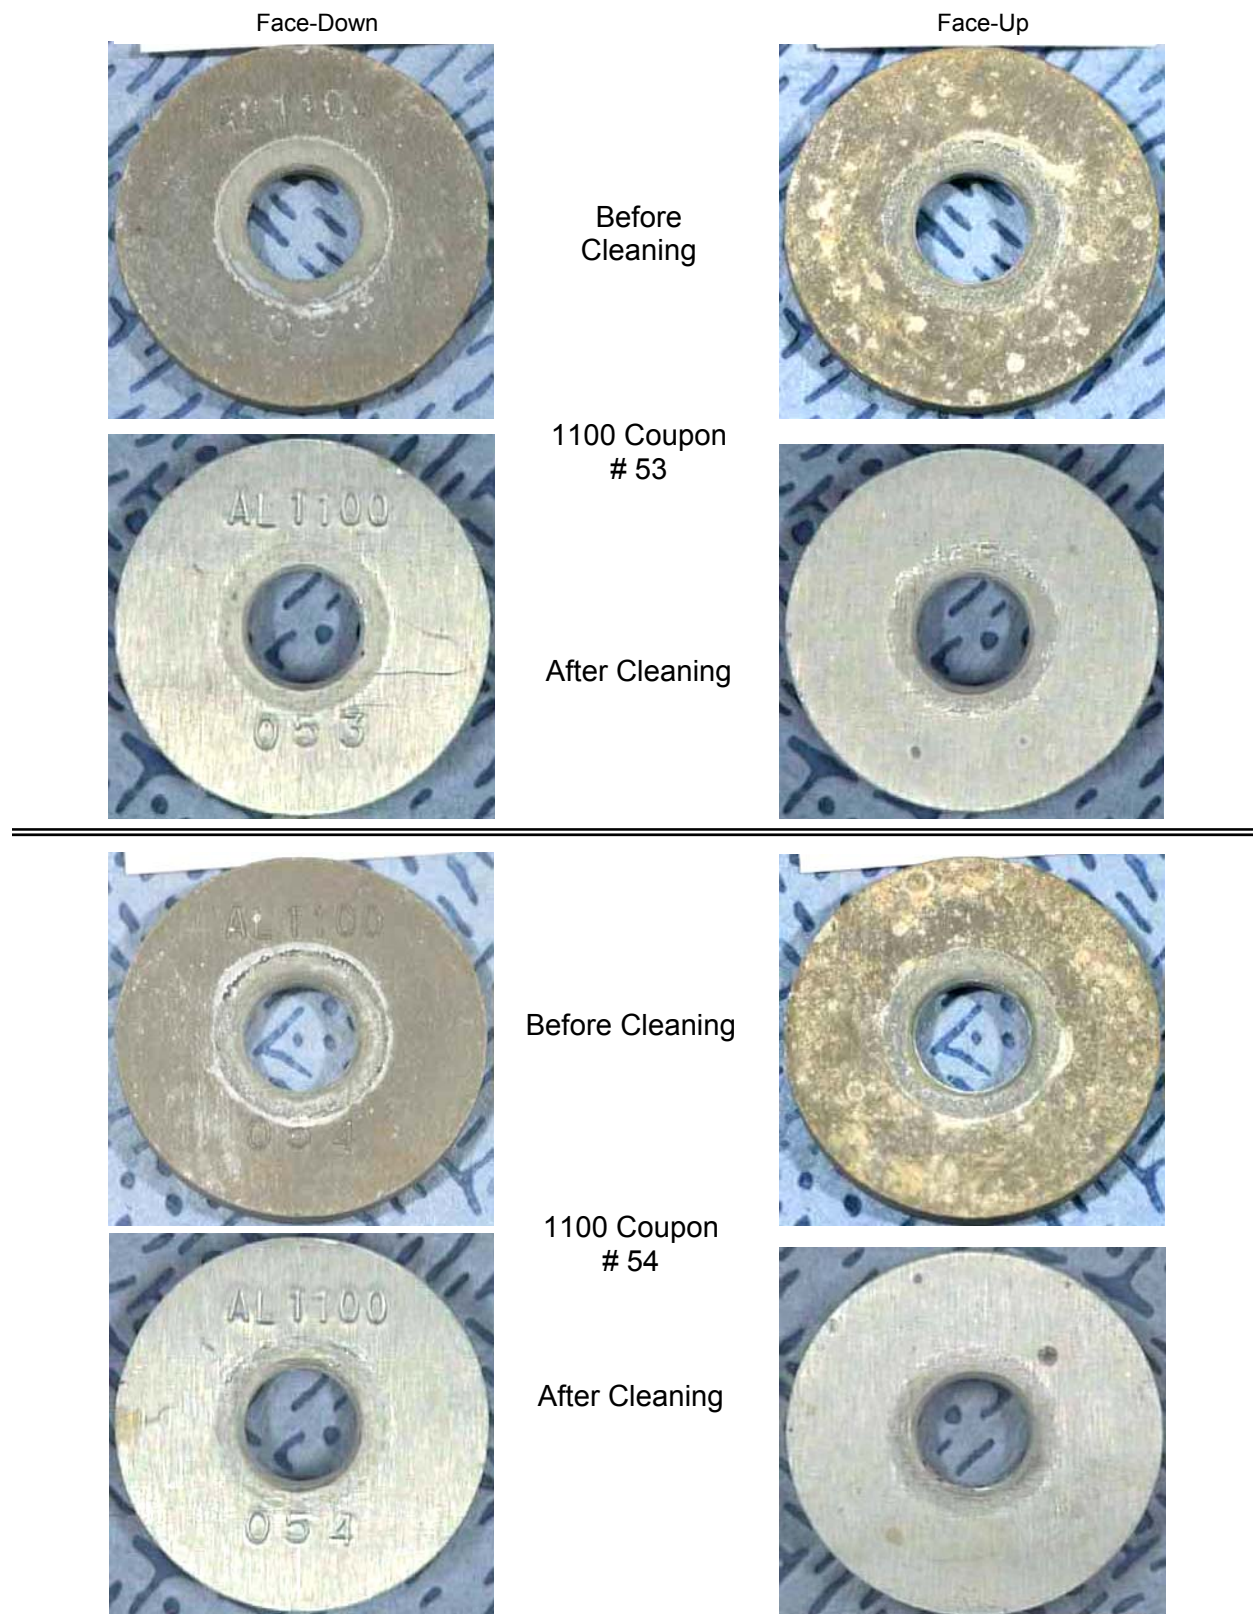
Figure A.6 Photos taken before and after cleaning of single 1100 coupons, #'s 53 and 54.

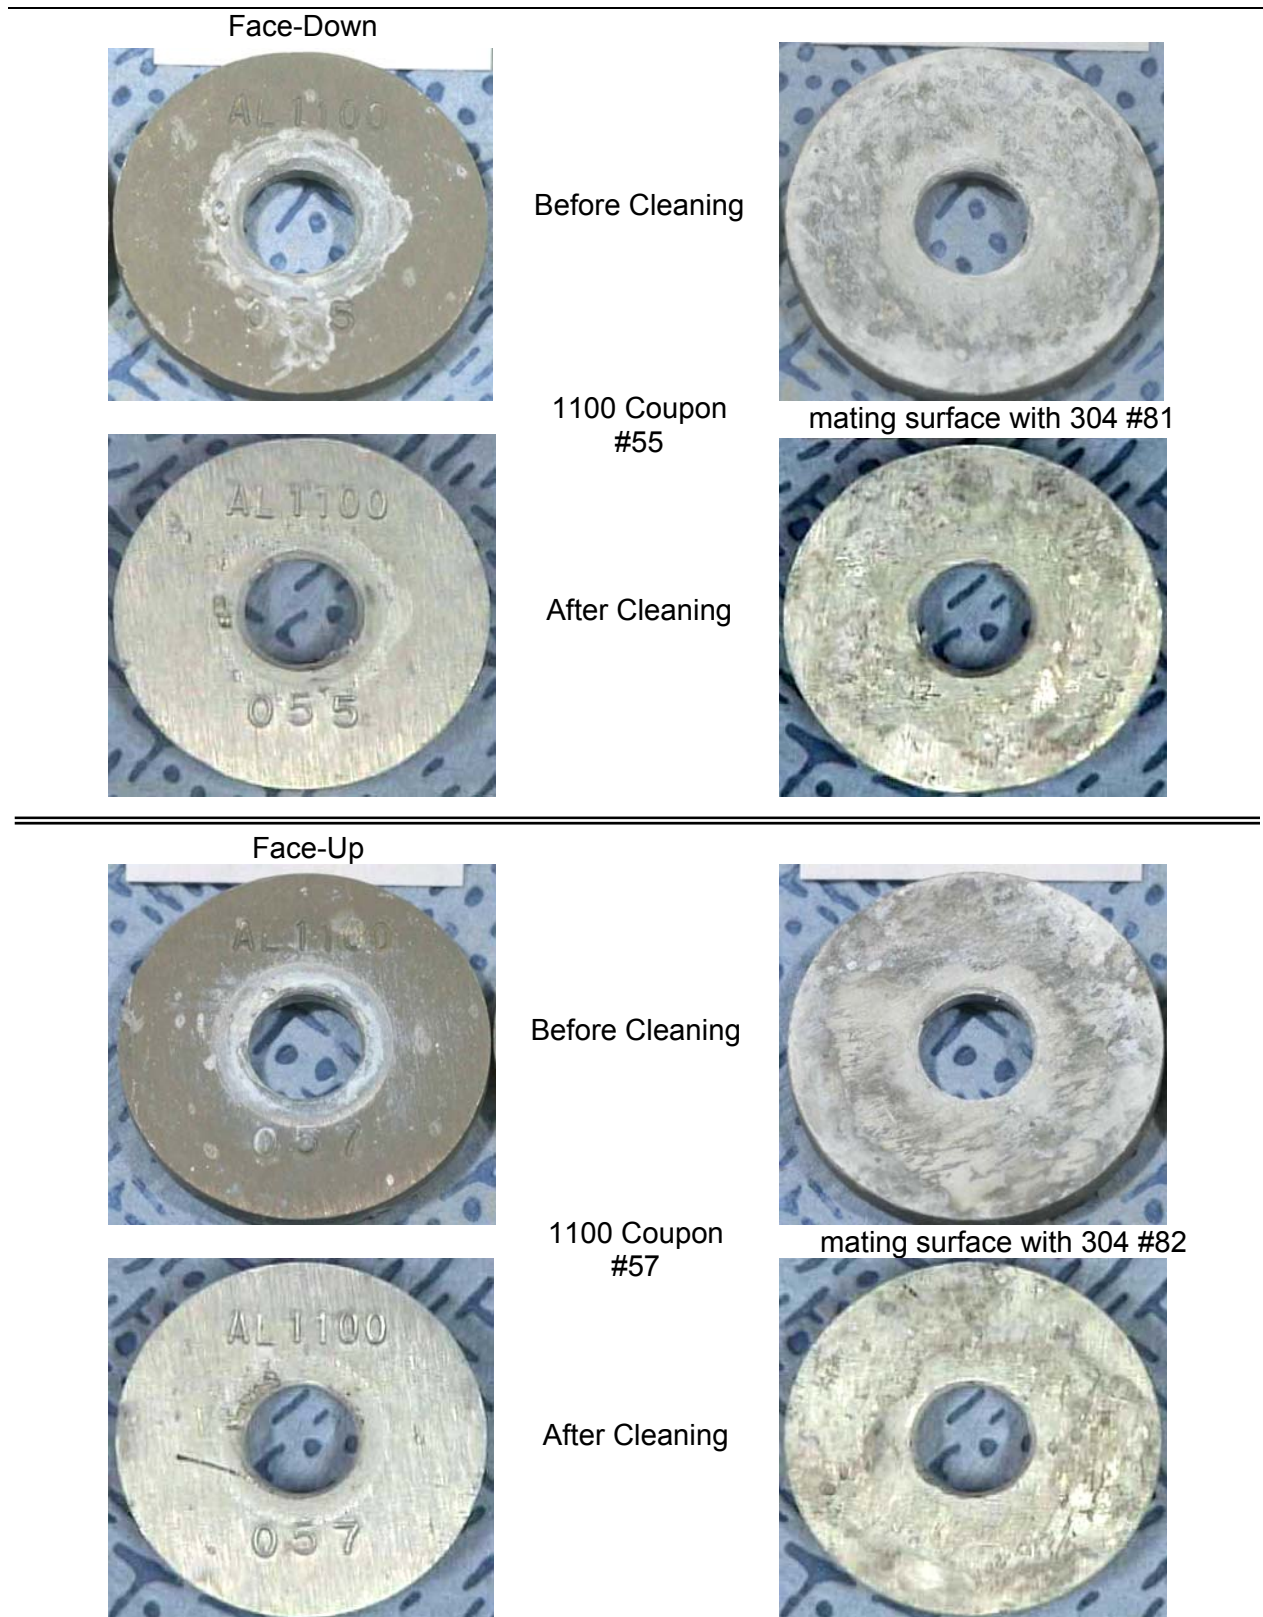
**Galvanic Coupon Specimen Sets:** Galvanic coupon surfaces (mated with 304 stainless steel) are shown in Figure A.12 through Figure A.14 (2005) and Figure B.16 through Figure B.19 (2006). For the non-mating surface side, four out of the six aluminum coupons were facing up in the 2005 galvanic coupon set and coloring was not visible on these surfaces. In the 2006 galvanic coupon set, all non-mating surfaces of the aluminum coupons faced down. Large pits are visible below the Teflon washer area on an Al 6061 coupon (2006) on the side opposite to that mated to 304 stainless steel (Figure B.18).

Figure A.12 Photos taken before and after cleaning of galvanic 1100 coupons, #'s 55 and 57, mated to 304 stainless steel.

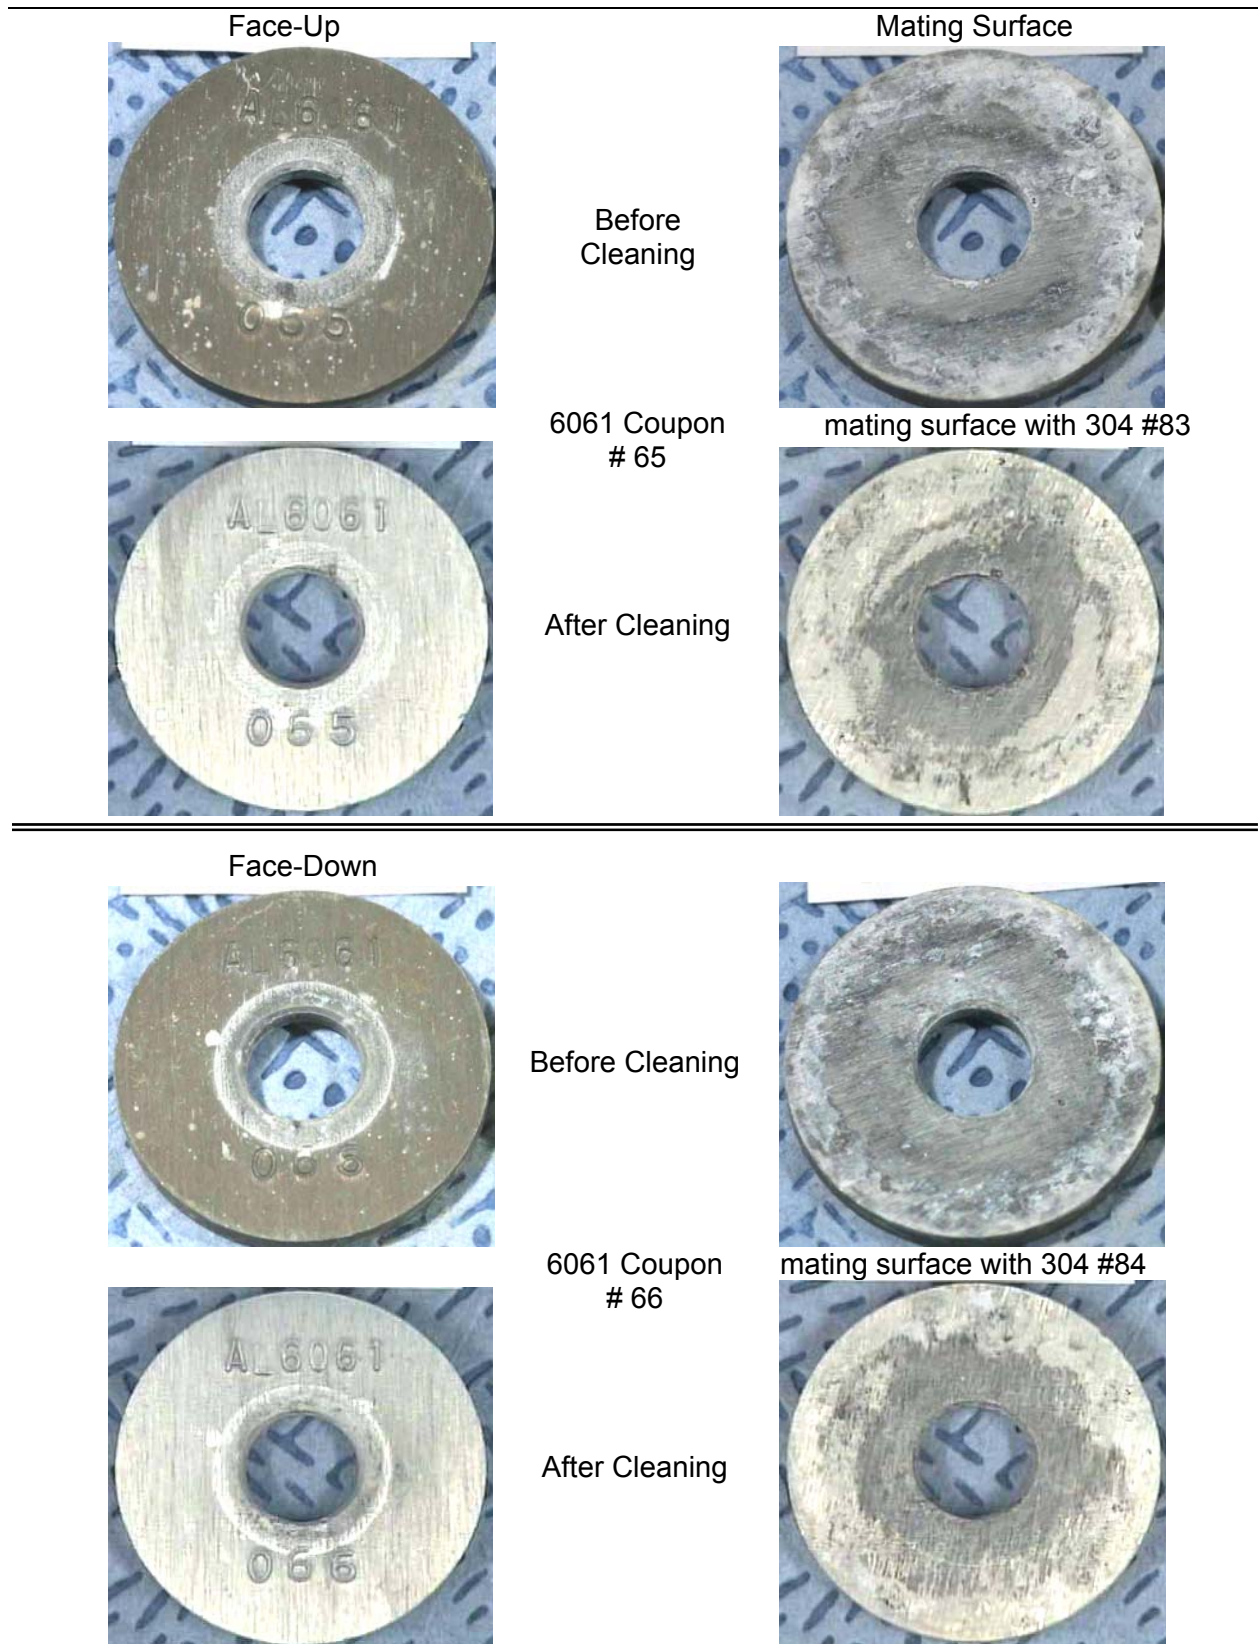
Figure A.13 Photos taken before and after cleaning of galvanic 6061 coupons, #'s 65 and 66, mated to 304 stainless steel.

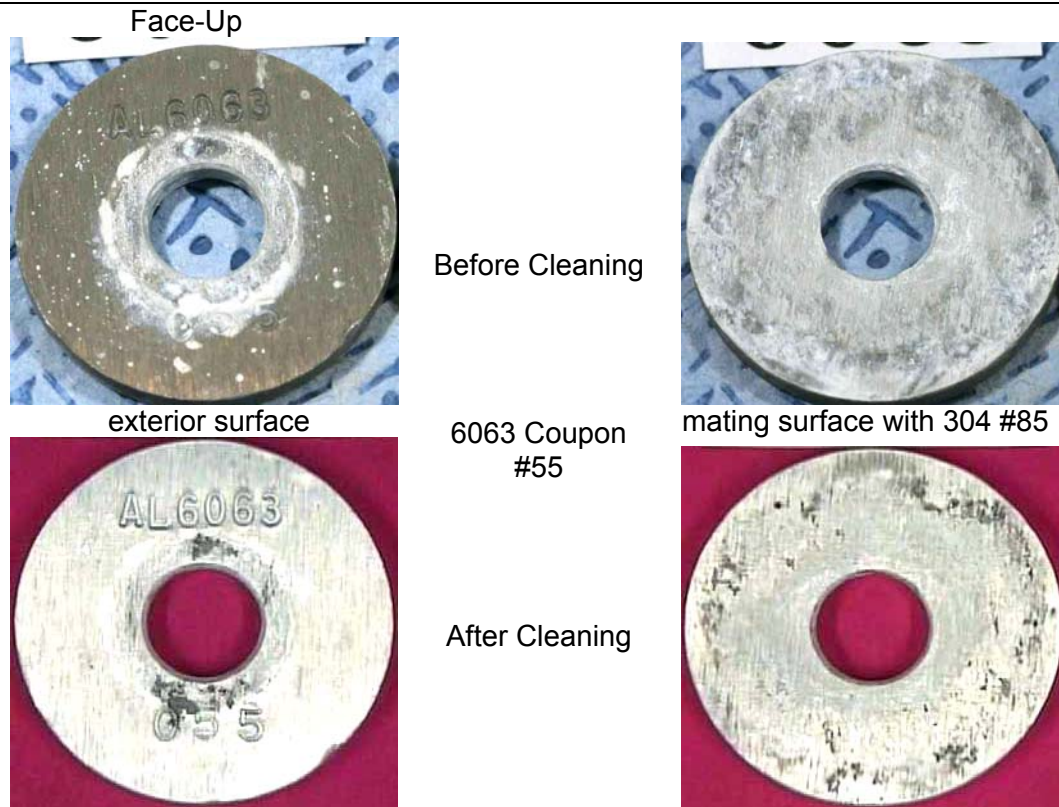
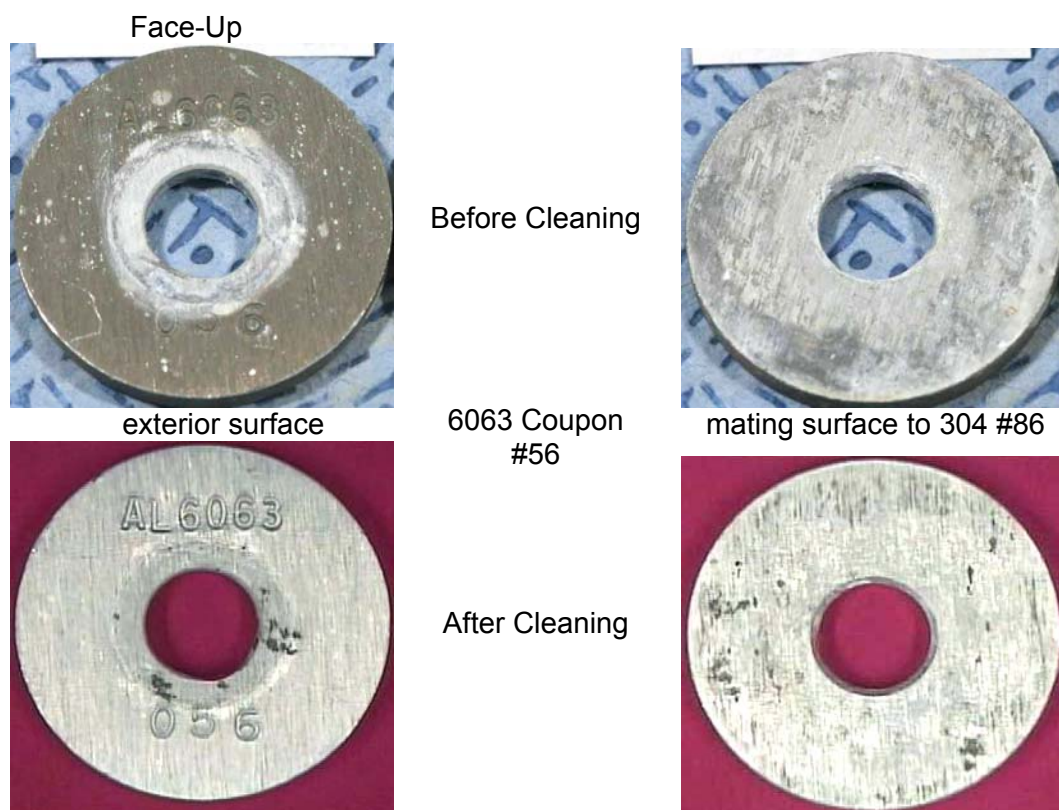
Figure A.14 Photos taken before and after cleaning of galvanic 6063 coupons, #'s 55 and 56, mated to 304 stainless steel.

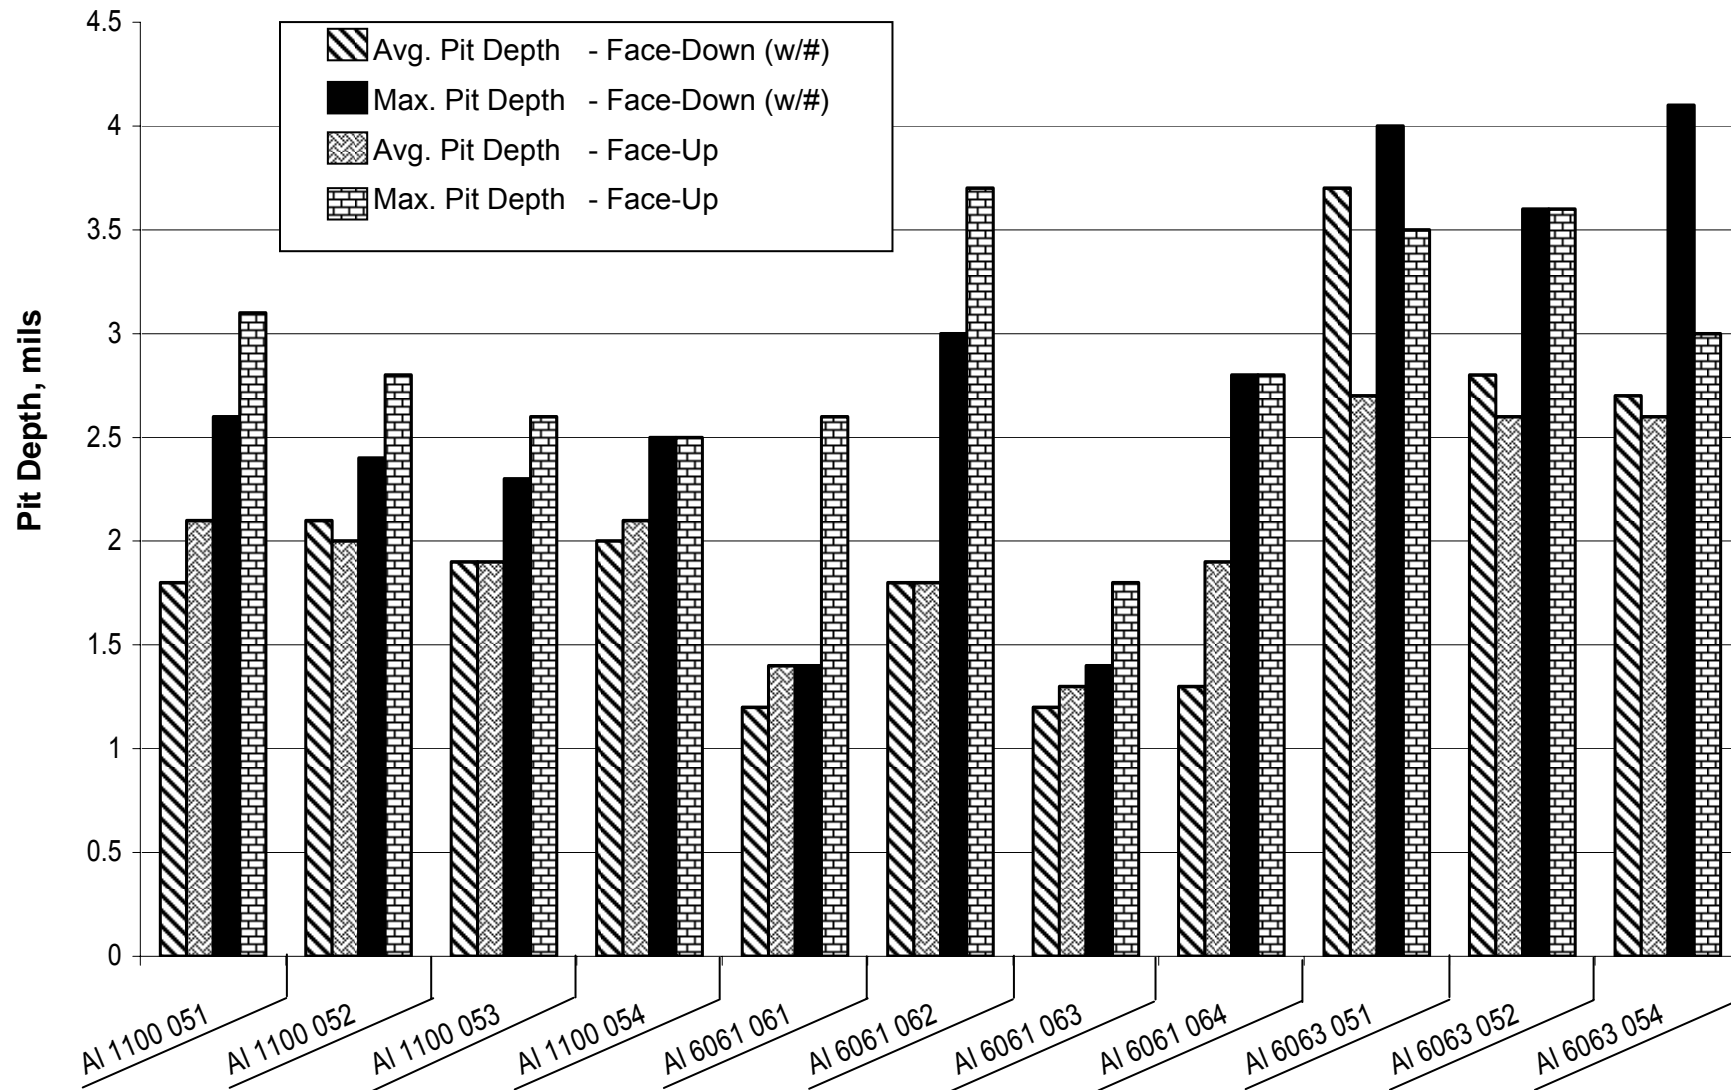
Pit depth measurements were performed on all coupons using a measuring microscope with averages based on the 10 deepest pits per ASTM G46. Pit depth values for single coupons are graphed in Figure A.24 (2005). Pit depth averages and maximums for the 2005 Face-Up coupons (Al 1100 and Al 6061) are greater than or equal to the values ( $\leq 0.7$  mil difference) for the Face-down coupons except for the low average pit depth for the Face-Up side of the Al 1100 #052 coupon. However, the same trend was not observed in the single 6063 coupons where the Face-Down side of the 2005 coupons exhibited higher pit depth averages than the Face-Up side ( $\leq 1$  mil differences). In the 2006 single coupon set, pit depth averages and maximums for the Face-Up surfaces (Al 1100 and Al 6061) exhibited greater than or equal to the values for the Face-down surfaces (Figure B.24). All 6063 coupons revealed pit depth averages and maximums that were greater in the Face-Up surface versus the Face-down surface except for the #132 coupon which displayed higher average pit depths on the Face-down surface. However, the maximum pit depths were higher on the Face-Up surface.

The average pit depth for the 2005 Al 6063 coupons ranged from 2.6-3.7 mils (A.24). These depth averages are higher than the Al 6063 coupon averages of 1.6 mils and 1.3 mils for single 2004 and 2003 Al 6063 coupons, respectively. In 2006, the Al 6063 coupons average pit depth was  $\leq 3.6$  mils (B.24). The Al 6063 pit depths (average and maximum) are graphed in Figure B.23 which also displays a decrease in rates as observed for Al 1100 and Al 6061.

Figure A.24 Effect of aluminum alloy type and orientation on pit depths. Note: In this figure, the numbered (#) side was always face down in the basin.

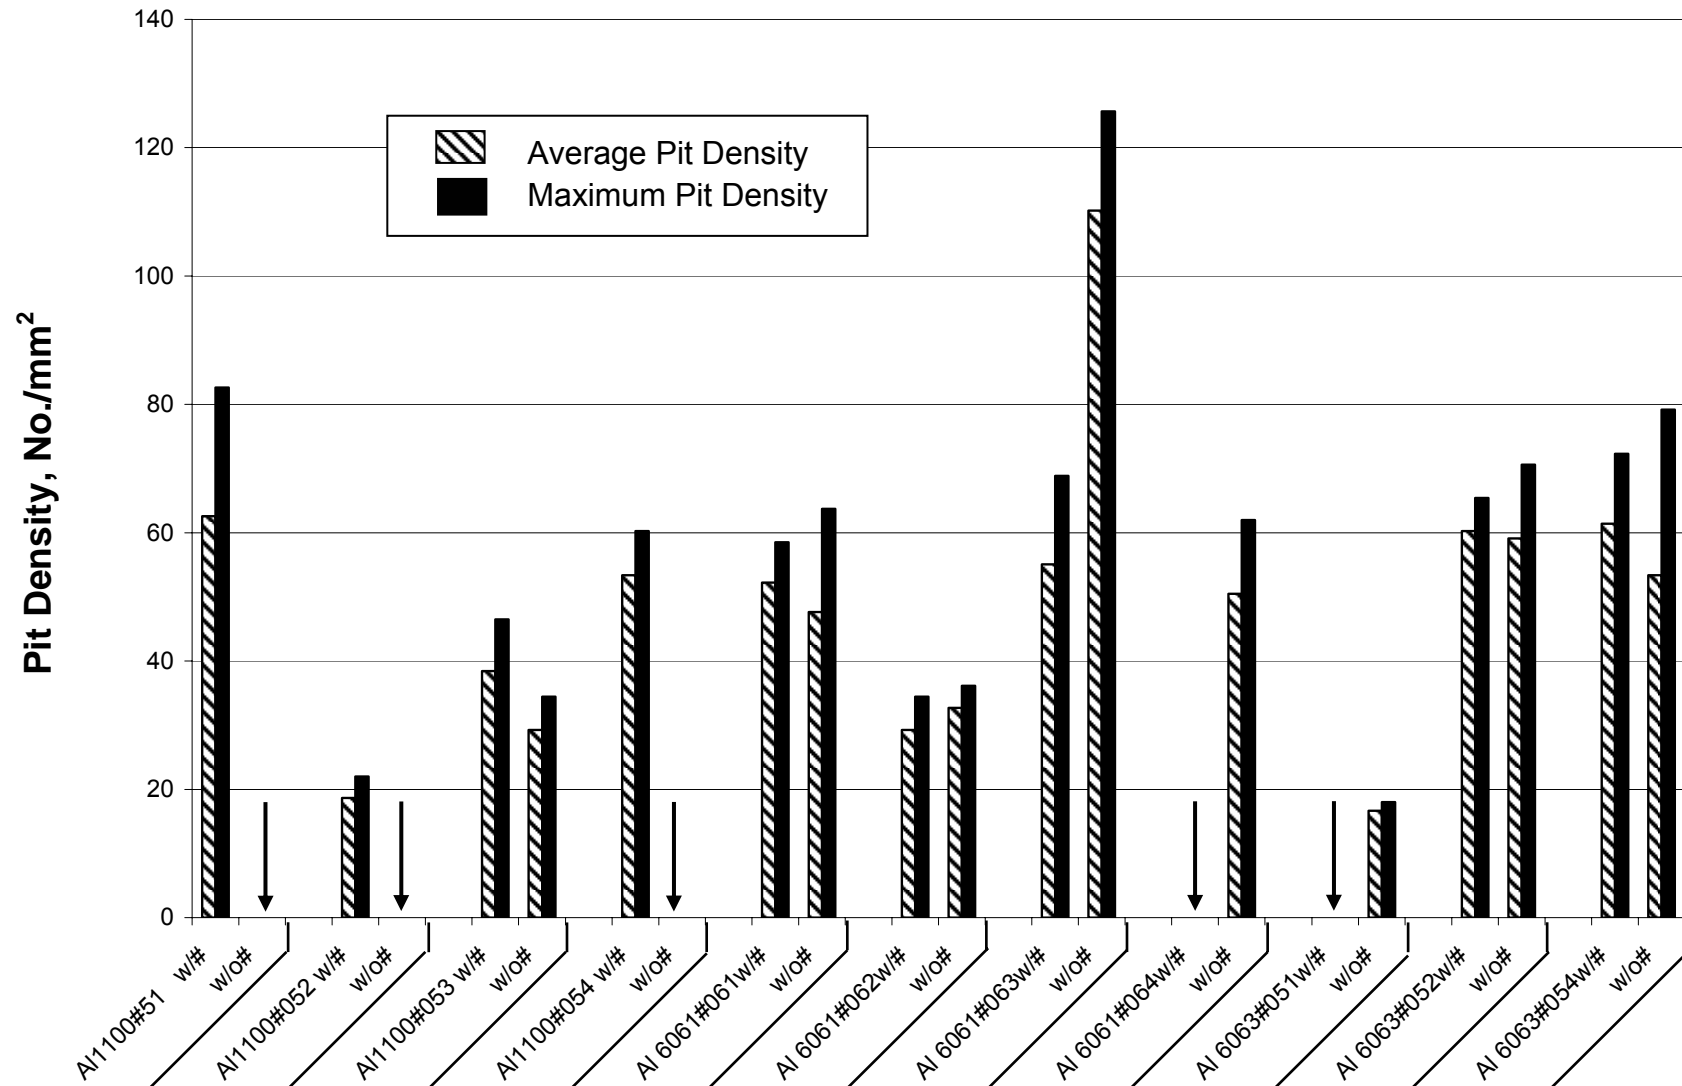
Figure A.25 Effect of aluminum alloy type and orientation on pit densities. Data for both sides of the coupon are shown: w/# is side facing down in the basin while w/o# is side facing up. Arrows indicate very low pit densities (< 5 pits/mm<sup>2</sup>).

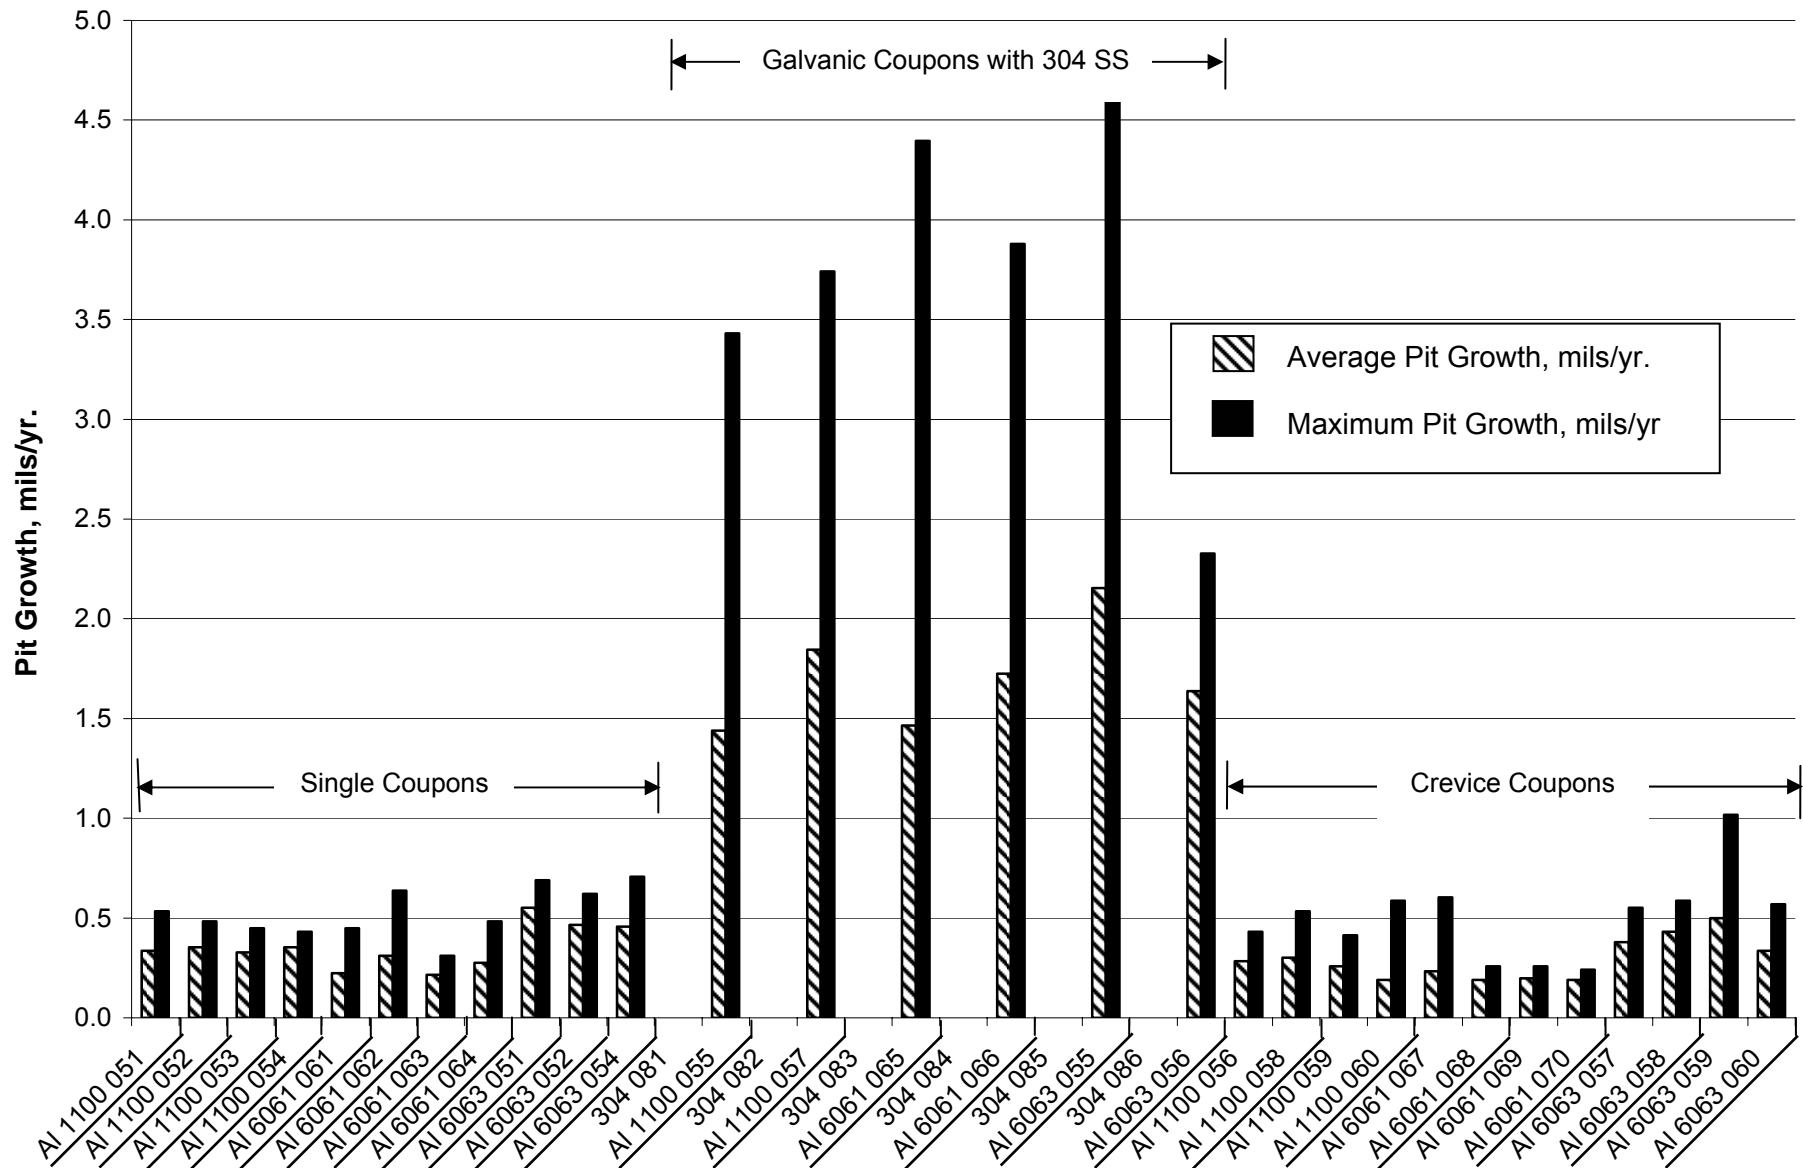
Figure A.27 Effect of coupon types and alloy on pit growth.

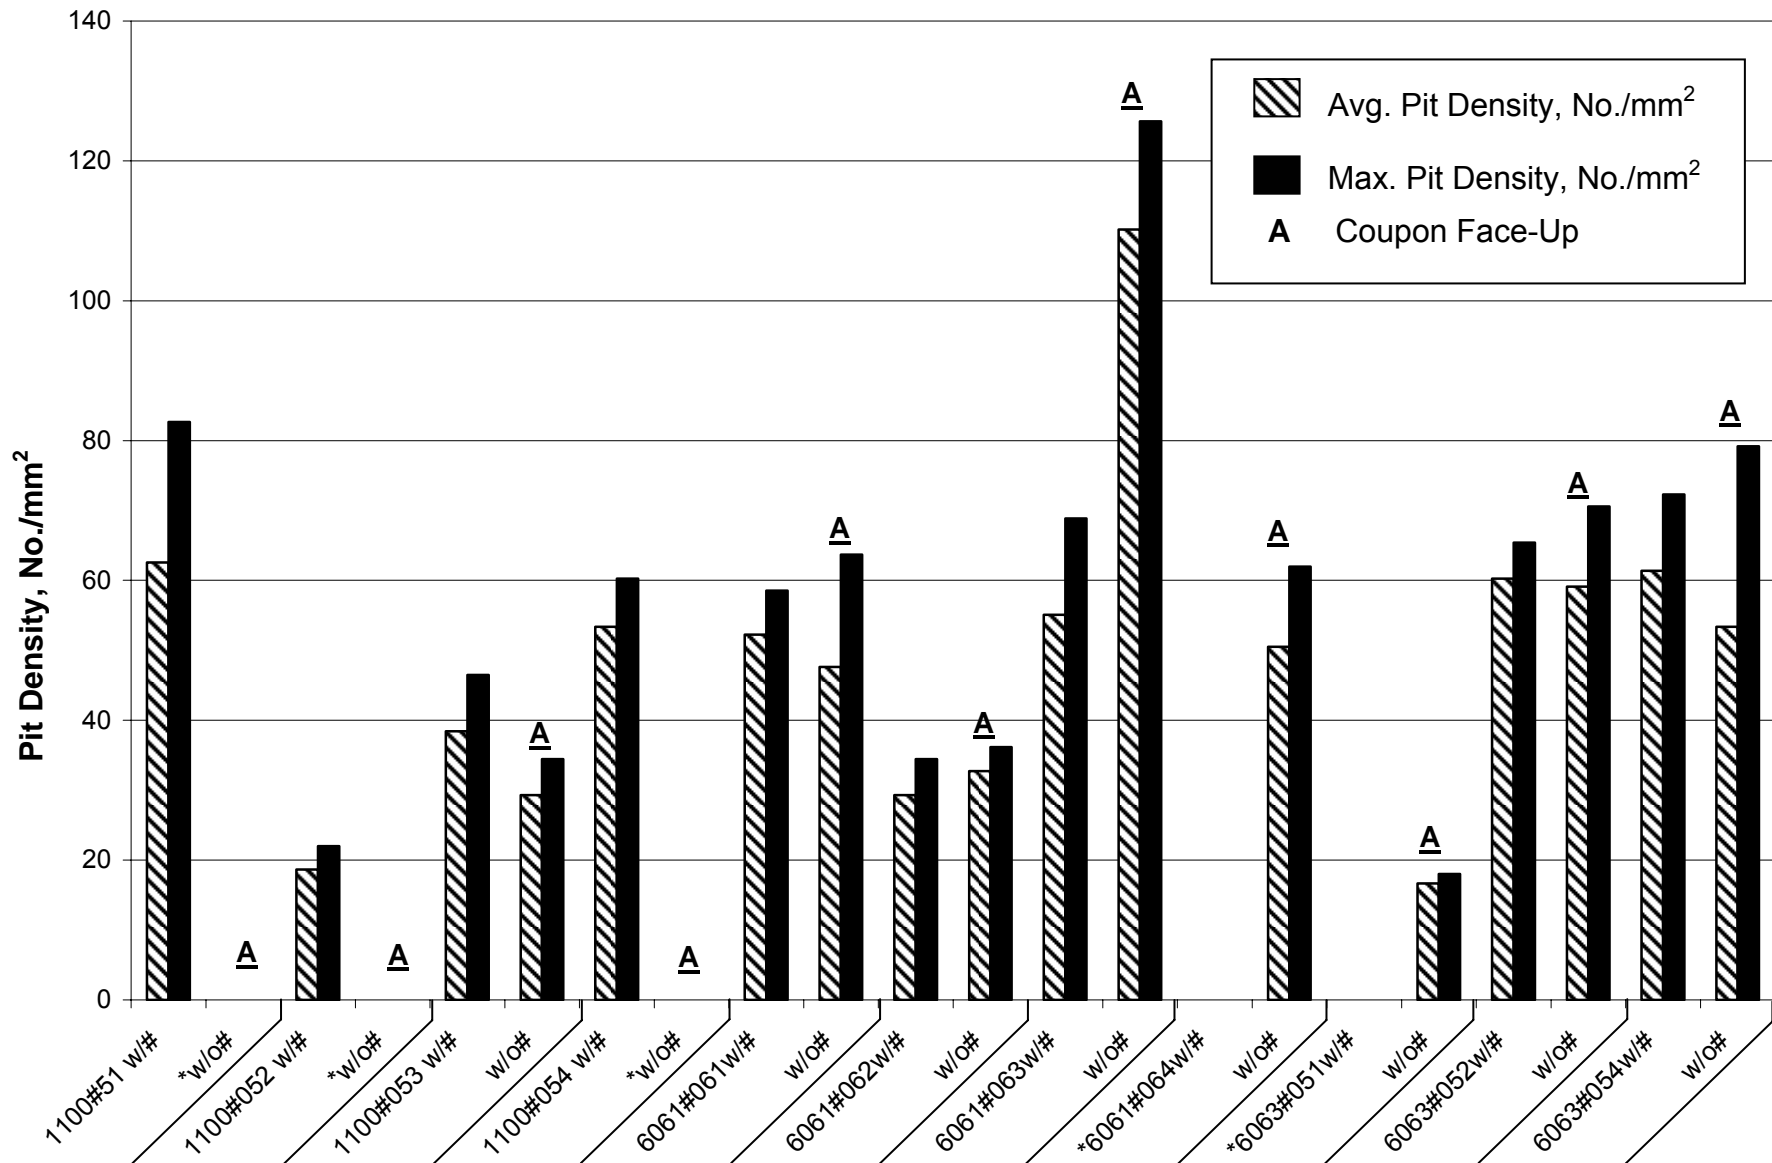
Figure A.28 Effect of coupon type, alloy type and surface orientation on pit density. The asterisk indicates that surface displayed less than 50 pits.

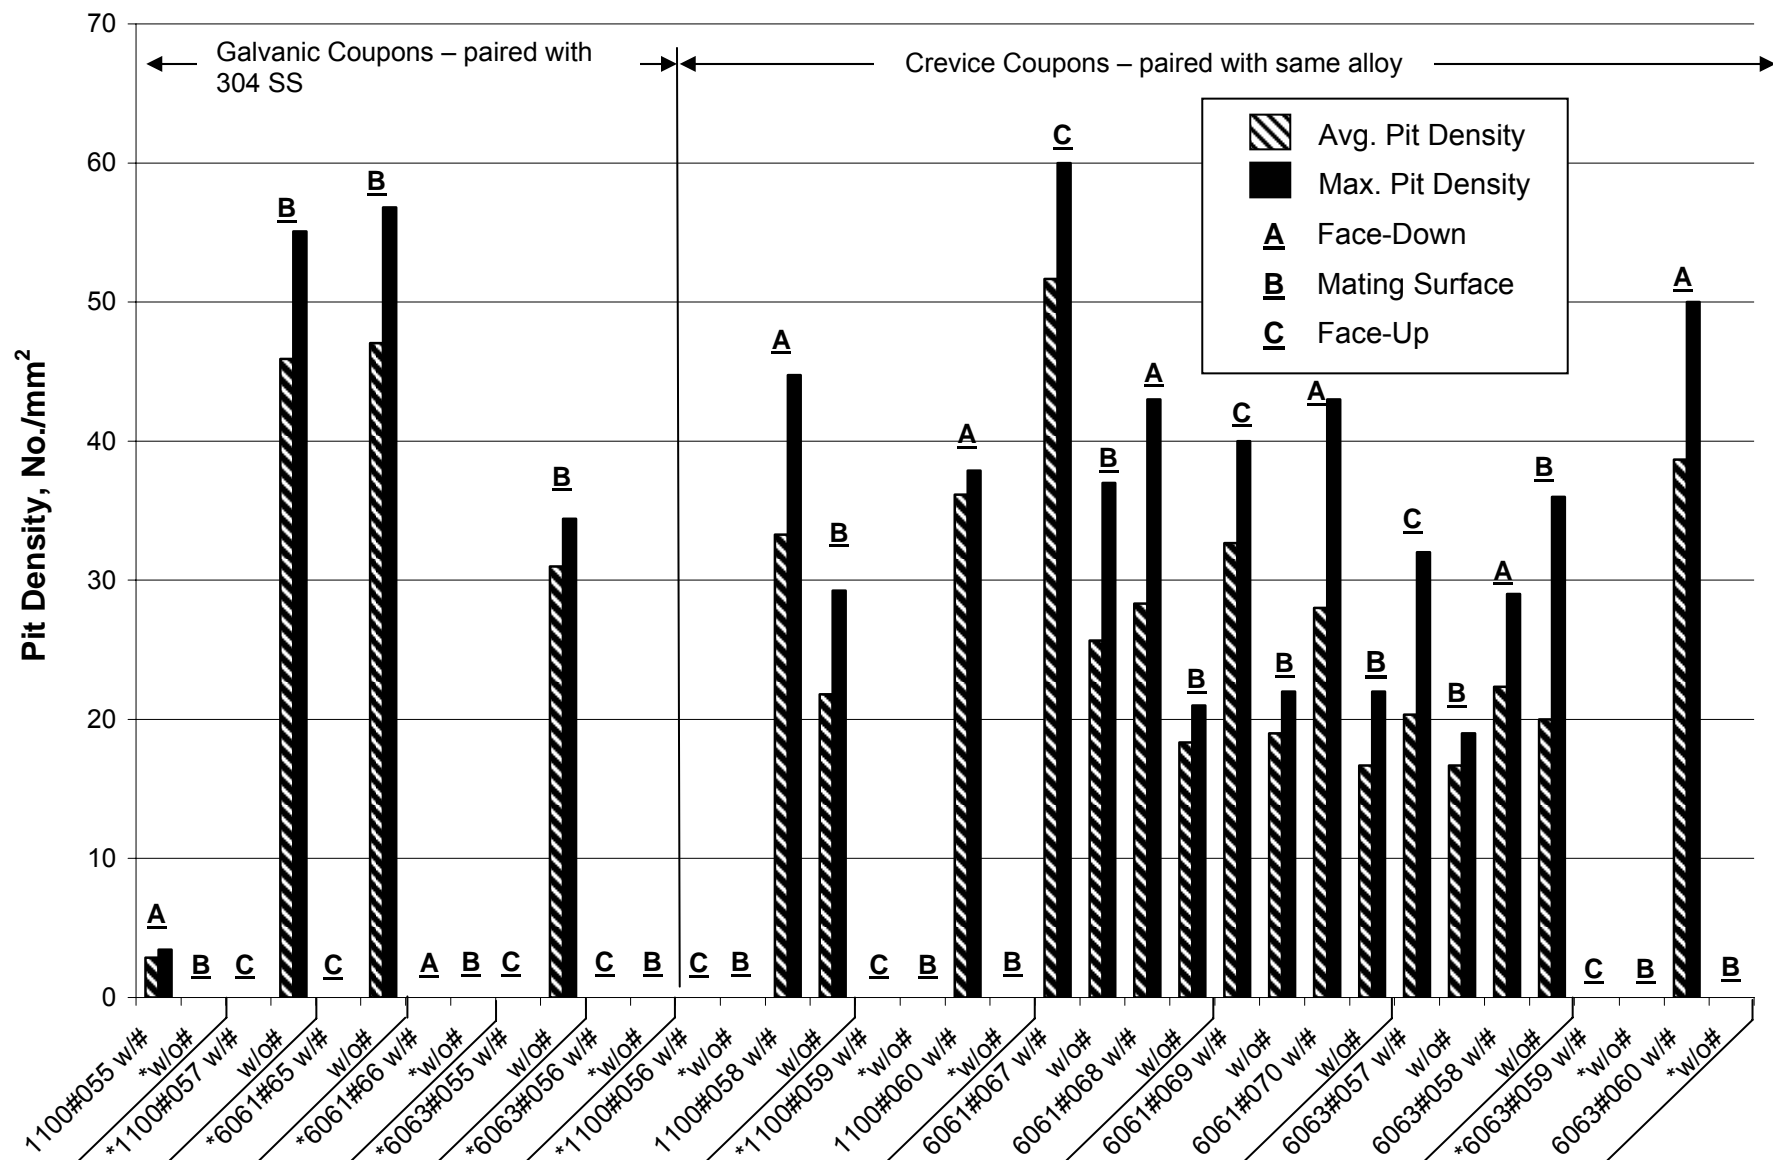
Figure A.29 Effect of galvanic or crevice pairs, alloy type, and orientation on pit density. Alloy coupon surfaces denoted with an asterisk displayed a total number of pits in three separate 0.58 mm<sup>2</sup> areas to be < 50.

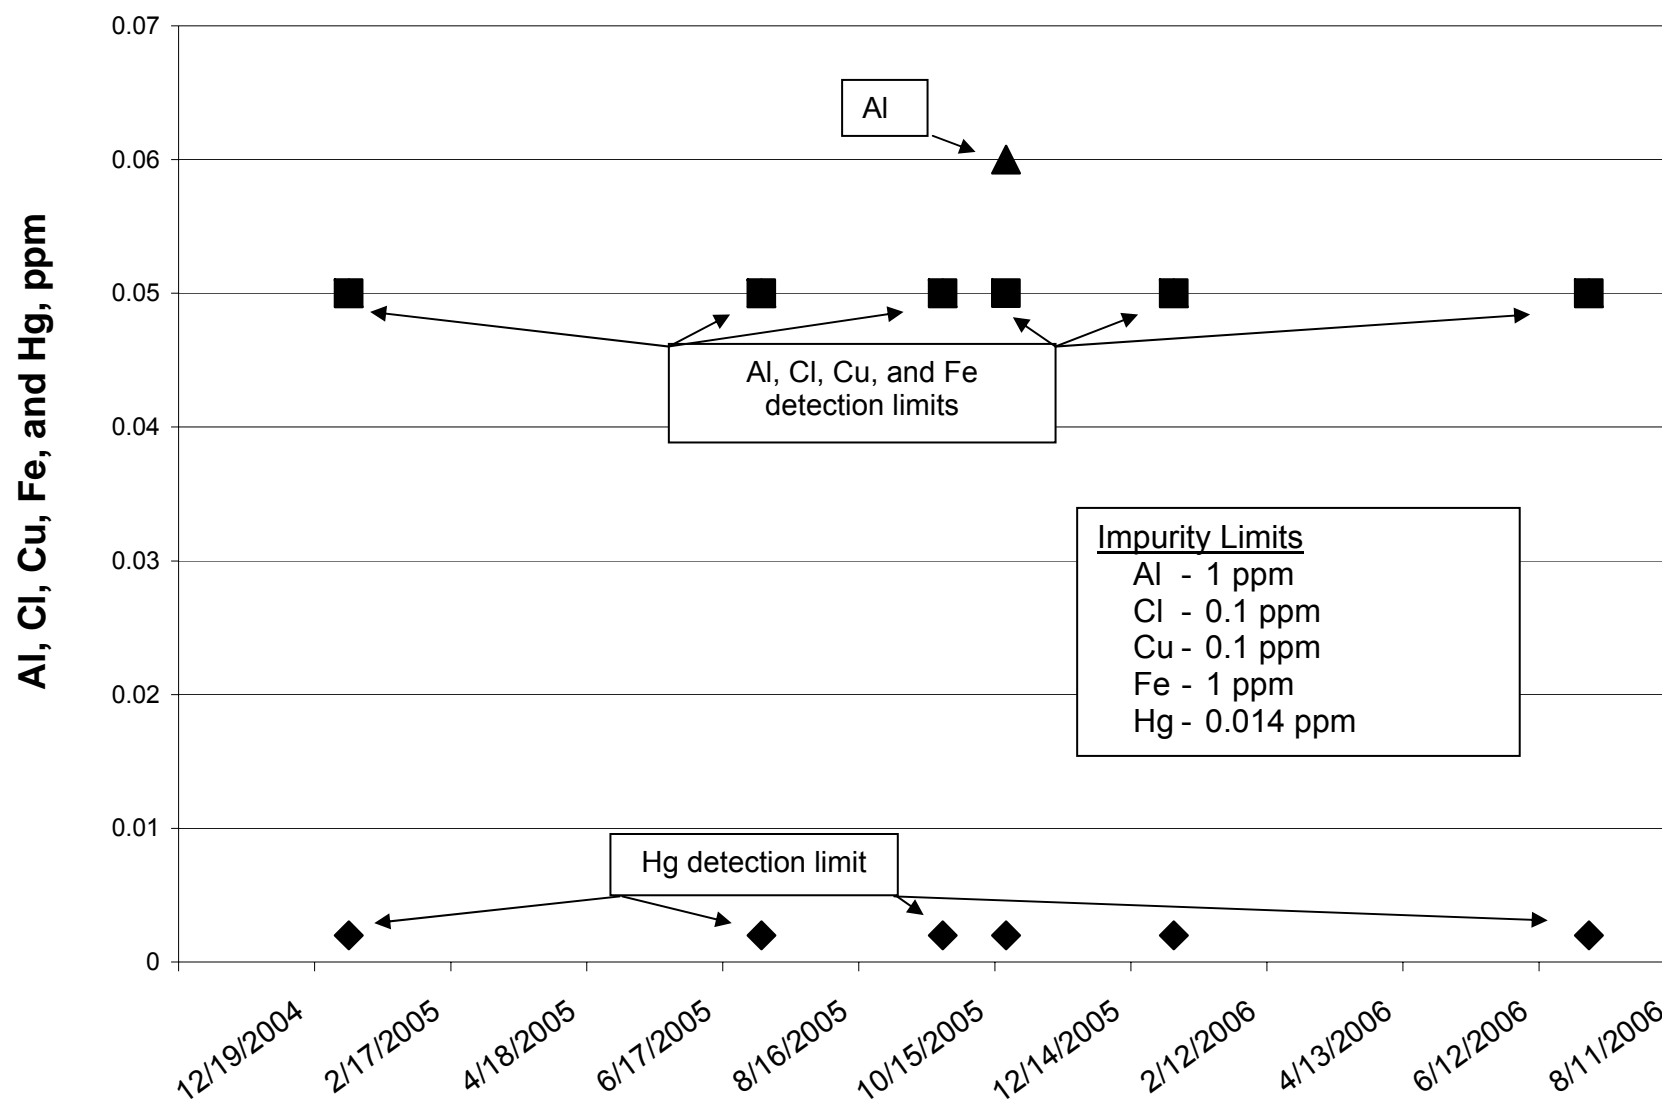
Figure B.3 Time dependent impurity levels in L-Basin during the period January 2005 to July 2006. All but one data point is below the detectible limits. Elemental Aluminum was detected at 0.06 ppm on 10/20/2005 but is still well below the limit of 1 ppm.

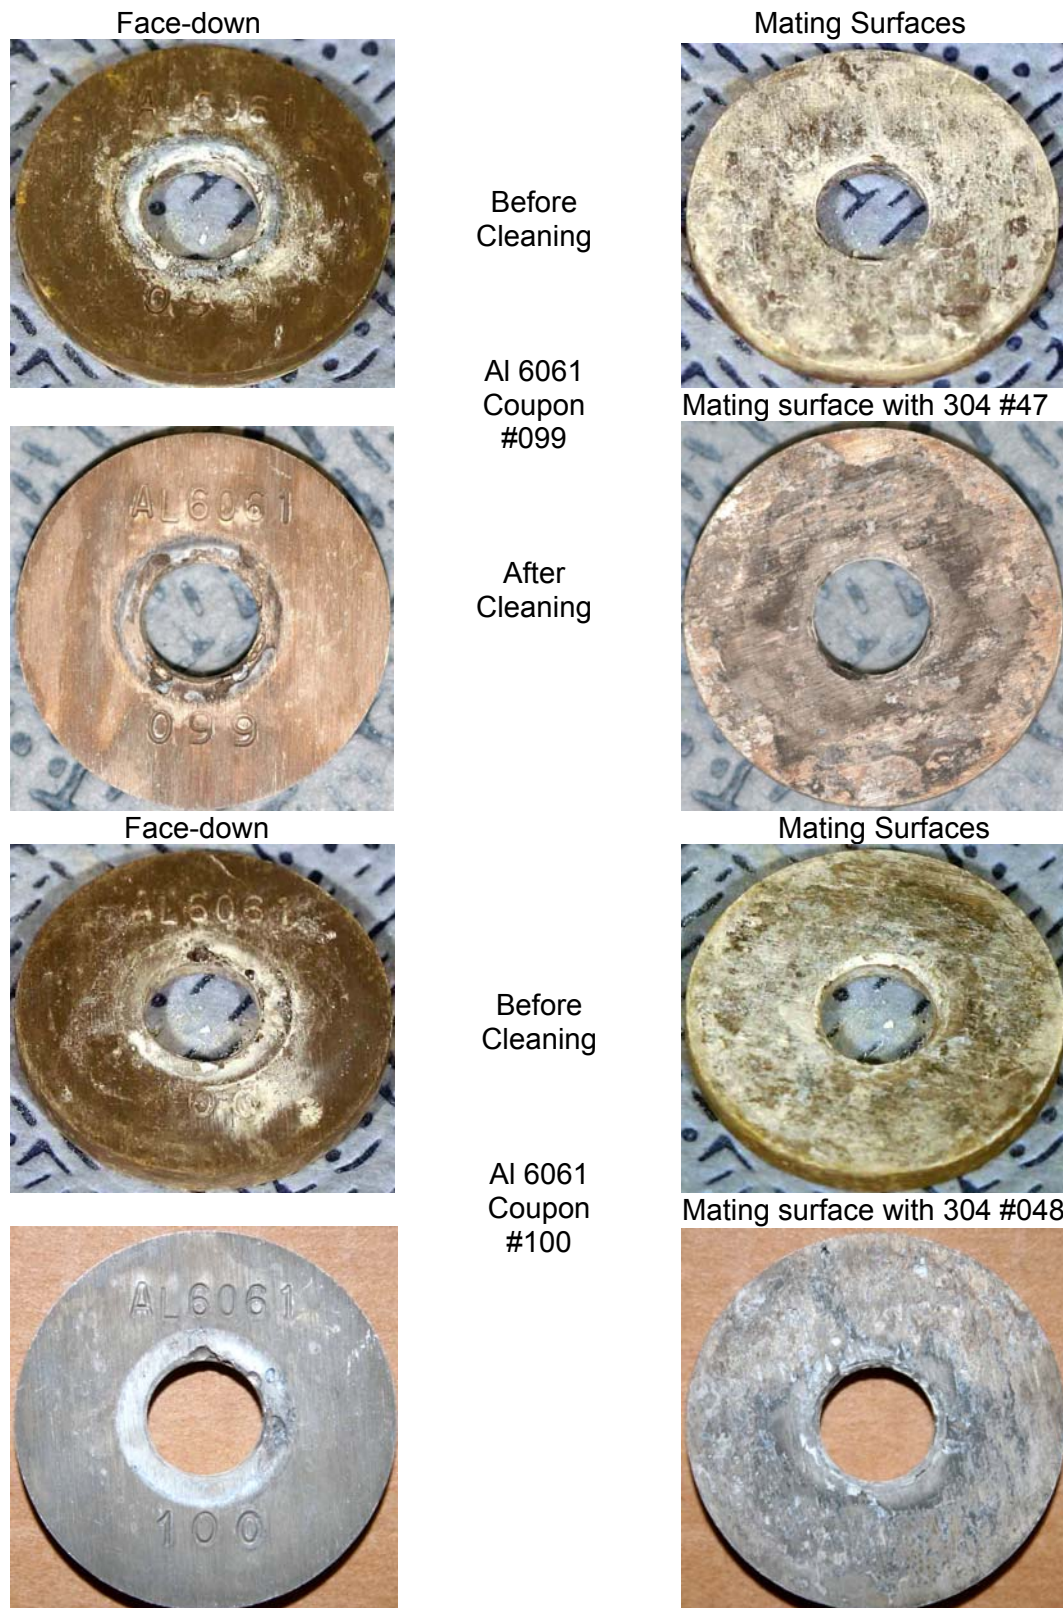
Figure B.17    Photos taken before and after cleaning of of galvanic 6061 coupons, #'s 99 and 100.
