# FY2005 and FY2006 Corrosion Surveillance Results for L-Basin

Savannah River National Laboratory  
Materials Science and Technology

Publication Date: September 2007

**DOCUMENT: WSRC-STI-2007-00692****Title: FY2005-2006 Corrosion Surveillance Results for L-Basin (U)****MS&T APPROVALS**

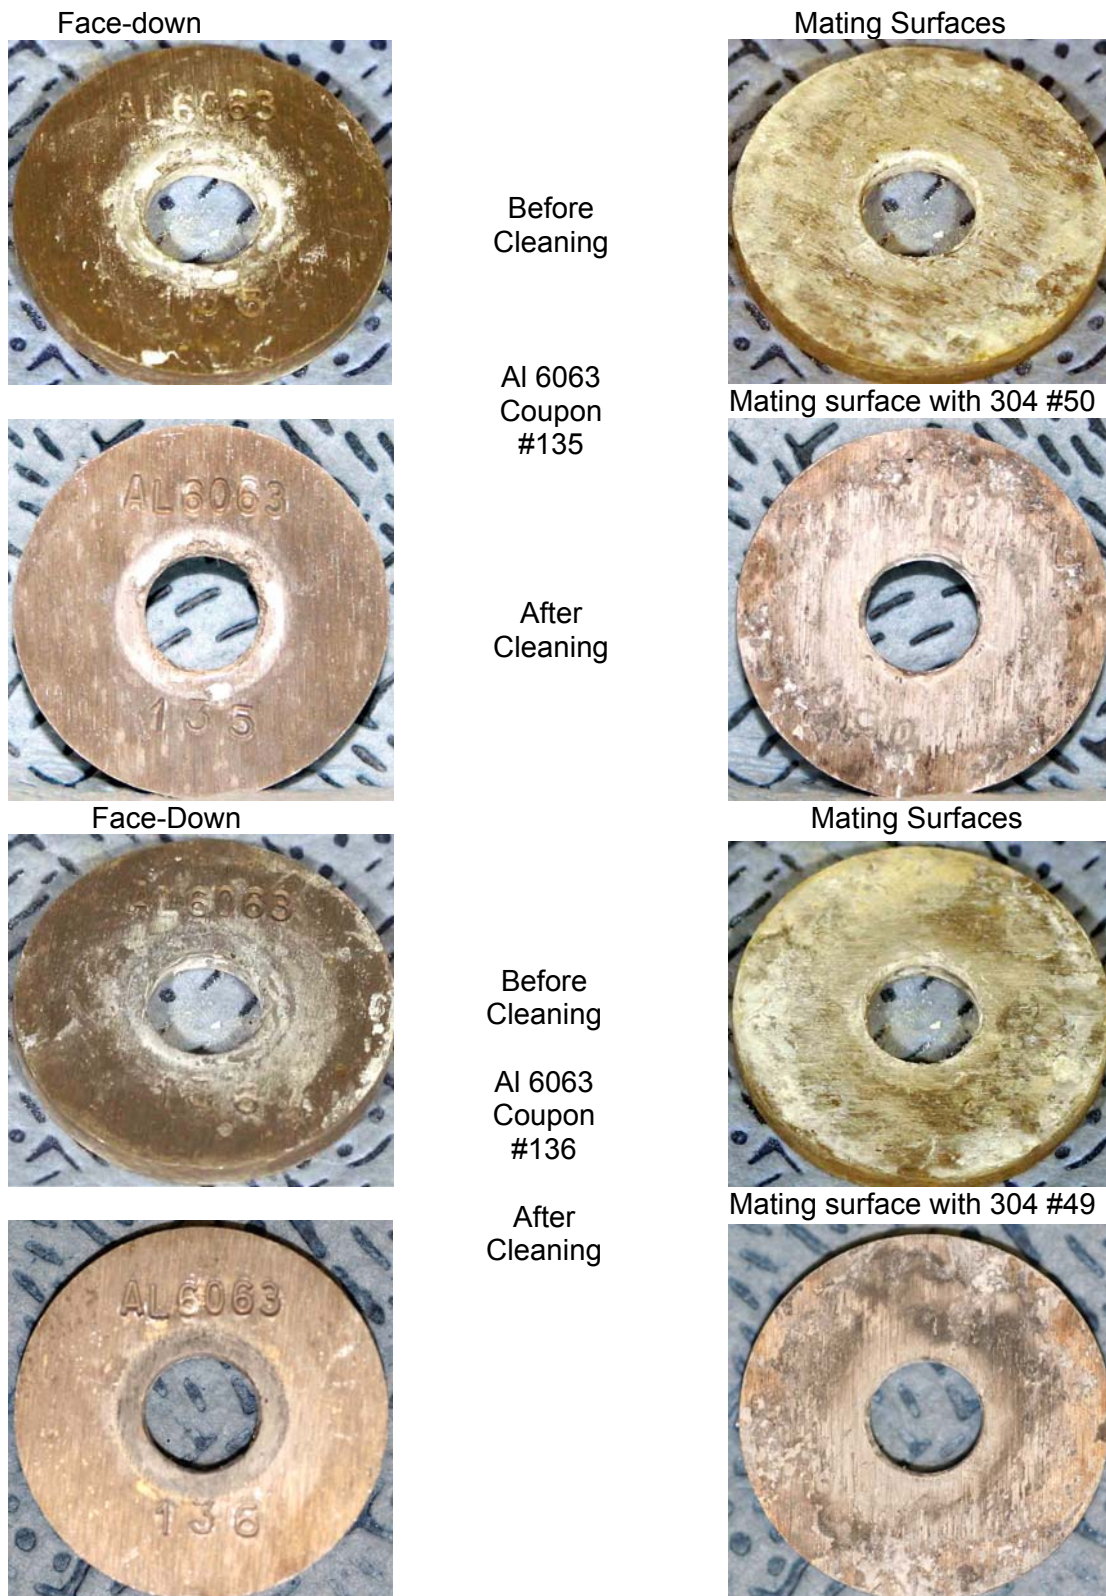
**Galvanic Coupon Specimen Sets:** Galvanic coupon surfaces (mated with 304 stainless steel) are shown in Figure A.12 through Figure A.14 (2005) and Figure B.16 through Figure B.19 (2006). For the non-mating surface side, four out of the six aluminum coupons were facing up in the 2005 galvanic coupon set and coloring was not visible on these surfaces. In the 2006 galvanic coupon set, all non-mating surfaces of the aluminum coupons faced down. Large pits are visible below the Teflon washer area on an Al 6061 coupon (2006) on the side opposite to that mated to 304 stainless steel (Figure B.18).

Figure B.19    Photos taken before and after cleaning of of galvanic 6063 coupons, #'s 135 and 136.

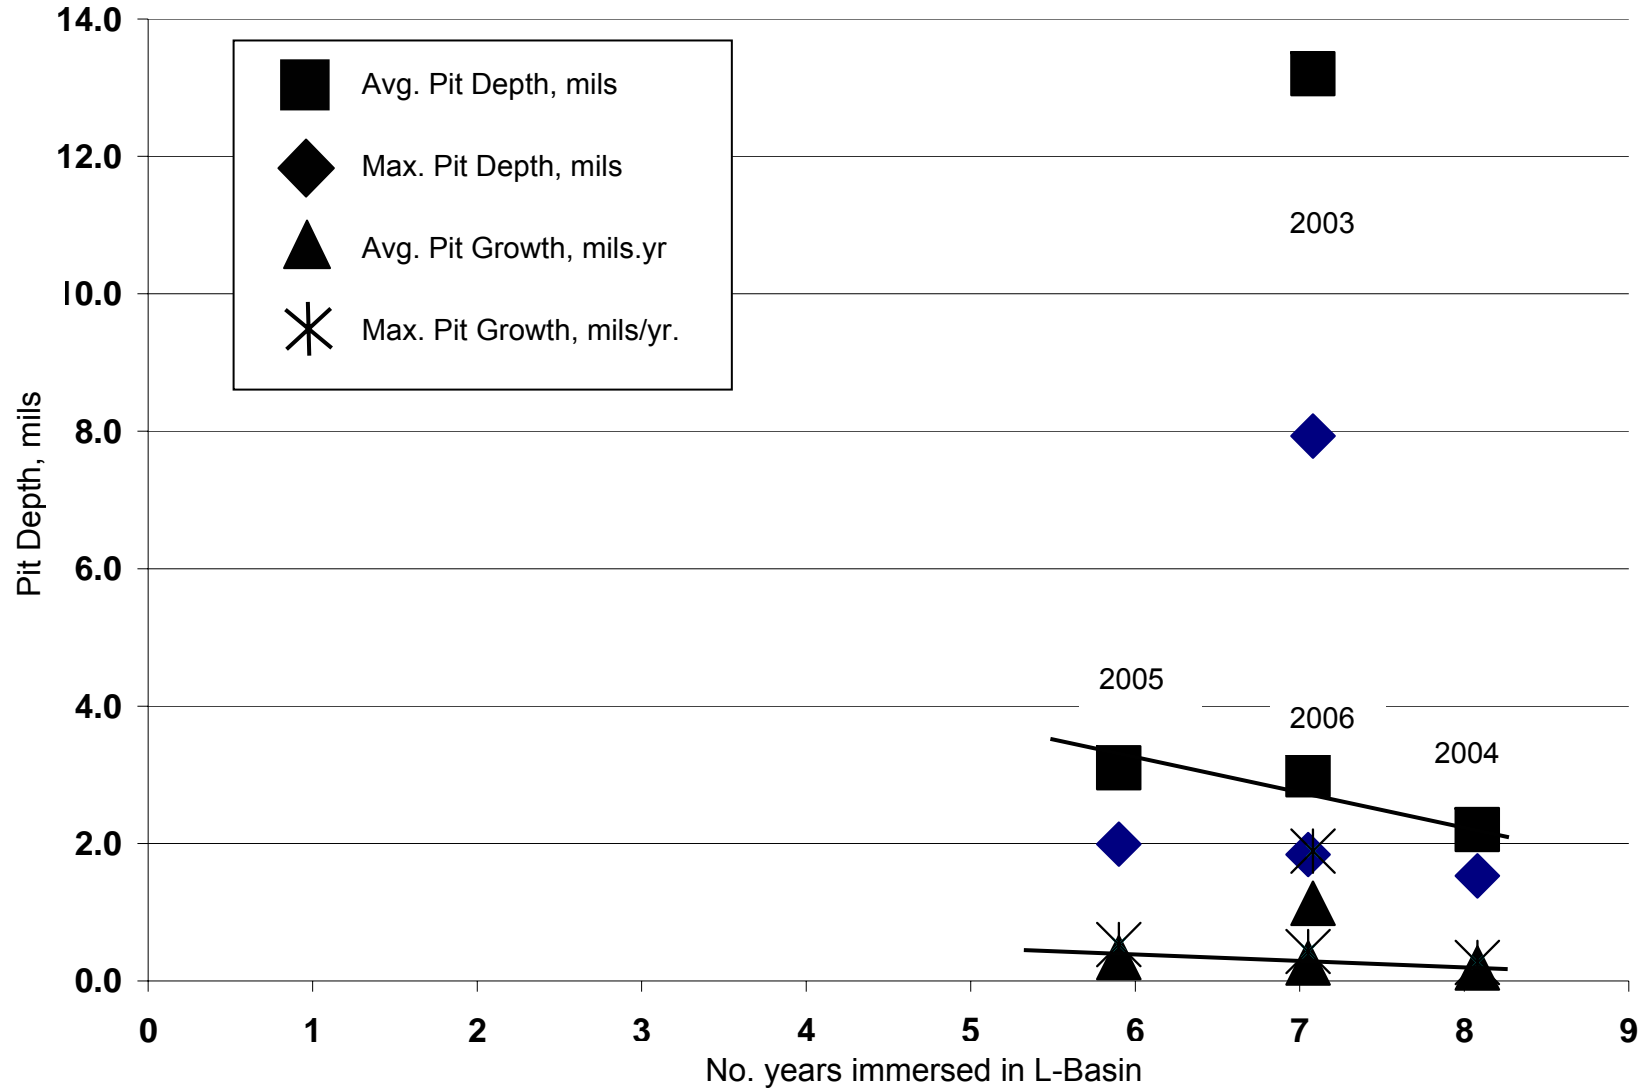
Figure B.21 Average and maximum pit data for Al1100 coupons removed in 2003, 2004, 2005, and 2006. The average and maximum 2003 data are beyond the drawn boundary lines compared to remaining data.

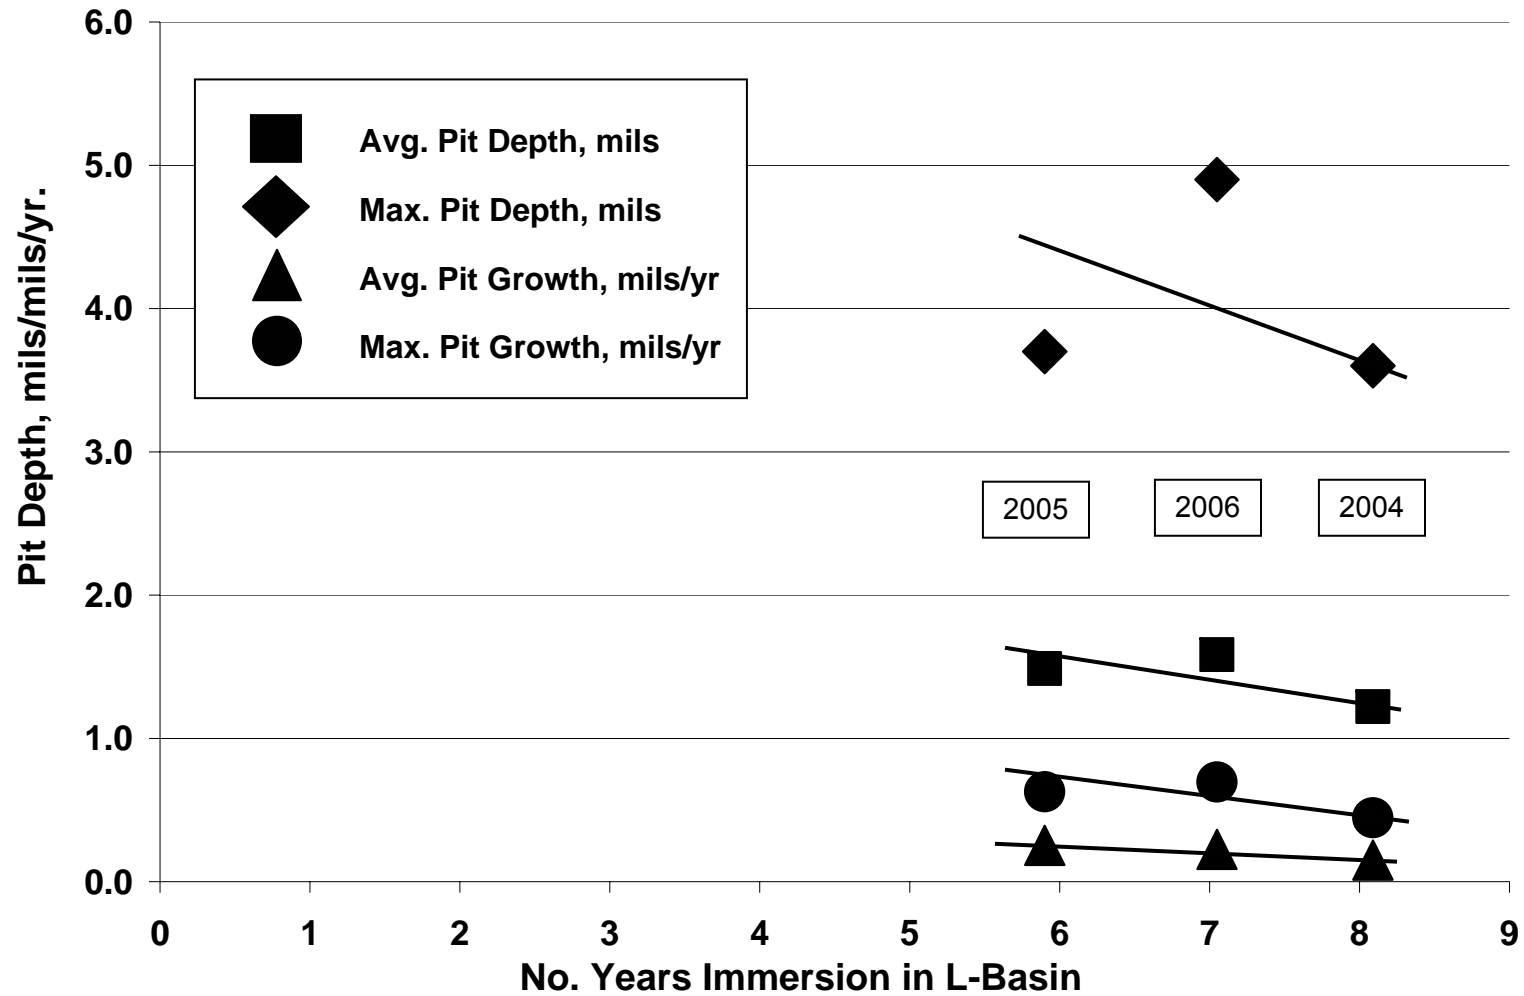
Figure B.22 Average and maximum pit data for Al 6061 coupons removed in 2004, 2005, and 2006.

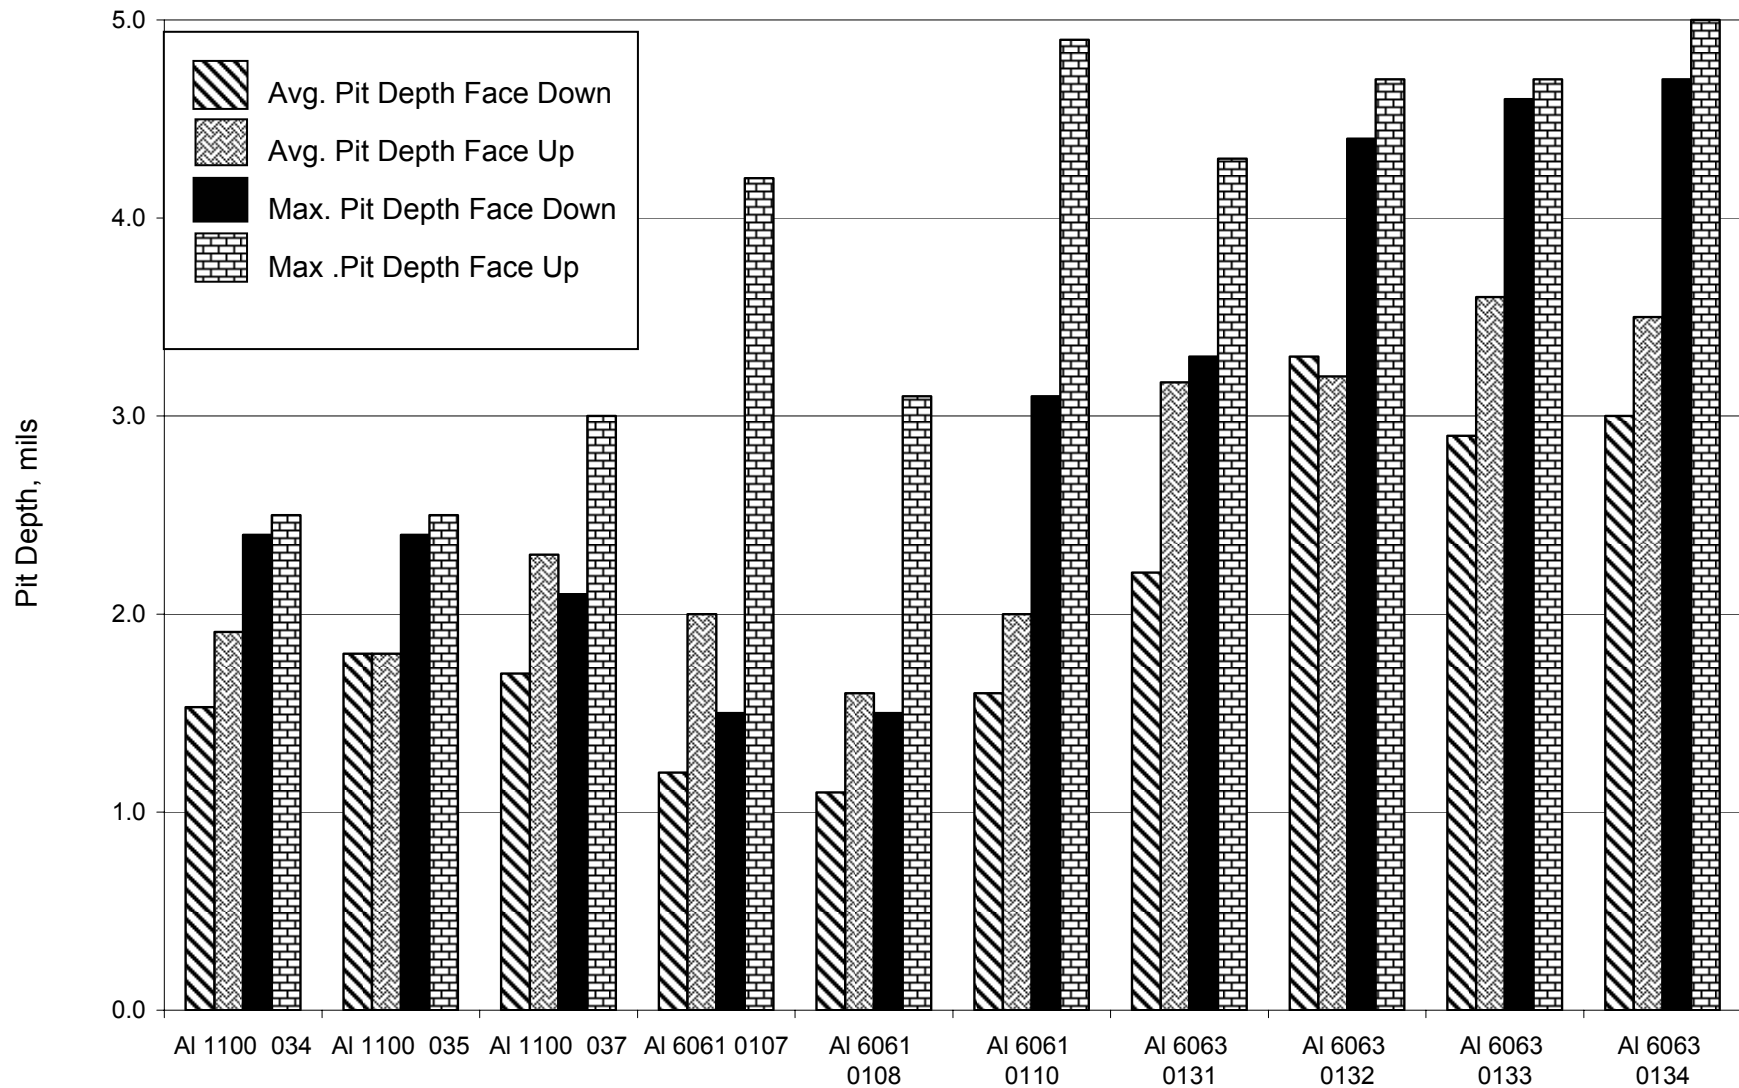
Figure B.23 Average and maximum pit data for Al 6063 coupons removed in 2003, 2004, 2005, and 2006.

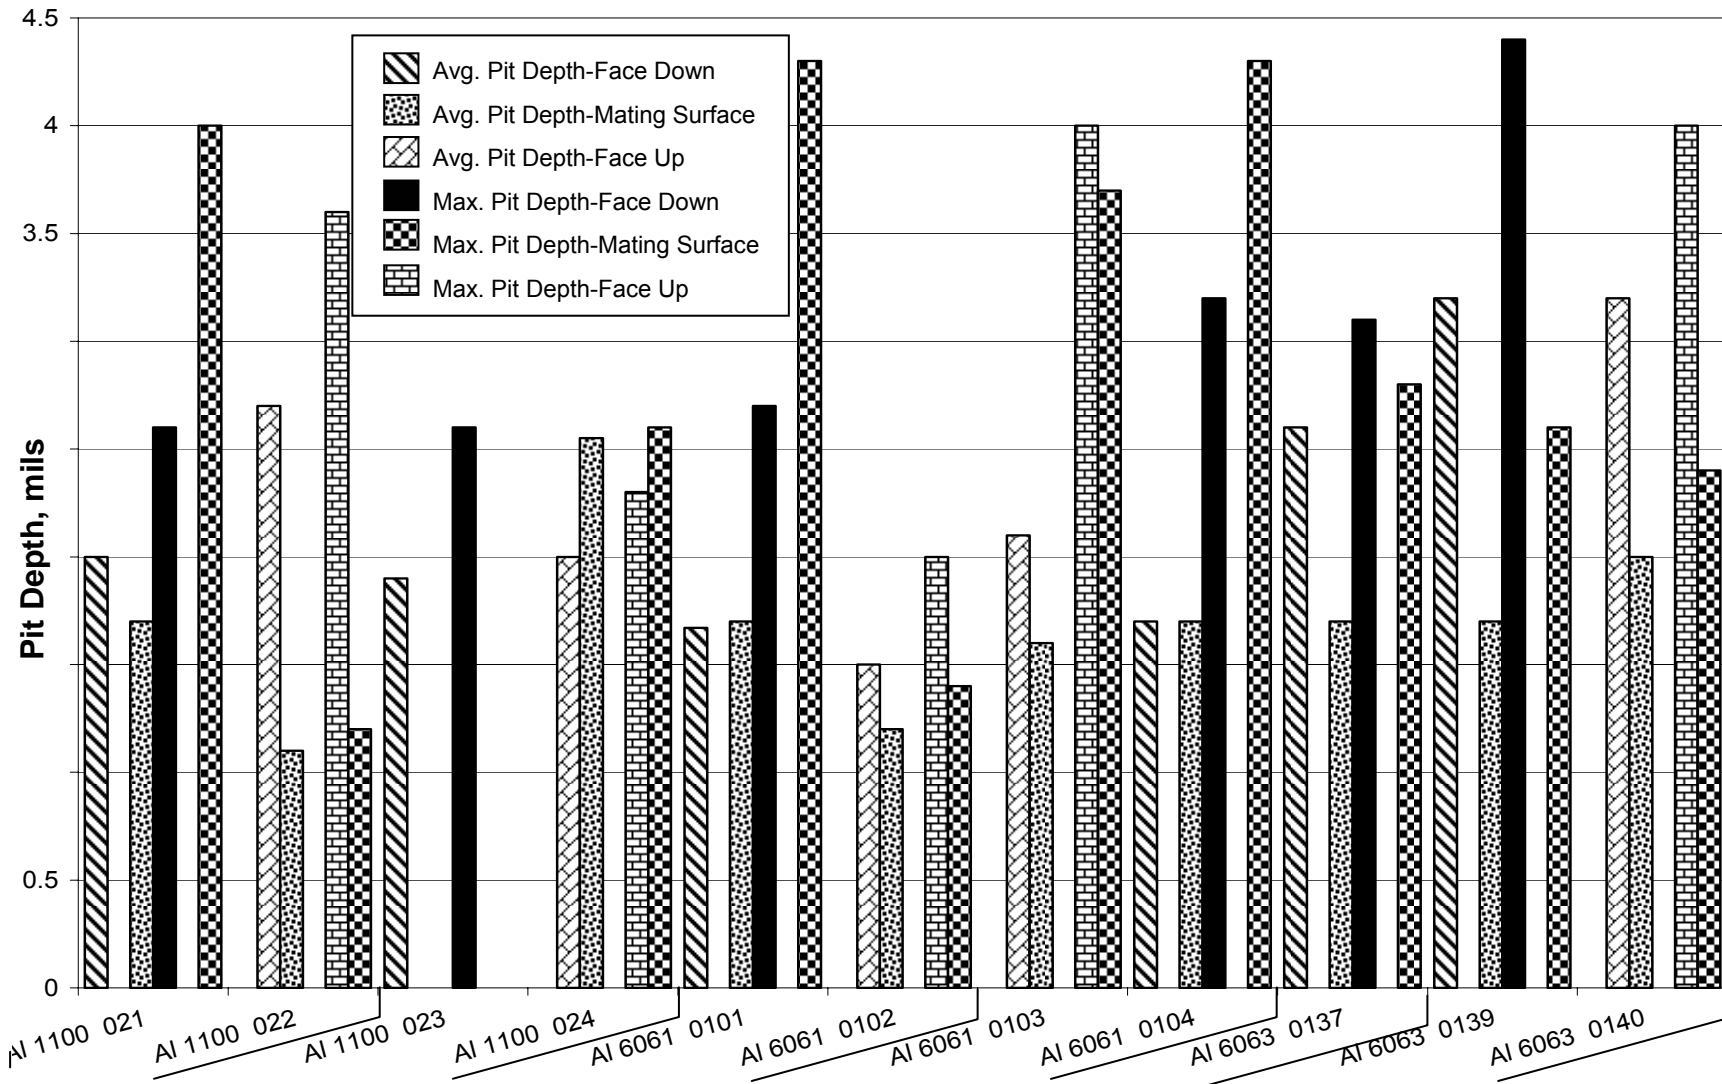
Figure B.24 Effect of aluminum alloy type and orientation on pit depths on 2006 corrosion surveillance coupons. These are individual coupons.
