L-Area Wastewater Storage Drum Evaluation

P. R. Vormelker, D. Z. Nelson, C. N. Foreman, D. J. Hathcock, and D. W. Vinson
Savannah River National Laboratory
Materials Science and Technology

Publication Date: November 2007

DOCUMENT: WSRC-STI-2008-00228

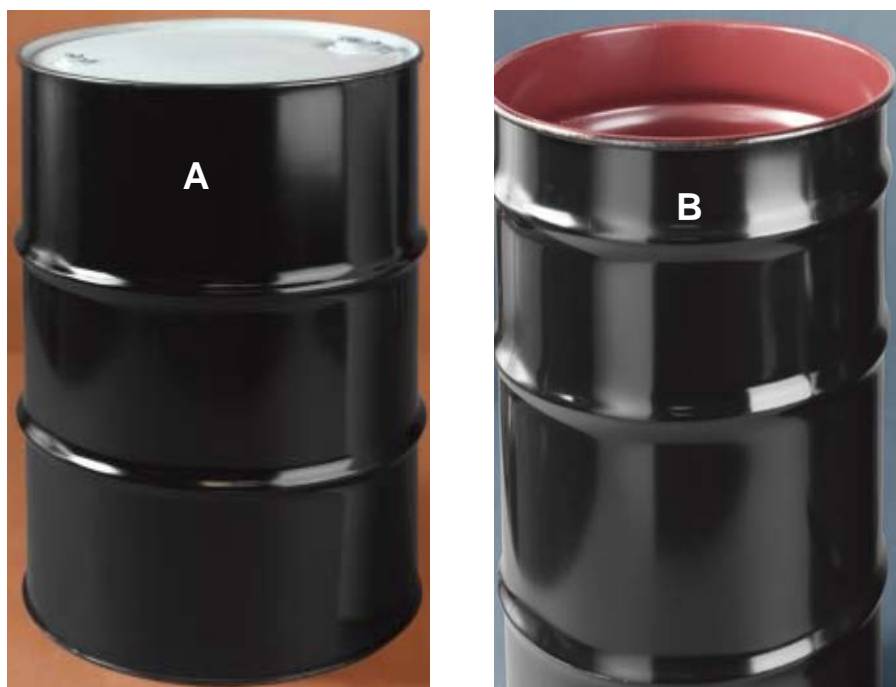
The 55 gallon drums were manufactured by Skolnik Industries out of carbon steel with an epoxy phenolic coating on the interior as shown in Figure 5. The drums are approximately 35 inches tall and 23 inches in diameter. The epoxy phenolic coating (1 mil nominal thickness), applied by Skolnik, is produced by Delta Coatings.

Figure 5. Exterior view of new 55 gallon carbon steel tight head drum (A) in left photo with red epoxy phenolic lined drum (B) shown in right photo (Vendor photographs). Note that the B drum has an extra rolled hoop near the top. SRS drums have two roll hoops as shown in A.

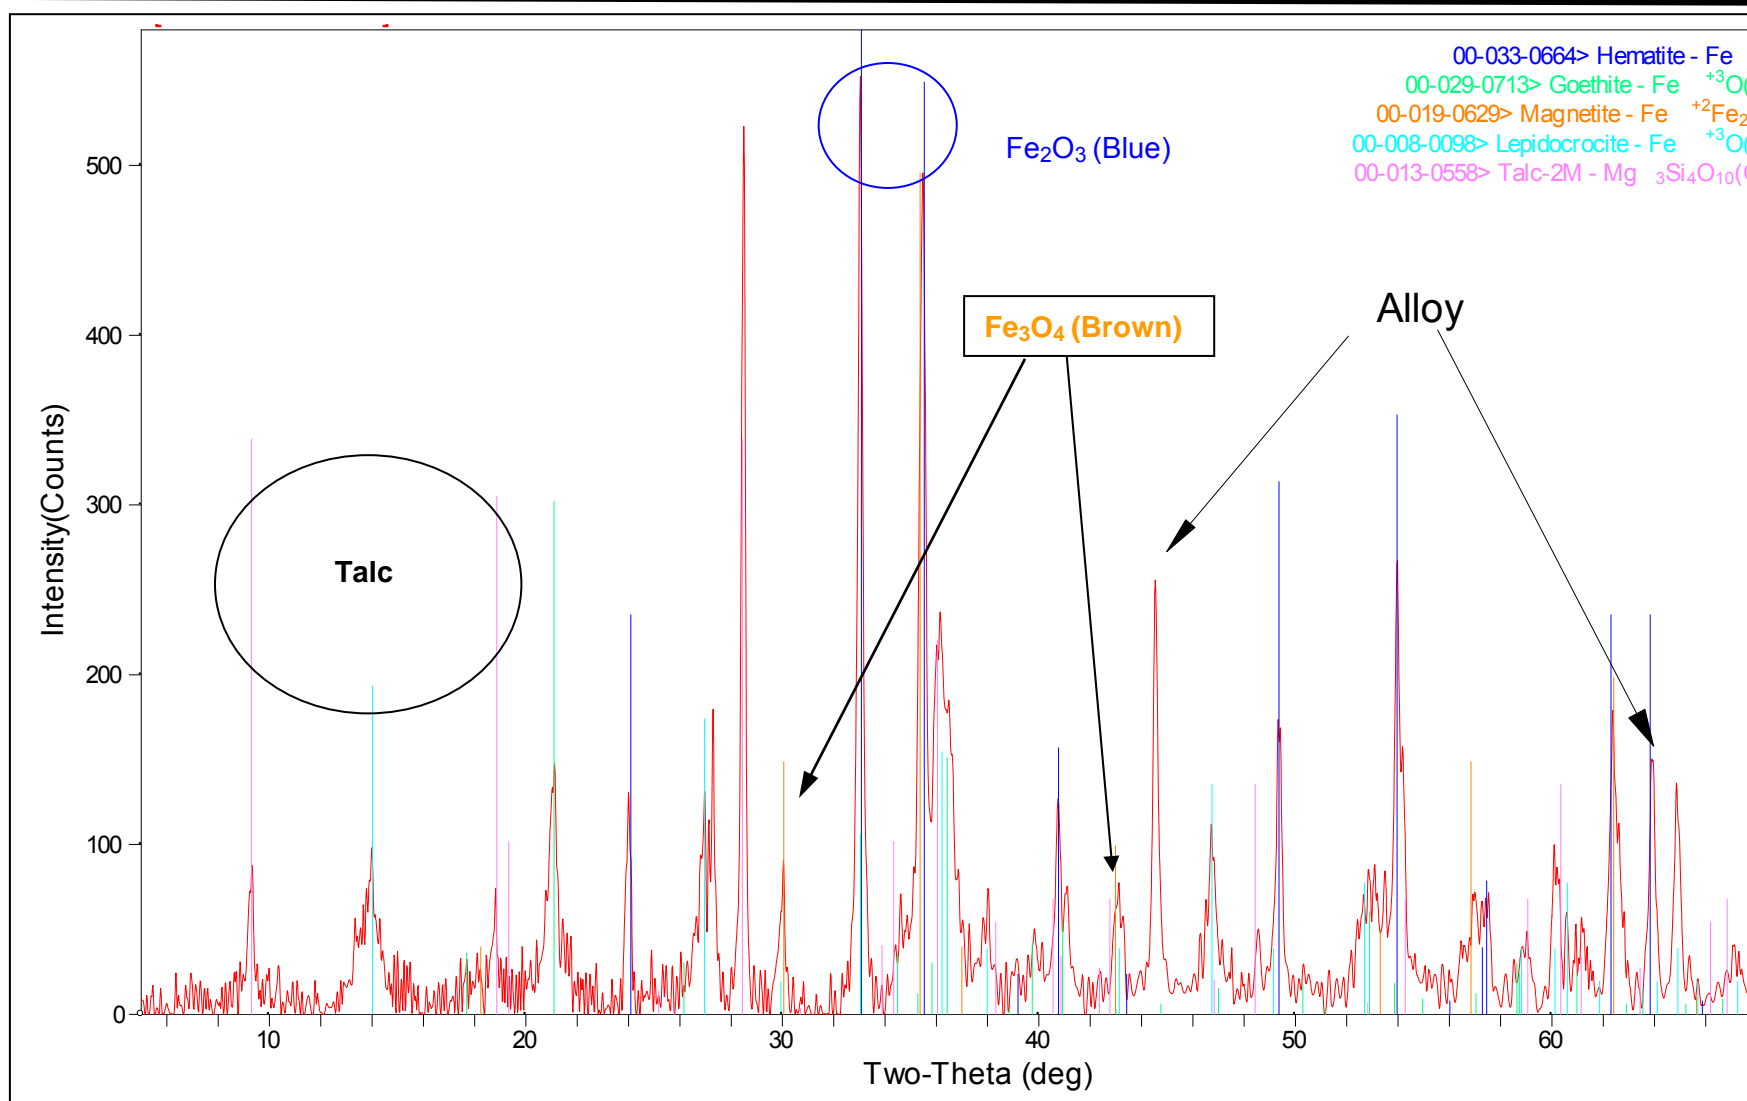
Figure 9. XRD analysis of the surface from sample 2 revealing the presence of Fe₂O₃, Fe₃O₄, Talc, FeOH, and the FeC base carbon steel.

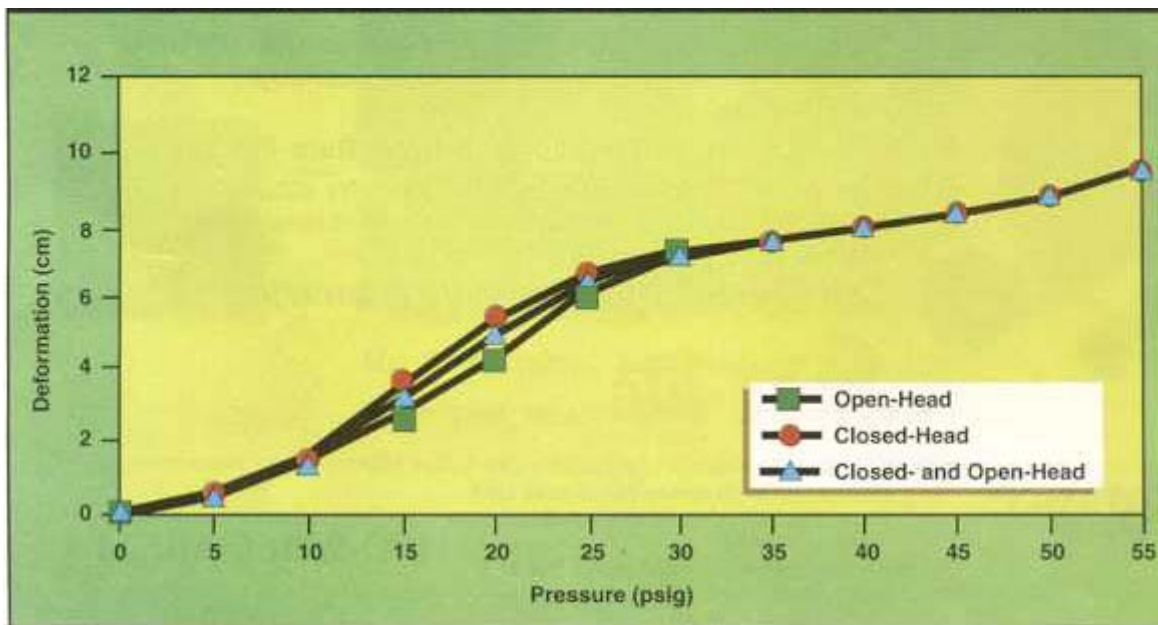
Figure 18. Open-head vs. closed-head drum top deformation averages versus pressure curve (upper graph) for 55 gallon steel drums.[10] The curves overlap each other at low and high pressures, except between 10 and 30 psi.
