A Structural Integrity Evaluation of the Tank Farm Waste Transfer System

WSRC-TR-2005-00532 Rev. 1

Keywords: Corrosion, Structural Integrity, Transfer Lines

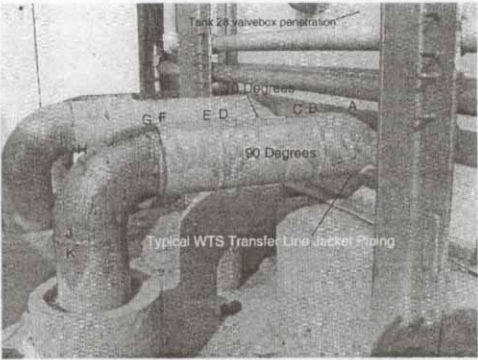
Figure 29. UT data for Line # 1218 jacket (near Tank 28) [103].

Figures 28 through 31 show the location where the spot UT thickness data was taken on each jacket. The average thickness for the pipes was 0.284", while the minimum thickness ranged between 0.244" to 0.252". The minimum thickness was always associated with the extrados of a pipe elbow. The minimum allowable installed thickness is 0.245" [106]. The majority of the data indicate that the measured wall thickness is well above the minimum allowable installed wall thickness.

EXAMINATION RESULTS					SKETCH - IDENTIFY AREAS/CONTROL POINTS EXAMINED
Location	0°	90°	180°	270°	
A	0.301"	0.299"	0.314"	0.311"

B	0.296"	0.309"	0.315"	0.312"	
C	0.271"	0.280"	0.276"	0.278"	
D	0.270"	0.297"	0.291"	0.286"	
E	0.294"	0.292"	0.272"	0.281"	
F	0.286"	0.286"	0.270"	0.291"	
G	0.290"	0.293"	0.272"	0.300"	
H	0.252"	0.290"	0.281"	0.289"	
I	0.273"	0.289"	0.297"	0.289"	
J	0.280"	0.292"	0.283"	0.292"	
K	0.265"	0.269"	0.283"	0.264"
