Analyses of HAZEN Corrosion Coupons, Rev. 1 (U)

Savannah River National Laboratory
Strategic Materials Technology Department
Materials Technology Section

Publication Date: April 2006

DOCUMENT: WSRC-TR-2006-00142, Rev. 1

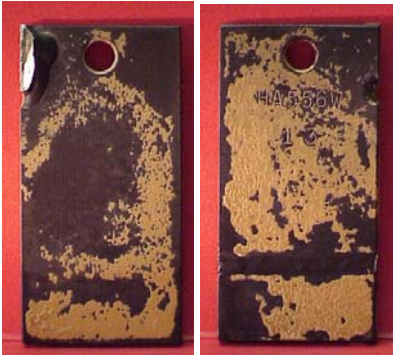
COUPON	MATERIAL	PHOTOGRAPHS	XRD DEPOSIT ANALYSIS
1A	Haynes 556

The pictures of the coupons exposed to the DMR bed are shown in Table 5. The coupons showed pervasive oxidation with process deposits as well as oxides from the coupons. The primary deposits were sulfates and sodium aluminosilicates.

The Haynes 556 appeared to have a uniform corrosion front with a continuous protective oxide scale. The Haynes 230 showed evidence of non-uniform attack, i.e. pitting and a slightly thicker oxide scale. The Haynes HR-160 exhibited uniform and shallow intergranular attack (IGA). The 316L stainless steel exhibited a thick oxide scale.

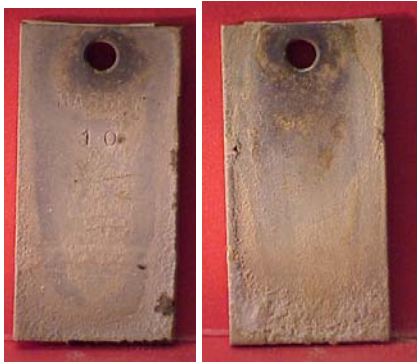
COUPON	MATERIAL	PHOTOGRAPHS	XRD DEPOSIT ANALYSIS
1D	Haynes 556

The photographs of the coupons are shown in Table 6. There was evidence of significant process deposits on the coupons.

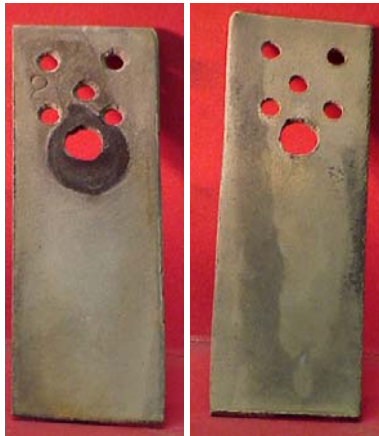
NiO (nickel oxide) KNaSO ₄ (potassium sodium sulfate) Na ₂ SO ₄ (sodium sulfate)
5 Hole	Pall Inconel 601

The micrographs and photographs showing overall condition of the swatches were used to rank these coupons. The Pall Inconel 601 Alloy appeared to have superior performance in this environment. However, it was clear the swatches did not retain sufficient integrity to maintain filter functionality. The orientation of the coupons played a key role in the degradation of the filters, as the process deposits were minimal on the Pall Inconel swatch while extensive on several of the other swatches.

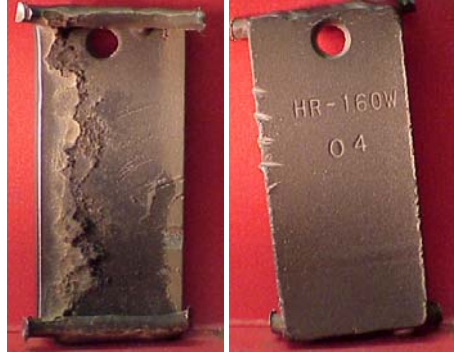
2A	Haynes HR-160

The pictures of the coupons are shown in Table 9. The coupons showed pervasive corrosion with significant erosion on the coupons, indicated by the smoothness on the edges. There was evidence of process deposits on the coupon, including silicates, sulfates, and phosphates.

The placement of the coupon in the process stream plays a significant role in the erosion of the coupon. The erosion resistance of these alloys is expected to be similar; however, it appears that the HR-160 eroded less than the other alloys. The micrographs of the coupons exposed to the CRR bed reducing are shown in Figure 28 - 30. All the alloys exhibited relatively straight corrosion fronts, with evidence of intergranular attack and dealloying at the surface.

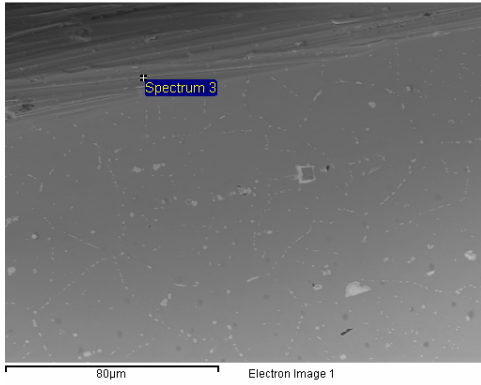
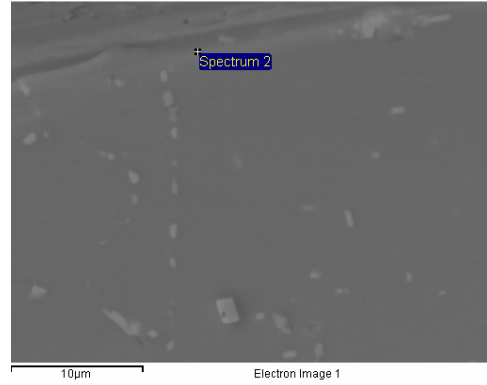
Figure 32: SEM/EDX of Haynes 556 Alloy Exposed to DMR Bed Indicating Lack of Stable Oxide on Surface

The SEM/EDX of the coupons exposed to the reducing portion of the CRR bed are shown in Figure 32 - 34. The analyses indicated the lack of an oxide on the surface of the Haynes 556 alloy, with iron as the primary chemical constituent. The HR-160 alloy and the Haynes 230 alloy had a chromia surface oxide with underlying silica. Even though the HR-160 alloy has significantly higher silicon content than Haynes 230, silica formed on both surfaces. The silicon additions are known to provide superior oxidation resistance at relatively high temperatures where the silica can form. The enhanced resistance has been attributed to the formation of a protective and tenacious silica layer.[11] It has also been proposed that the silica layer enhances the formation of stable chromia layers and may act as a diffusion barrier.[12]

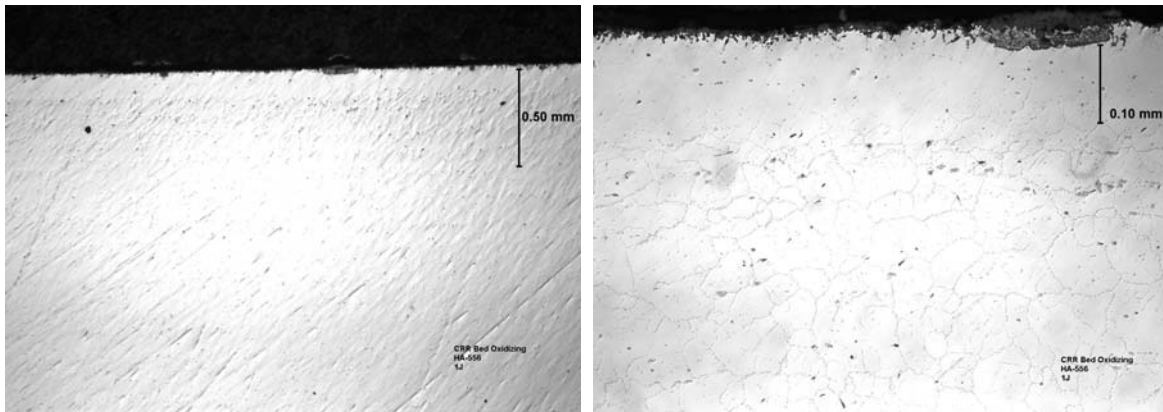
Figure 35: Metallographic Cross Section of Coupon 1J - Haynes 556 Alloy Exposed to CRR Oxidizing

The metallographic analyses of the coupons are shown in Figure 35 - 37. The cross sections show surface dealloying with significant internal attack. Once again, the placement of the coupon in the process stream is suspected to influence the corrosion response. The Haynes 230 alloy shows evidence of potential incipient melting based upon the overall photograph. The Haynes HR-160 alloy appeared to have experienced breakaway corrosion.

All alloys tested in this section of the process exhibited significant corrosion. It is recommended that the alloys be protected with a high-temperature refractory. Furthermore, the refractory must seal the metal completely, since incomplete sealing may create a potentially worse crevice situation.

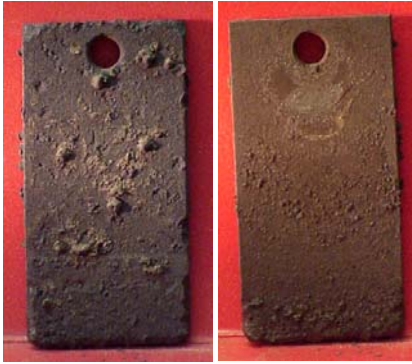
COUPON	MATERIAL	PHOTOGRAPHS	XRD DEPOSIT ANALYSIS
1L	Haynes 556

The pictures of the coupons exposed to the freeboard above the CRR bed are shown in Table 11. The coupons showed pervasive significant corrosion, with process deposits, primarily sulfates.

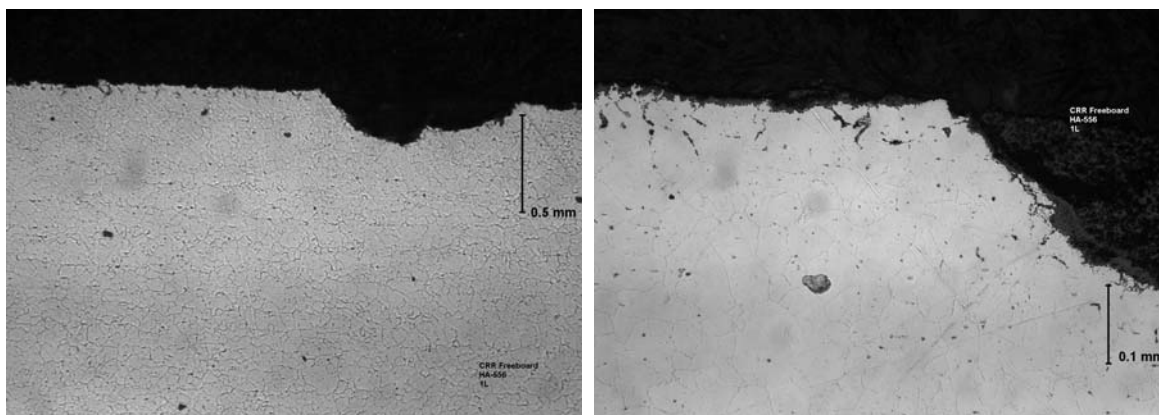
Figure 39: Metallographic Cross Section of Coupon 1L - Haynes 556 Alloy Exposed to CRR Freeboard

The metallographic analyses of the coupons are shown in Figure 39 - 41. The cross sections show surface dealloying with significant internal attack including IGA and pitting.

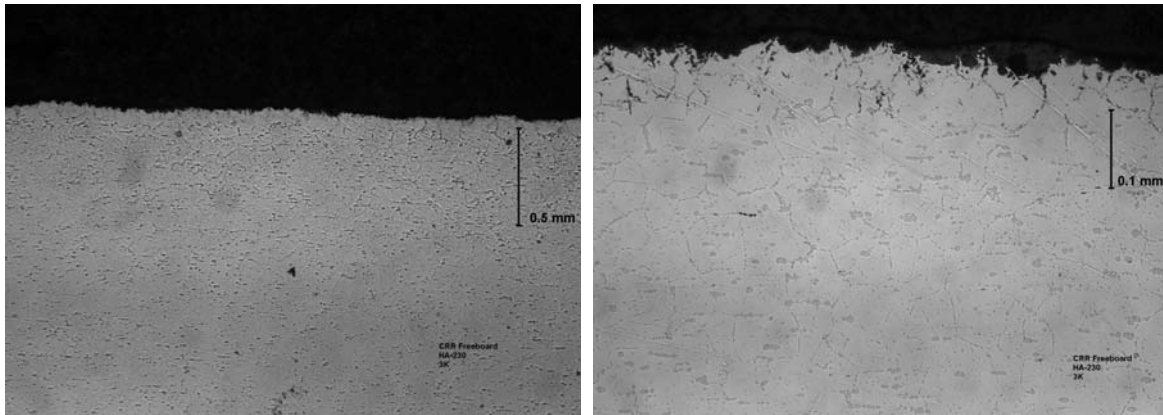
Figure 41: Metallographic Cross Section of Coupon 3K – Haynes 230 Alloy Exposed to CRR Freeboard

In the case of the coupons exposed to the CRR freeboard, the corrosion mechanisms are expected to be similar to the CRR bed. However, the temperatures may not be sufficient to form the stable silica layer in the samples, and the gas flows may be not equivalent to the coupons indicating differential corrosion in the coupons due simply to geometry. In this case, the Haynes 556 alloy performed better per calculations (as will be shown in the discussion sections) even though a silica layer was found on the Haynes 230 layer and a chromia layer was found on the HR-160 alloy.

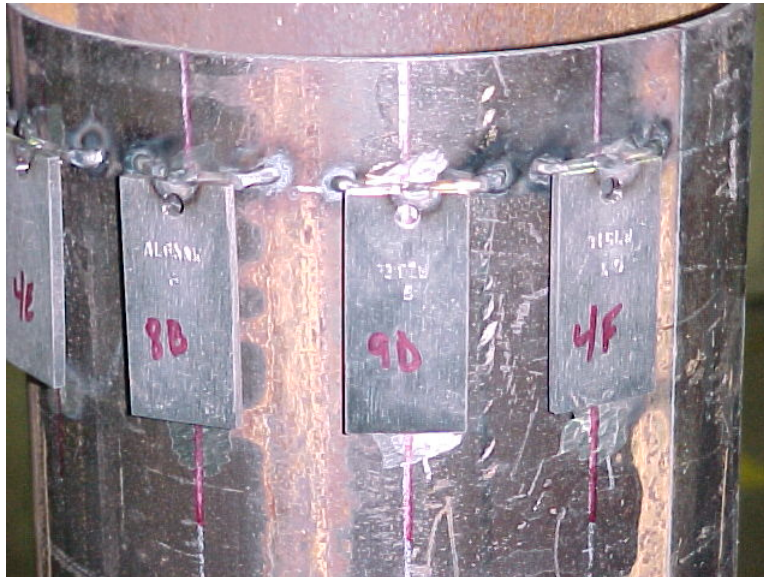
Figure 42: Coupon Exposed in the PBF

The CRR process gas stream, now almost entirely nitrogen, oxygen, water vapor, and carbon dioxide, is cooled in the off-gas cooler (OGC) and scrubbed for trace acid gases in the Quencher/Scrubber (Q/S) system, reheated by the Reheater, and filtered in the Process Baghouse Filter (PBF). The corrosion coupons in the PBF section were mounted on the dirty side of the filter. The coupons were mounted vertically with one face out on a steel cylinder in the inlet to the filter, with one short edge (w/o) hole down in upward gas flow, as shown in Figure 42. The nominal temperature in this region $150^{\circ}\text{C} \pm 10^{\circ}\text{C}$.

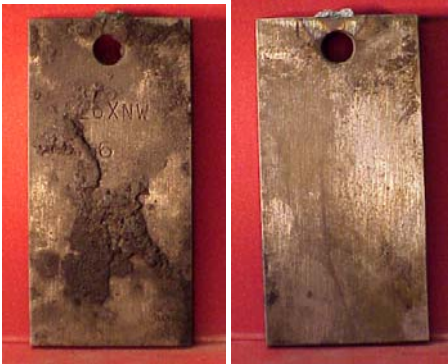
COUPON	MATERIAL	SERIAL #	XRD DEPOSIT ANALYSIS
8B	AL6XN

The pictures of the coupons are shown in Table 12. The coupons showed pervasive corrosion but not as extensive as other sections, based upon the visibility of the machining marks.. There was evidence of process deposits on the coupon, including sulfates, carbonates, and hydroxides.

Graphite CaSO ₄ (anhydrite) KFe ₃ (SO ₄) ₂ (OH) ₆ (jarosite) Fe ₂ (CO ₃)OH (iron carbonate hydroxide)
9D	317 SS

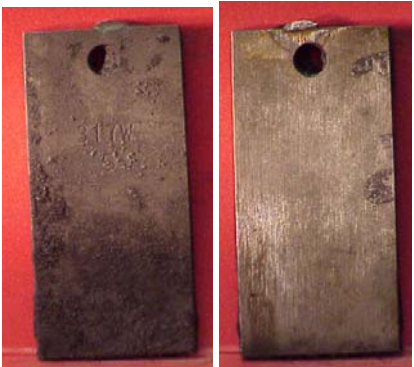
CaSO ₄ (anhydrite) Graphite
4F	316L SS

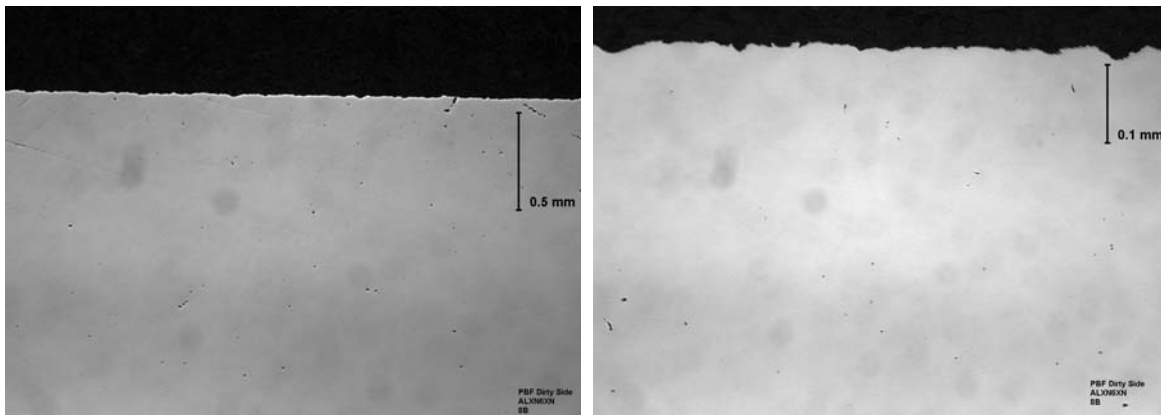
The metallographic analyses for the PBF coupons are shown in Figure 43 - 45. The metallographic analysis indicates pervasive pitting with little intergranular attack beyond the pitting front. However, the AL6XN is a superaustenitic alloy with additional Cr and Mo to increase the pitting resistance when compared with conventional stainless steel.

Figure 43: Metallographic Cross Section of Coupon 8B - Alloy AL6XN Exposed to PBF Dirty Side

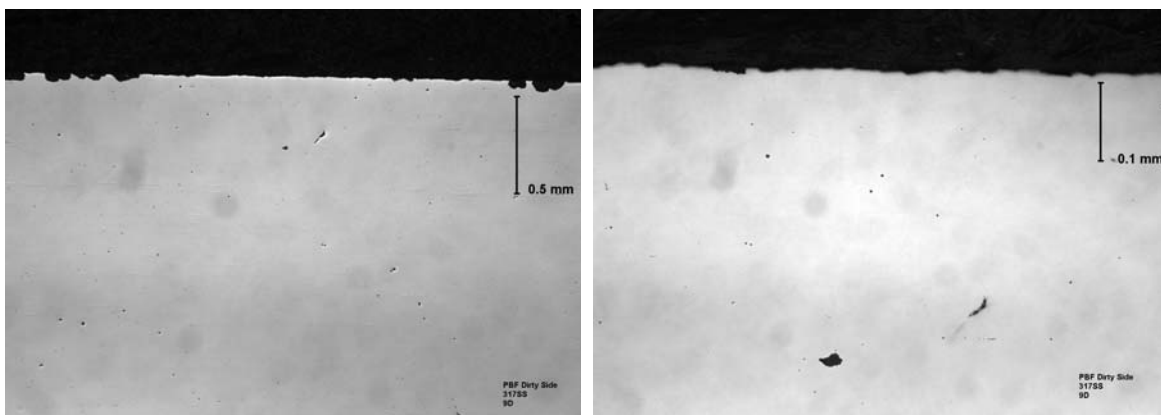
Figure 44: Metallographic Cross Section of Coupon 9D - 317SS Exposed to PBF Dirty Side

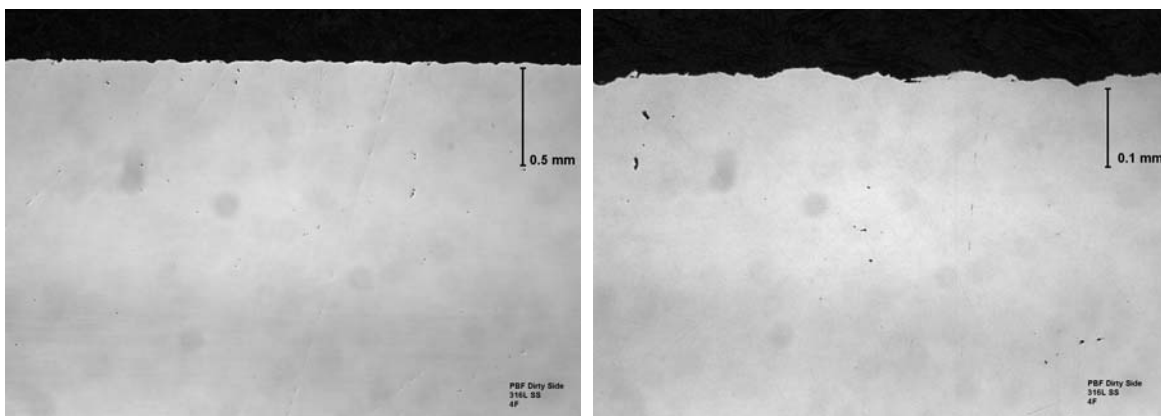
Figure 45: Metallographic Cross Section of Coupon 4F - 316L SS Exposed to PBF Dirty Side
