# Tank Inspection NDE Results for Fiscal Year 2007 Including Waste Tanks 35, 36, 37, 38 and 15

**Savannah River National Laboratory**

**DOCUMENT:**      **WSRC-TR-2007-00064**

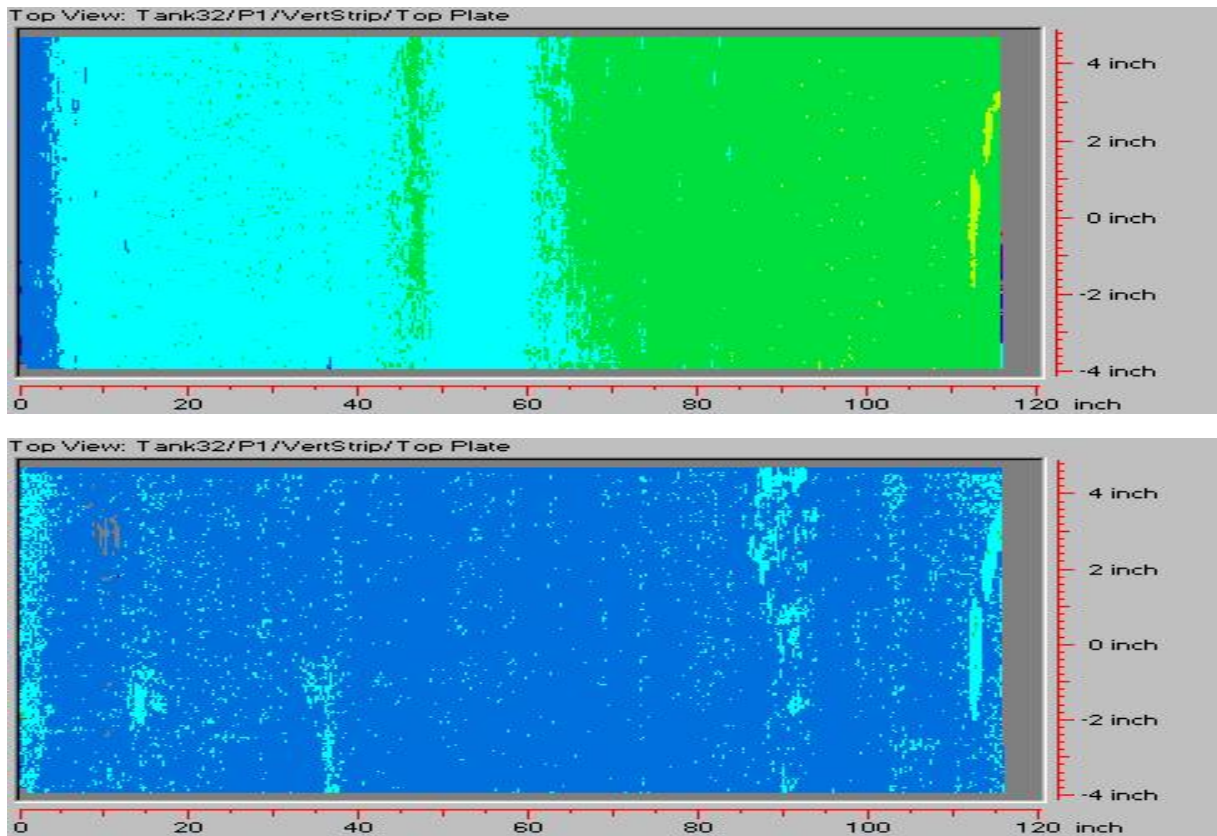
**Figure 5: Comparison of First and Multiple Echo Techniques**

The images in Figure 5 are of the same area shown with different techniques that were collected simultaneously with the same transducer. The top image appears to show thinning as the scan progresses, starting dark blue and changing to light blue, green and light green at the end. The bottom image shows that the thickness actually remained consistent over the length of the plate. The thinner ID grinding areas at the end are displayed in both images. In this case, the transducer position in the probe holder was apparently changed during deployment or while crossing a weld. The probe wore slightly as the scan progressed, thereby indicating thinner than actual readings. The technique used in the top image was found to be out of tolerance on the calibration check, but the multiple echo technique remained in calibration. The calibration check showed the first echo technique to read over 0.03 inches thinner than actual, but the multiple echo technique remained within 0.005 inches of the initial calibration. All thickness values are based on the multiple echo technique, which remained in calibration so no corrective action was required. The contact techniques are for information and increased sensitivity to pitting.

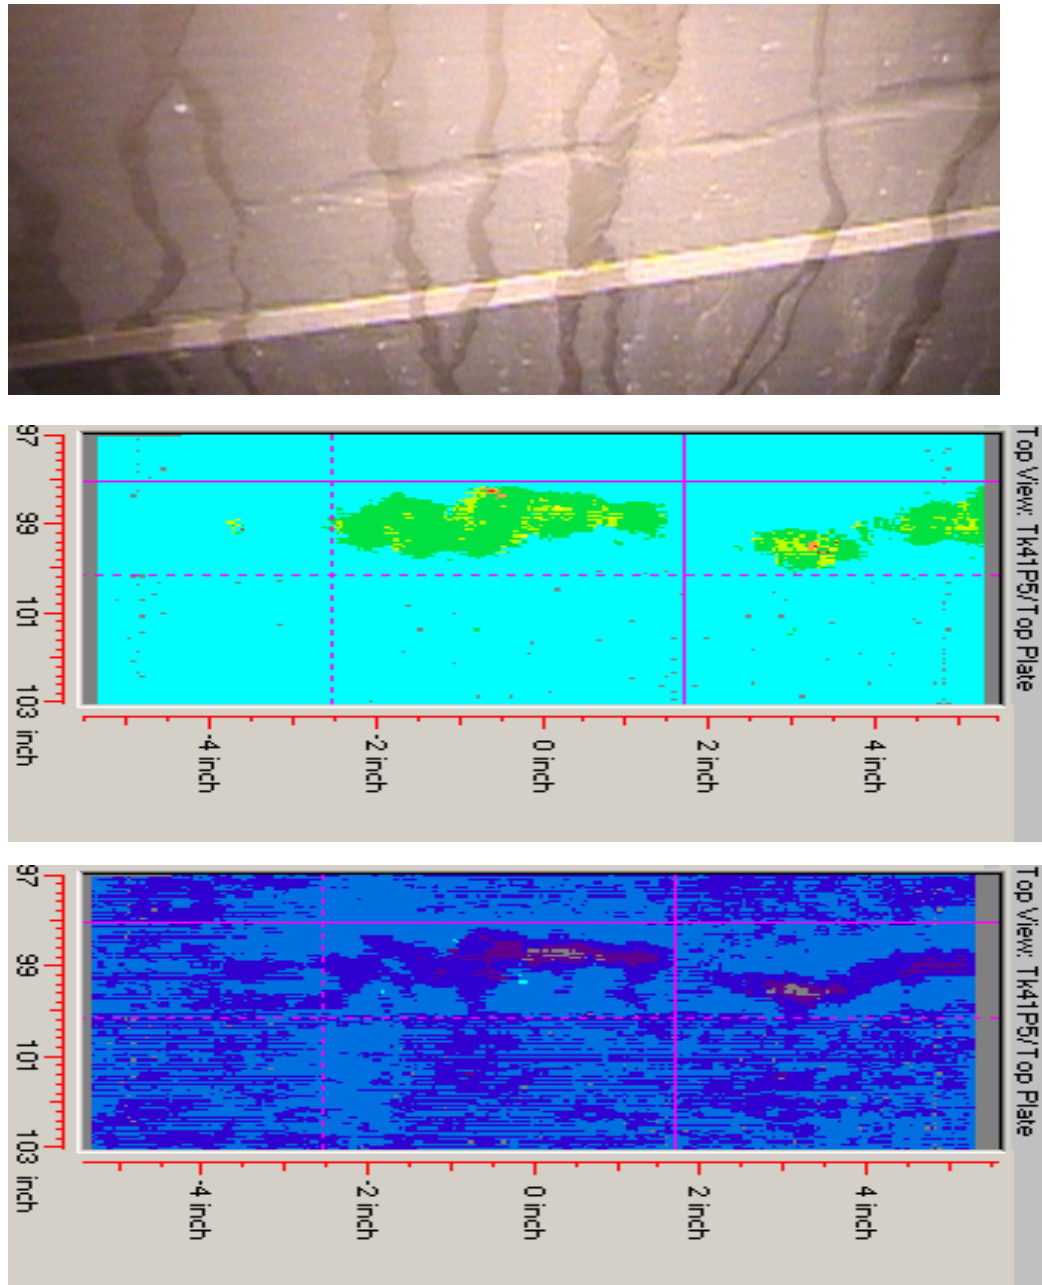
**Figure 6: OD Grinding With First and Multiple Echo Techniques**

Another advantage of the multiple echo technique is its ability to help discriminate exterior surface conditions from interior surface conditions. Figure 6 provides a photograph of a grinding area on the exterior of the tank. The area is painted, proving it is pre-service. The images below the photograph show the multiple echo (top) and first echo data. The multiple echo data shows the OD grinding area with the same pattern as the photograph as thinner than the surrounding area. The bottom image is contact data and does not provide as clear a picture of the OD grinding area. In fact, the contact method actually provides thicker than actual readings due to the increased water gap in the grinding area.

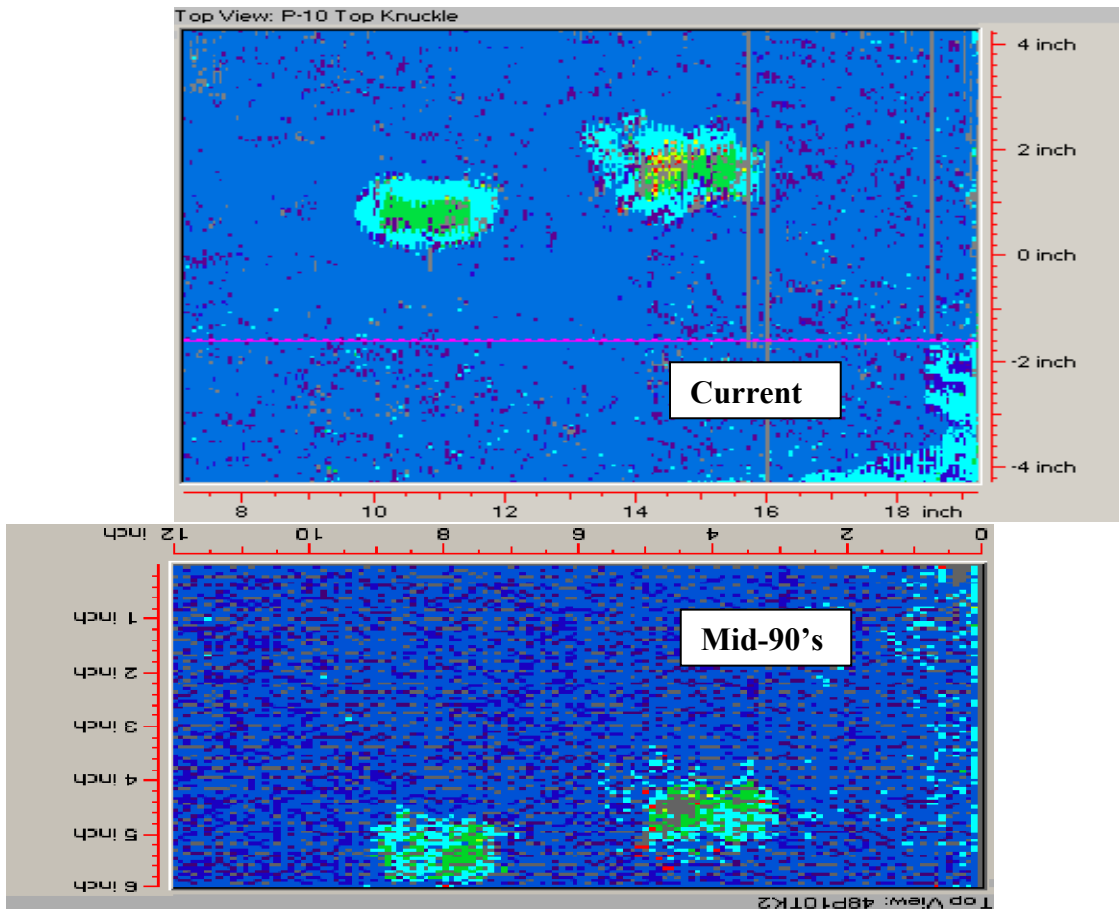
**Figure 7: Comparison of Mid-90's era Data with Current Technique**

The first instance of performing thickness mapping on an underground high level waste storage tank was performed on SRS Tank 50 in September 16, 1994. This performance demonstration was the first of many inspections performed on selected Type III tanks. During this period tanks 40, 42, 48, 49, 50 and 51 were examined at least once. These thickness mapping inspections have similarities with the examinations being performed as part of the current ISI program. The inspections were performed utilizing a site designed and fabricated magnetic wheel crawler and the commercially available P-scan automated UT system (PSP-3). The examinations were focused on detection of service induced thinning such as pitting and general wall thinning. The examinations included a thickness mapping scan in a vertical strip six inches wide for the entire accessible height of the tank. These examinations were typically performed on the same painted strips where the spot thickness readings were taken during the early 1980’s. The acceptance criteria for these examinations was contained in “Performance and Acceptance Criteria for Pending HLW Tank Insitu Ultrasonic Examination (U).”<sup>6</sup> The reporting criteria stated to report pitting which exceeds 35% of the tank plate section being examined and to report general thinning in excess of 15% of nominal thickness. The inspections utilized a dual element transducer for the detection of pitting. The resolution, or pixel size, of the inspections was typically 0.075 to 0.10 inches compared to the 0.050 inch pixel size of the current inspections. Figure 7 provides a comparison of the current technique (top image) with the mid-90’s era data (bottom image). The mid-90’s era data shows the same indications, but the resolution and detail is not as good. Several of the mid-90’s era images are presented later in this report. Due to different scanning devices being used and the Top Knuckle being scanned from the bottom up in the 90’s, the 1996 data image was flipped vertically and horizontally to match the current data display. The current data includes 8.5 inches where the mid-90’s vertical strips were 6 inches wide. The two sets of data, collected 9 years apart, are slightly offset, but the same indications are in both.

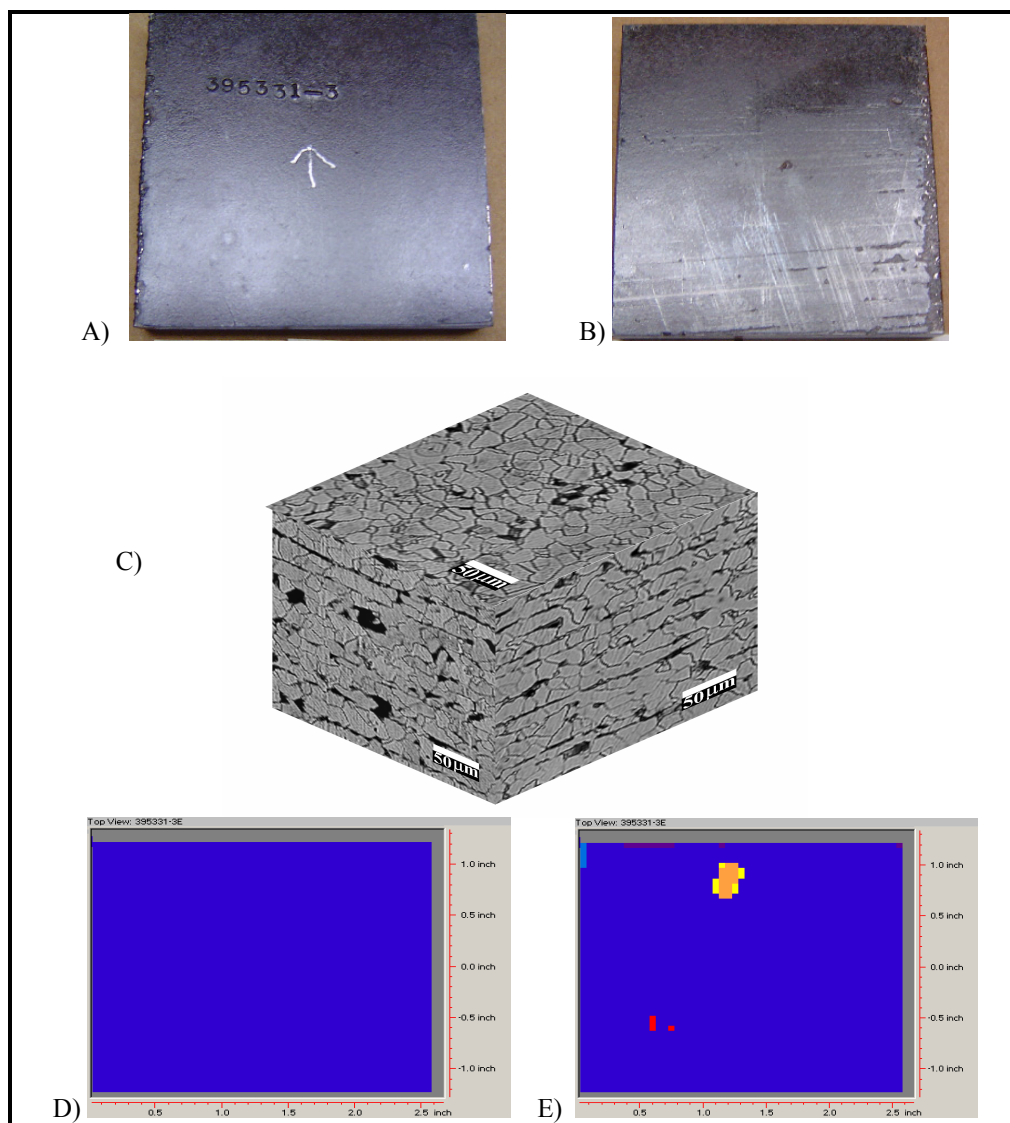
**Figure 13: Typical Metallurgical Indication**

While the steel is being fabricated, small impurities are sometimes caught in the metal. During the rolling process, larger impurities may become laminations. The following figure illustrates this condition and the type of indication that may be obtained during thickness mapping. Sample #395331-3 (A & B) was scanned utilizing the same technique as the tank inspection scans. The front and back surfaces of the sample show no pitting. The microstructure of this material is shown in image “C”. The thickness mapping data in images “D” and “E” were collected simultaneously. “D” displays the multiple echo data with no indications. “E” shows the first echo, “Edge Contact” technique producing indications from small laminar reflectors within the material. These types of processing indications are not uncommon when examining the type, vintage and thickness of steel used in the waste tanks. Detection of these metallurgical indications is due to the high sensitivity of the UT technique and is not uncommon in carbon steel.

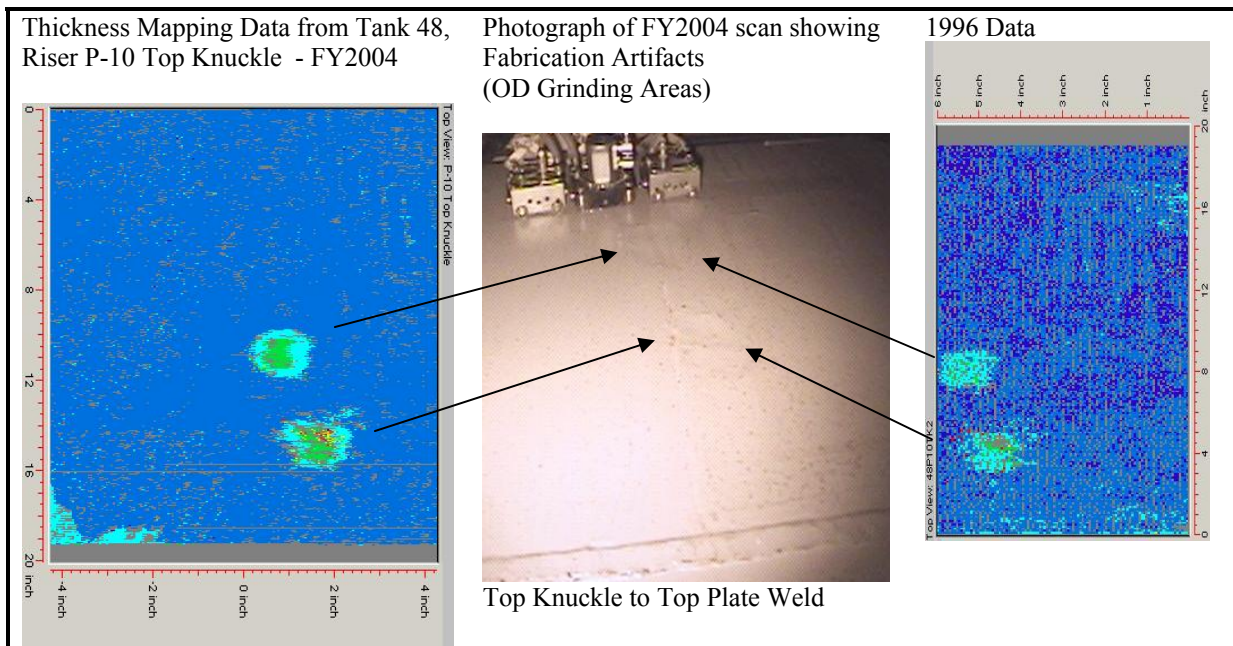
**Figure 14: Typical Fabrication Artifact**

During fabrication lifting lugs are temporarily attached to plates of steel to lift and align them during erection of the tank. After use the attachment is typically removed and that area smoothed out utilizing a grinder. This is common practice in tank fabrication. Many such fabrication artifacts have been encountered while inspecting waste tanks. Many of these areas have been encountered under the paint which was applied to the vertical strips prior to the tanks going into service, confirming that the indications are not service induced. The following figure illustrates a typical fabrication artifact. A photograph of the grinding areas in the top knuckle of Tank 48 under Riser P-10. The thickness mapping data collected in this area shows the indication in both the 2004 data and the data collected in 1996. These indications are not service induced and do not constitute reportable conditions.

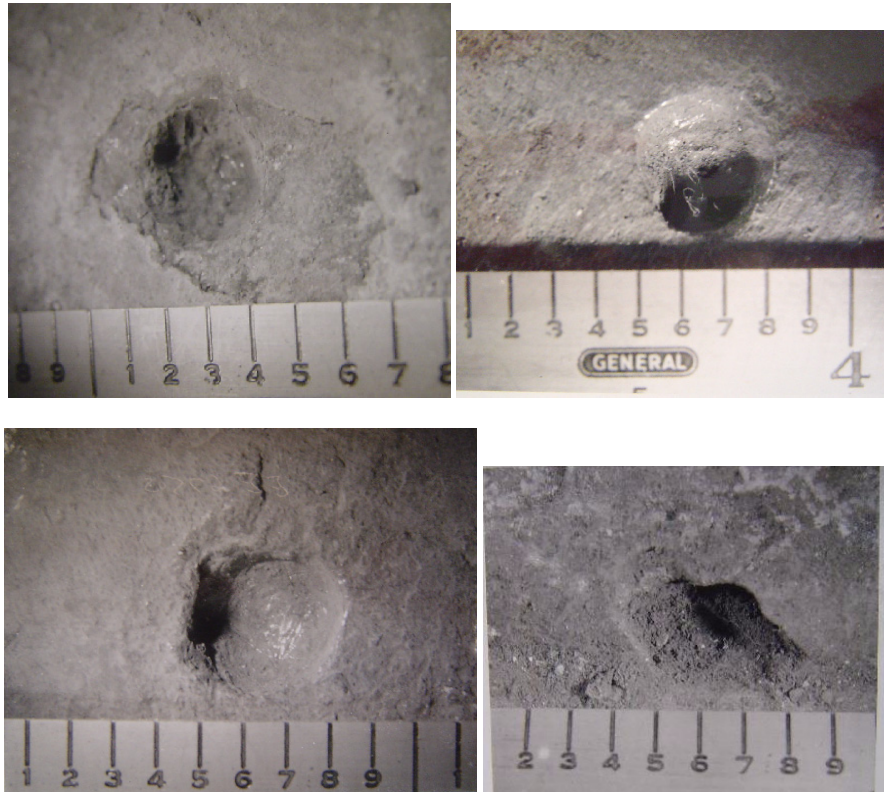
**Figure 16: Pre-service pitting**

Photographs include scale which is in 0.1 inch increments.

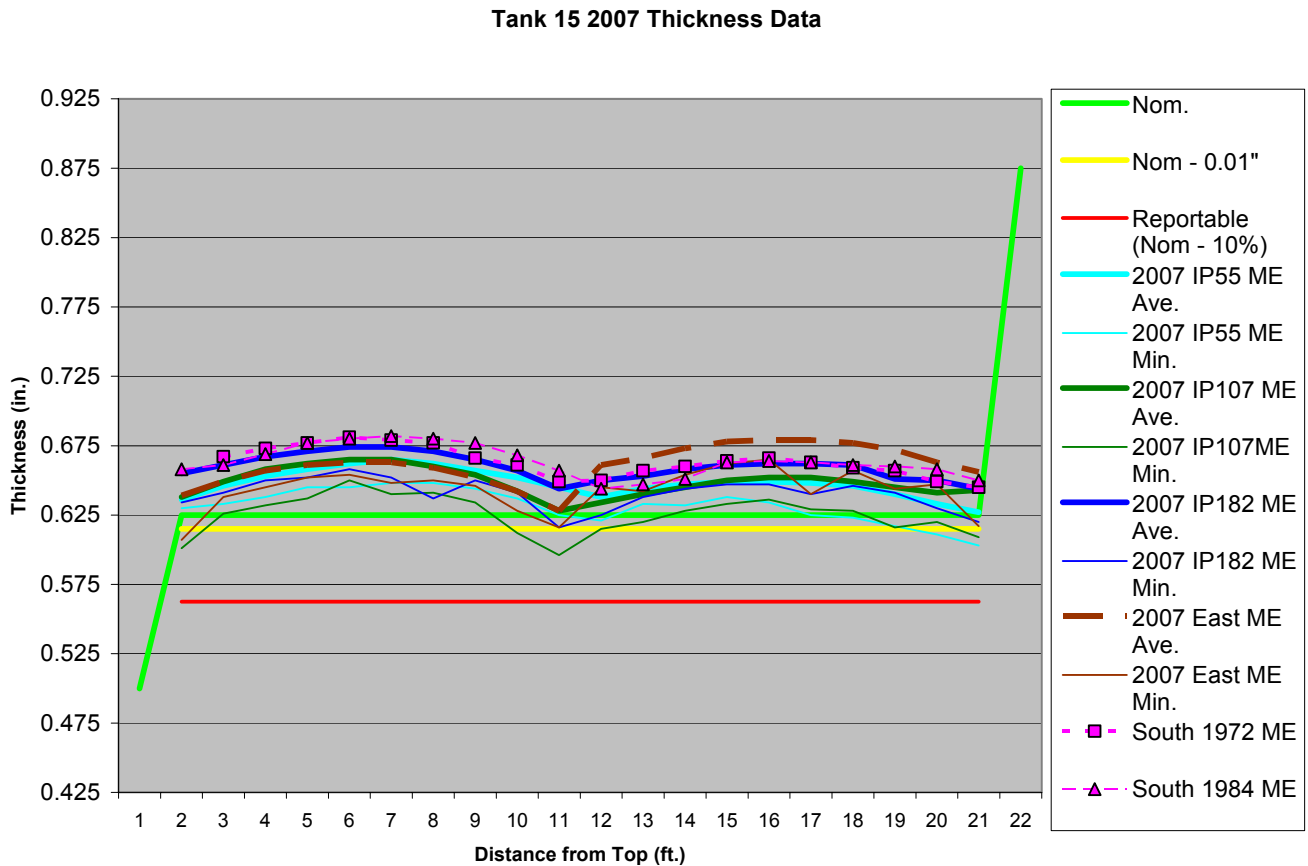
**Figure 26: Tank 15 Thickness Data All Risers 2007**

The measured average thickness was above the nominal thickness in all areas examined. Figure 25 illustrates the thickness mapping locations in Tank 15. The thickness mapping data is presented in Figures 26 through 30. Table 7 includes the 2007 Multiple Echo thickness values for the vertical strips.

Chart shows average and minimum multiple echo data from 2007 on chart with same scale as other tanks.

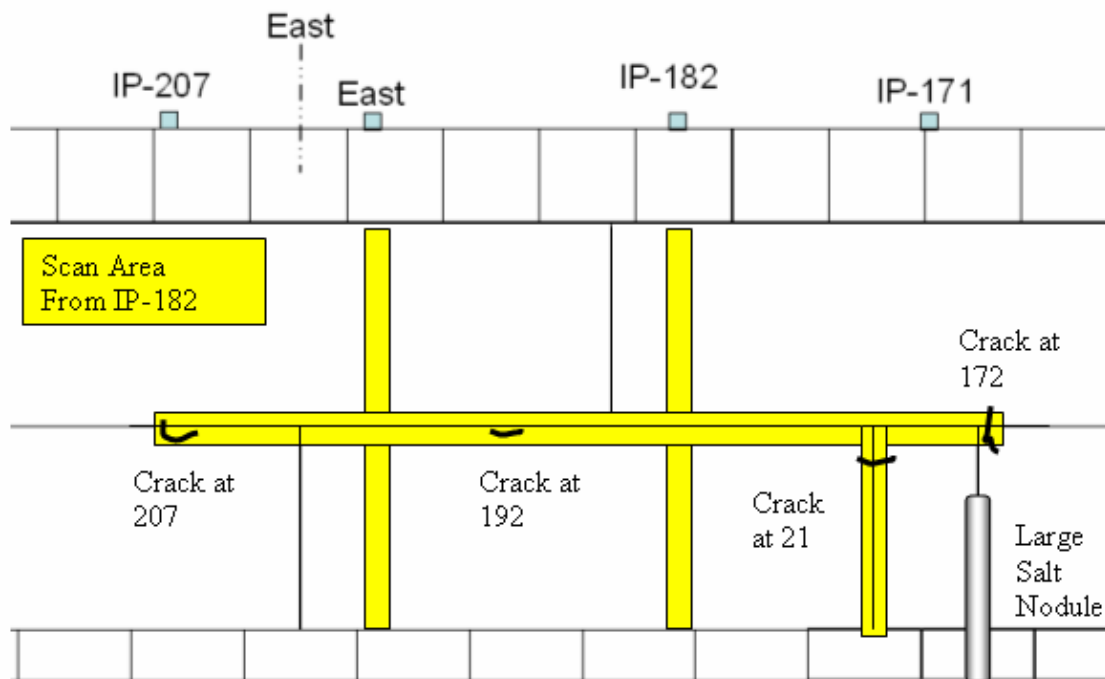
**Figure 33: Scan Locations Beneath Riser IP182**

The lower plate weld connecting the middle plate to the lower plate was examined for cracking parallel and perpendicular to the weld for over 10% percent of the circumference. The area between IP171 and IP207 was scanned. Other than the 3 cracks noted previously, no additional cracking was detected in the middle horizontal weld. Weld examinations covered both sides of the weld and included several repair areas. Figure 33 depicts the scan locations performed via Riser IP182. The middle horizontal weld, lower plate vertical weld and several cracks were examined as shown.

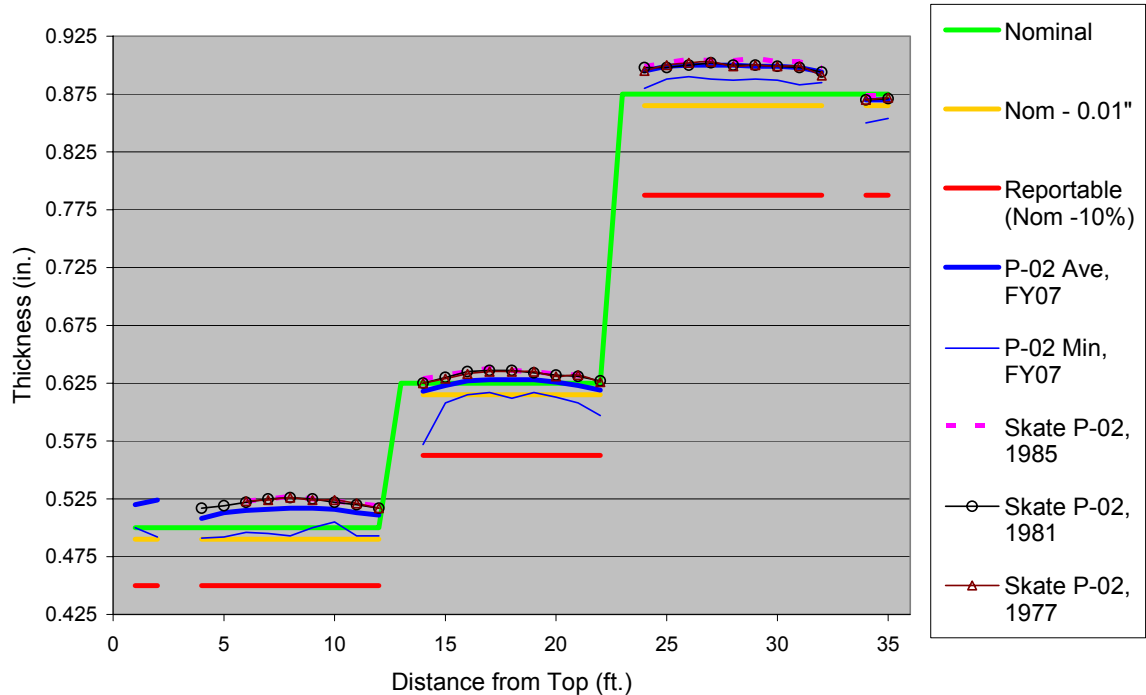
**Figure 41: Comparison Chart Tank 36 Skate vs. FY2007 Data**

Figure 41 shows a graph of the results of the historical UT spot thickness readings from Tank 36, Riser P-02 taken in 1977 the year the tank went into service. Spot readings from 1981, 1985 and the thickness data from 2007 is also included. The data shows the typical pattern for SRS waste tank plates where the edges of the plates are slightly thinner from the rolling process at the steel mill. There is excellent correlation between the four sets of data available for Tank 36. Similar graphs are included for all available tanks covered by this report. Current thickness mapping data is graphed with at least one set of skate data from early in the spot measurement program.
