Corrosion Evaluation of Tank 40 Leak Detection Box

WSRC-TR-99-00200 (U)

Publication Date: June 1999

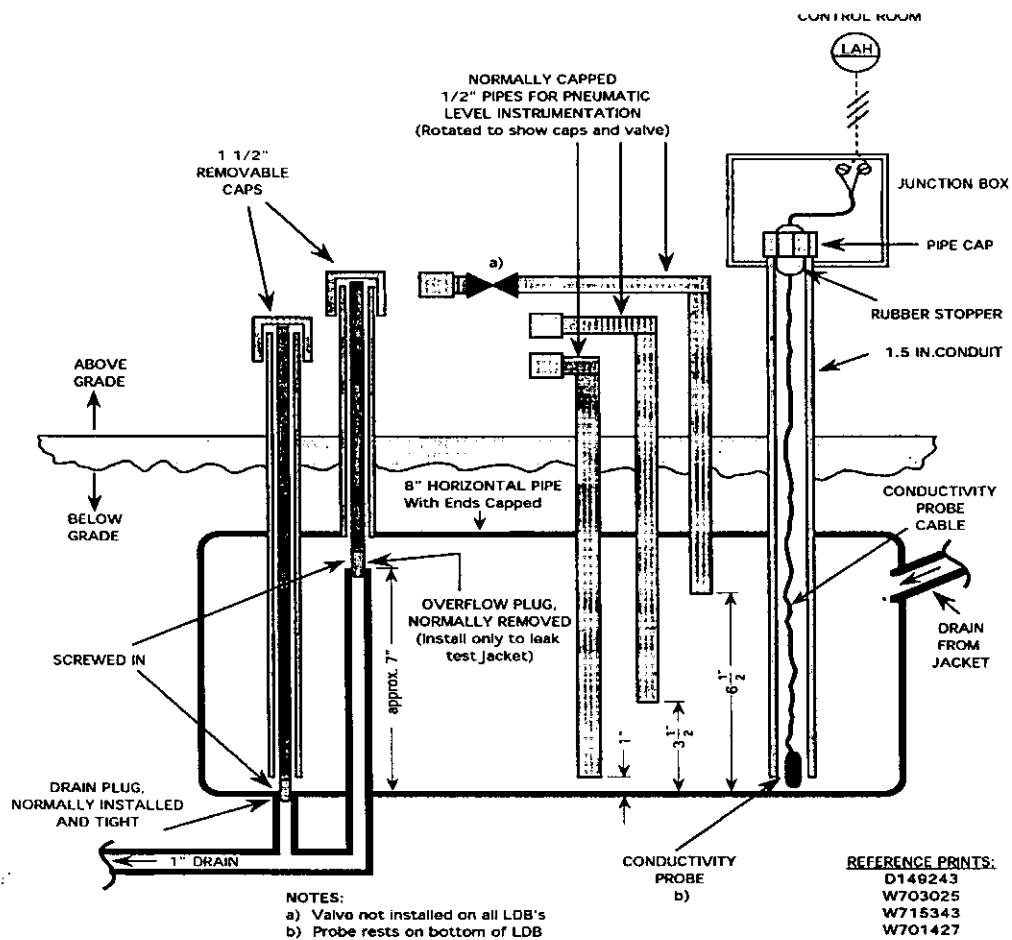
Figure 1. Drawing of a typical LDB

The LDB contains a conductivity probe which alarms when water or waste collects [3]. A typical LDB is shown in Figure 1. The LDB is connected to drain lines from the jackets of various transfer lines. As shown in the figure, the LDB has a discharge drain line to the sump and an overflow line, which are typically plugged or capped. Additionally, three capped dip tubes are available for instrumentation. The LDB is constructed of 8" diameter carbon steel pipe that was been welded closed at both ends. The discharge and drain lines are made of 1.5" carbon steel pipe, while the dip tubes are made of 0.5" carbon steel pipe. When the LDB was placed into service, a backfill, Gilsulate 500™, was used around it. The Tank 40 LDB had been in service for approximately 18 years.

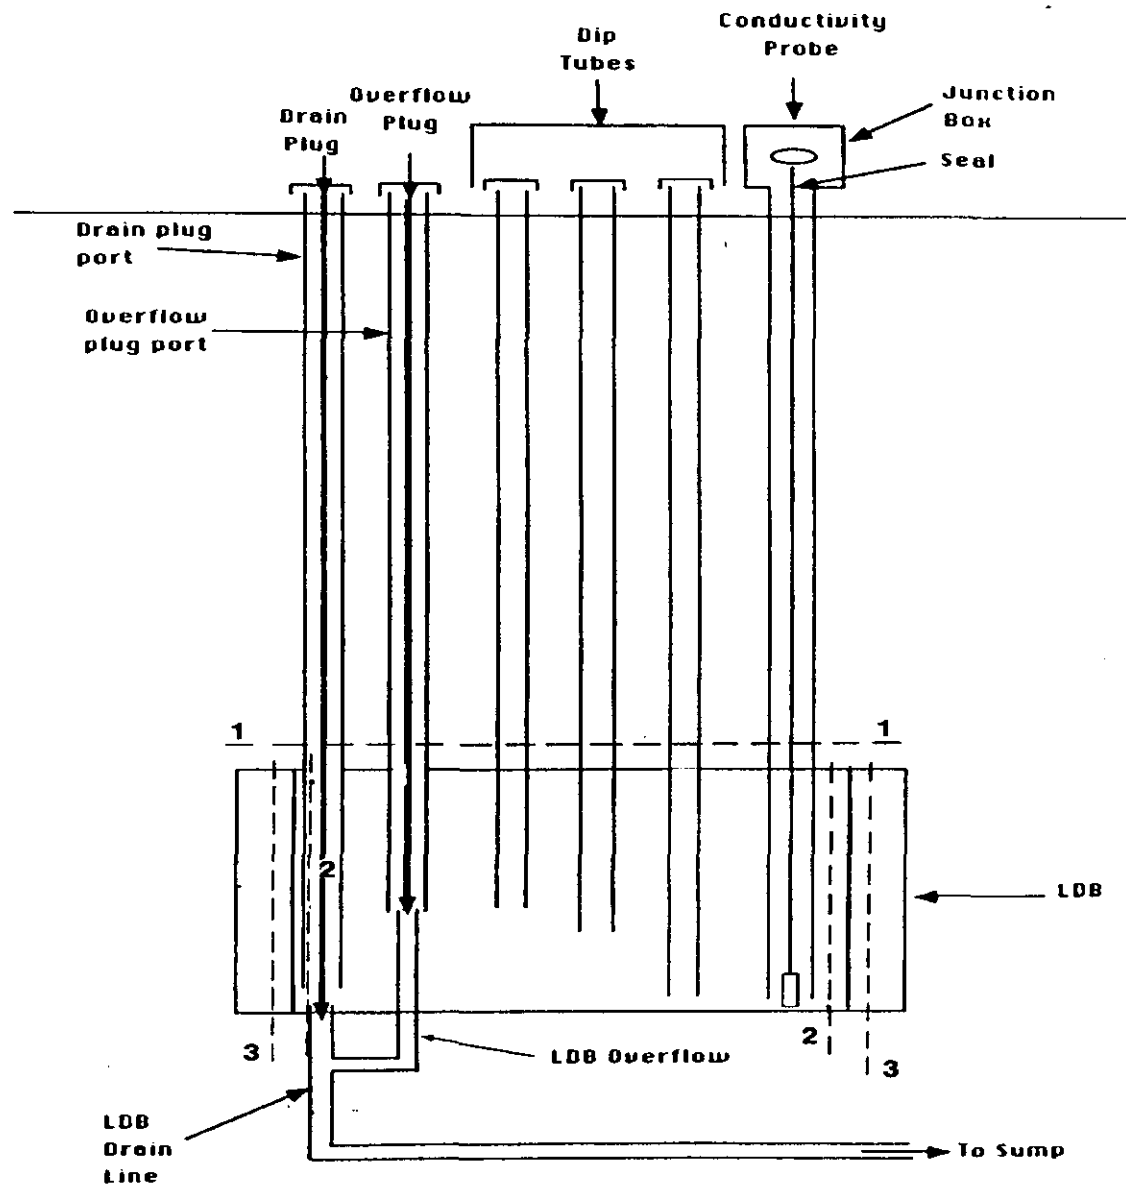
Figure 4. Schematic drawing of weld section cuts made in Tank 40 LDB

The LDB was sectioned so that the interior surface could be evaluated. Figure 4 shows the sectioning of the LDB. The two end caps and the pipes that extended to the surface were cut off the 8" pipe (cuts 1

and 2 in Figure 4, respectively). The interior surface was examined prior to further sectioning. The individual welds were then sectioned (cut 3 in Figure 4).
