ProTec™ Tear-Offs: A Preliminary Assessment

J.C. George
D.K. Peeler
J.W. DuVall
R.W. Blessing

Immobilization Technology Section
Savannah River National Laboratory
Aiken, SC 29808

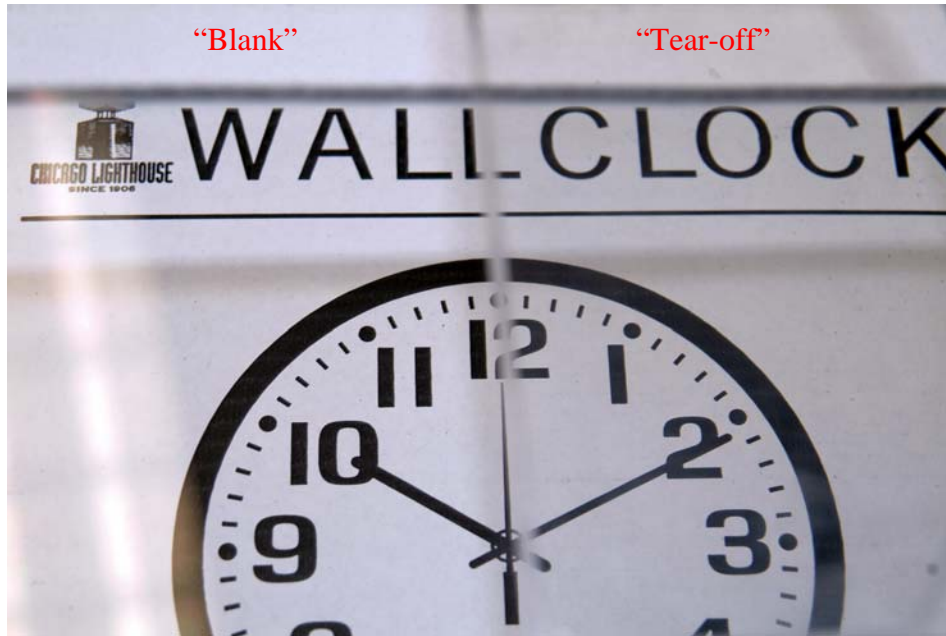
Figure 4-2. Pre-Exposed Condition of the Lexan “Blank” (left) and “Tear-off” System (right)

A visual baseline condition (pre-exposed) of the “blank” and “tear-off” systems was required prior to starting the actual tests. This was performed by taking a digital photo (see Figure 4-2) of a pre-exposed Lexan “blank” (on the left side of the clock) and “tear-off” system mounted on the Lexan (on right side of the clock). The “wall clock” was used as a back-drop to provide a basis for visual clarity (color and sharpness of lettering). Although hard to distinguish via the digital photos, the “tear-off” provided a slight tinting of the white background of the clock as compared to the baseline “blank”. There was no reduction to the sharpness of the lettering.

The in-situ Cell #15 test used a single sheet of Lexan with a Mylar tear-off system mounted on one side, similar to the mock-up scratch test described in Section 4.3. To assess visual clarity as a function of time, laminated test patterns were placed behind the Lexan sheet – one behind the “blank” system and another directly behind the “tear-off” system.¹¹ Figure 4-5 is the baseline condition of the Lexan sheet prior to Cell #15 entry. As previously noted, the “tear-off” provides a slight tinting effect, which was observed in Figure 4-2 and Figure 4-4.

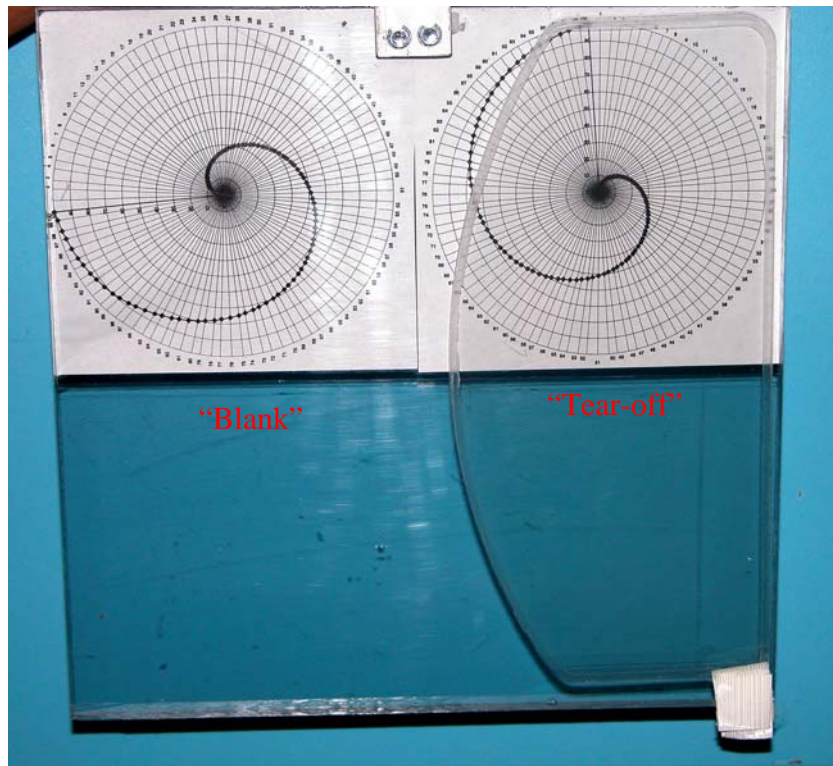
Figure 4-5. Baseline of “Blank” and “Tear-Off” System Prior to Cell #15 Entry
(Lexan “blank” on left; mounted “tear-off” on right)

¹¹ To provide a frame of reference, the Lexan plate is roughly 10” x 10”. The tear-offs (mounted on the right hand side) are roughly 9.5’ long and ~4.5” wide at the maximum width (center or mid-point).

Figure 5-22 shows the “blank” and “tear-off” systems hanging from an intermediate wall in Cell #15 just after cell entry (July 28, 2005). The “tear-off” is visible on the right hand side of the Lexan plate which is aligned vertically – see Figure 4-5 for a comparison photo. As previously mentioned, the average radiation dose in Cell #15 is 17.3 rad/hr (Bibler (2005)). The SRNL shielded cells personnel monitored the system on a daily basis for any signs of visual distortion or mechanical degradation.

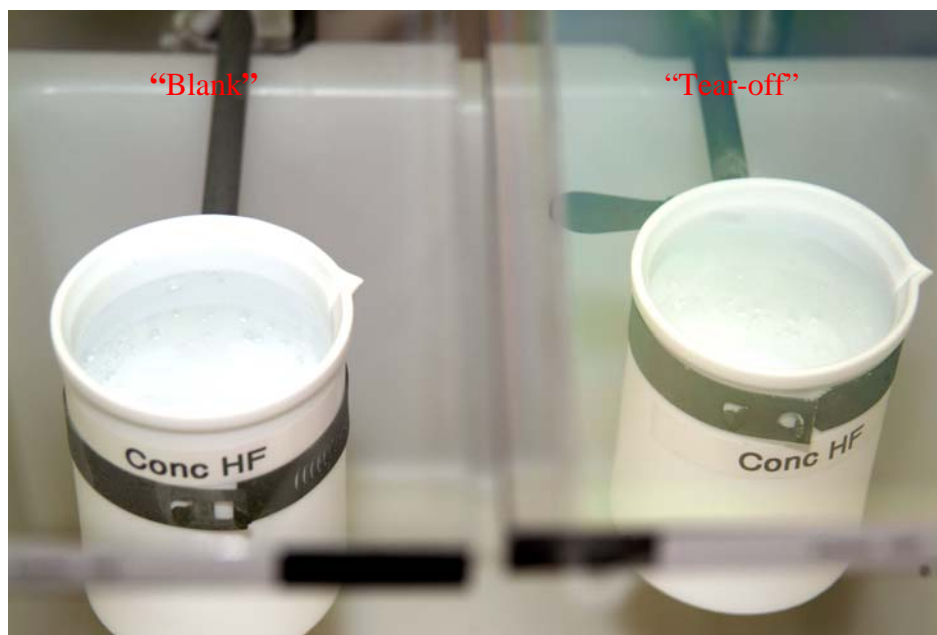
Figure 5-3. Visual Clarity of "Blank" (left) and "Tear-Off" (right) after 13 Days (Concentrated HF)
(plate heights are 4" above the acid vessel)

After 28 days of exposure, there were no signs of visual degradation noted on any of the tear-offs or “blank” systems for any of the acids (see Figure 5-6 through Figure 5-9).¹⁵ These photos can be compared to Figure 4-2 which is the baseline condition. These photographs can also be compared to Figure 5-1 through Figure 5-4 (after 13 days of exposure at the 4” level).

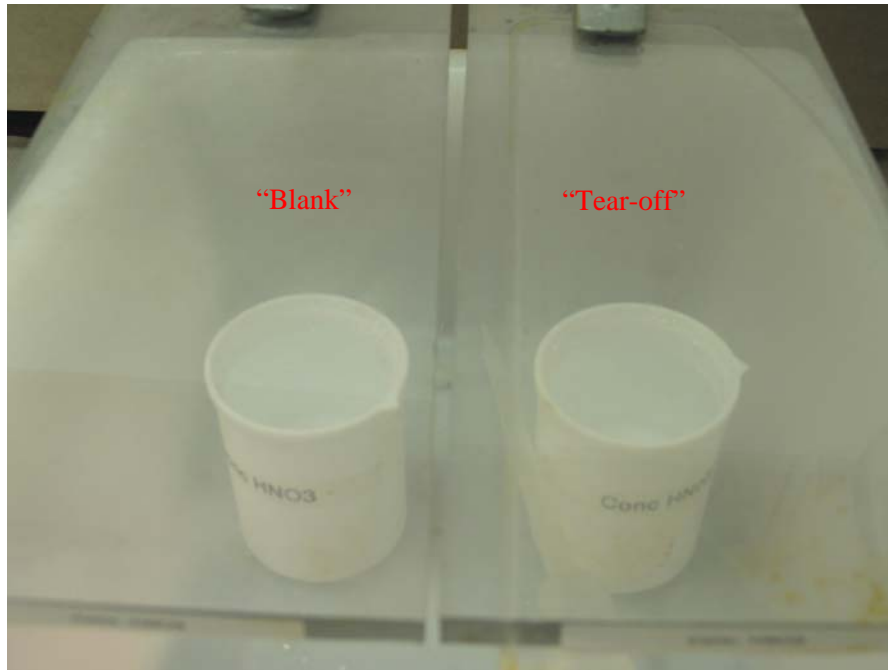
Figure 5-9. Visual Clarity of “Blank” (left) and “Tear-Off” (right) after 28 Days (Concentrated HNO₃)

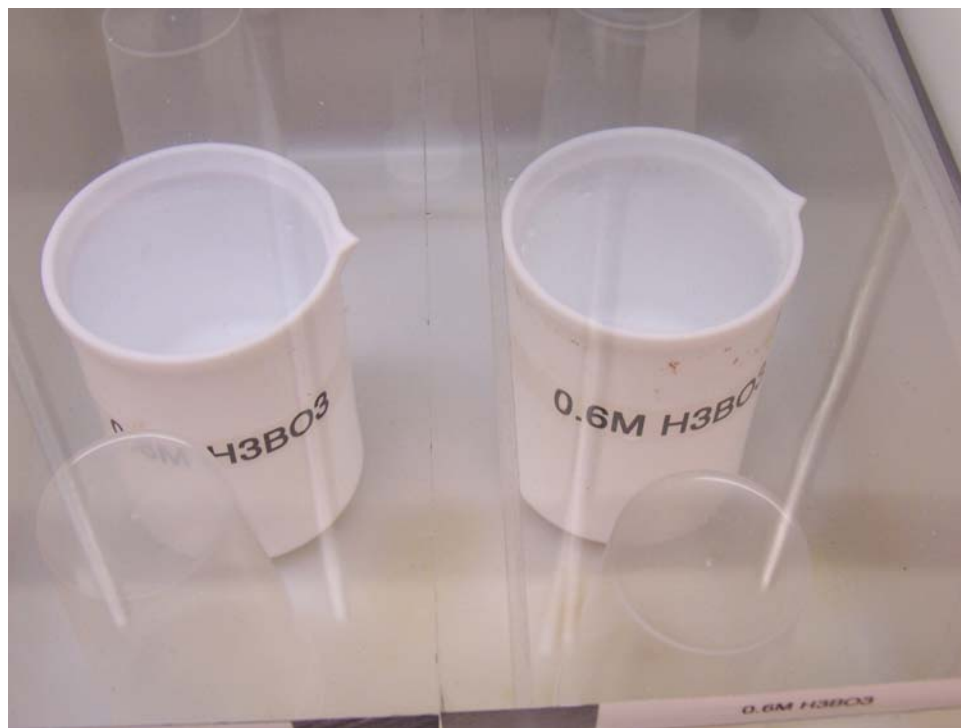
Figure 5-14. Visual Clarity of "Blank" (left) and "Lexan + Tear-Off" (right) after 35 Days at the 0" Mark (0.6M H_3BO_3)

After 35 days of testing at the 0" mark,¹⁶ the only signs of visual degradation were observed in the "blank" for concentrated HNO_3 . The circular yellow pattern was still very apparent. All the other "blanks" and all "tear-offs" systems showed no signs of visual or mechanical degradation. Figure 5-14 through Figure 5-17 provides a measure of the visual clarity for the various systems after 35 days at the 0" height level.

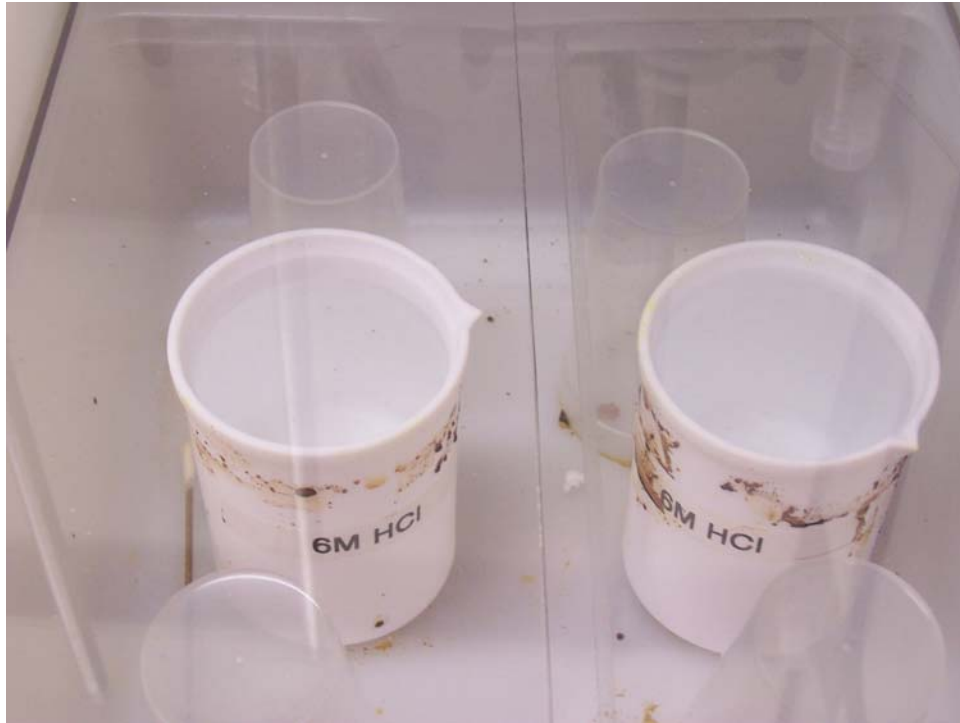
Figure 5-15. Visual Clarity of “Blank” (left) and “Lexan + Tear-Off” (right) after 35 Days at the 0” Mark (6M HCl)

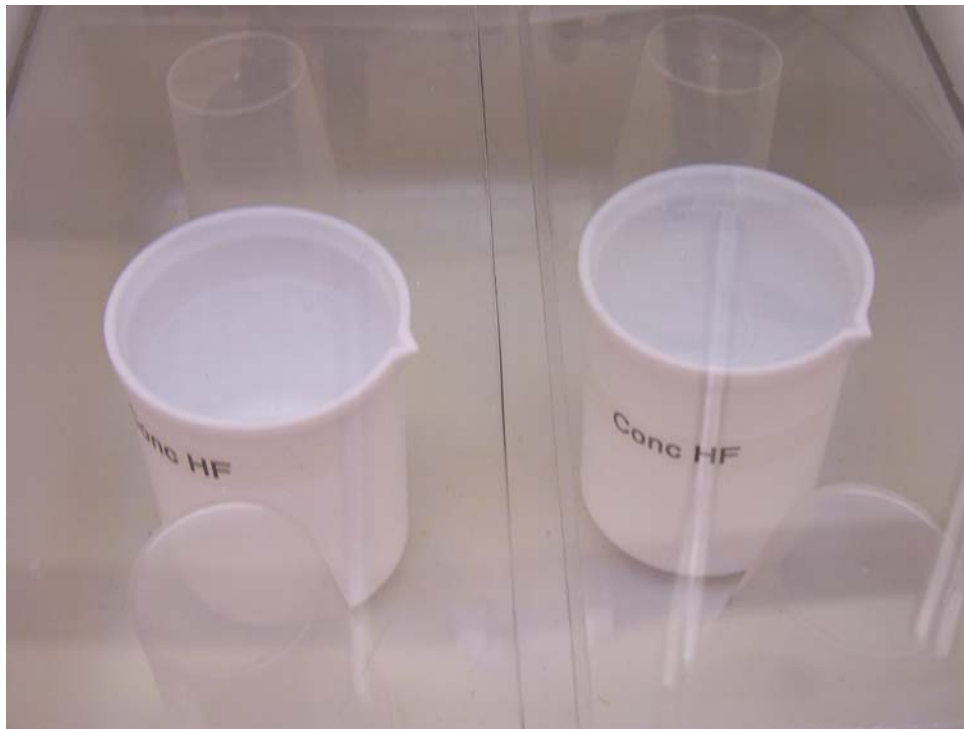
Figure 5-16. Visual Clarity of “Blank” (left) and “Lexan + Tear-Off” (right) after 35 Days at the 0” Mark (Concentrated HF)

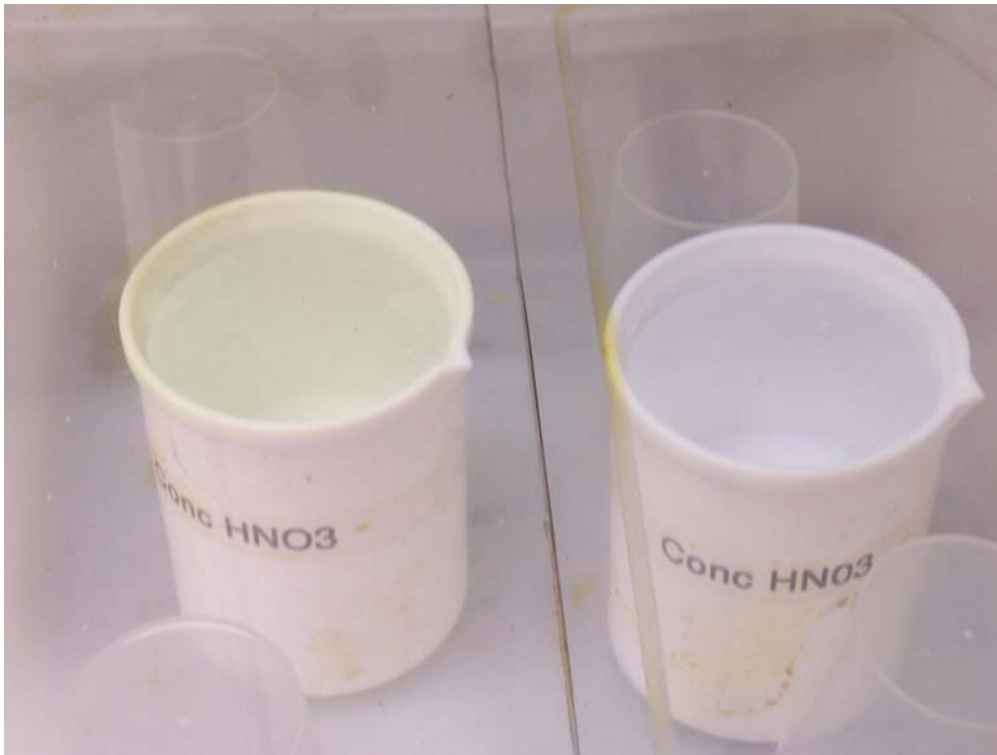
Figure 5-17. Visual Clarity of “Blank” (left) and “Lexan + Tear-Off” (right) after 35 Days at the 0” Mark (Concentrated HNO₃)
(Note: Yellow circular stain on Lexan “blank”)
