SRR-STI-2016-00008

Regulatory Compliance of H Retention Basin Using Rhombo Balls – 16151

M. H. Jackson, A. W. Wiggins, O. D. Stevens, S. L. Stinson
Savannah River Remediation LLC

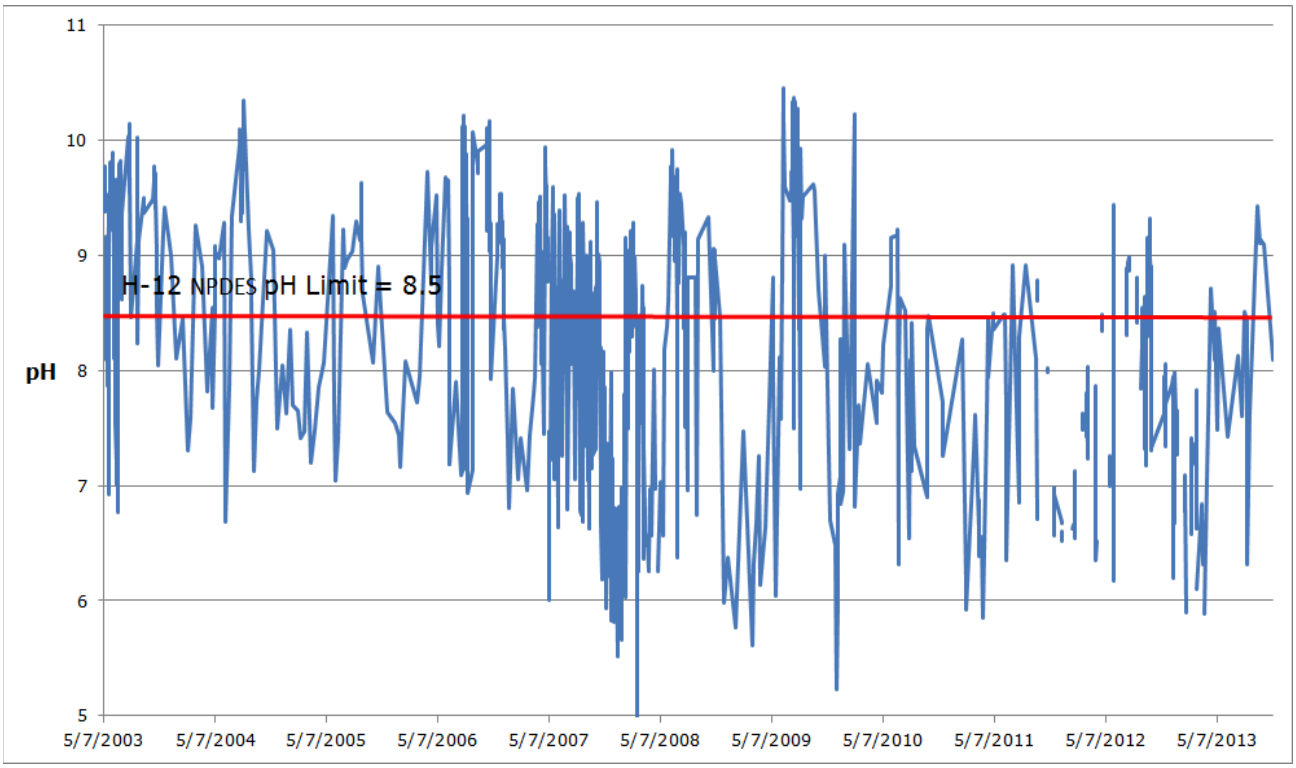
The HRB has had a steady history of having high pH, typically above 8.5 during the warmer months of the year, normally March through October. Despite the higher pH levels during the warmer months, the H-12 outfall was able to meet the NPDES pH discharge limits. This compliance requirement was accomplished by releasing the basin water simultaneously with a discharge of low pH (4.6 to 5.0) well water. In 2010 SCDHEC informed Savannah River Remediation (SRR) that this practice of blending will no longer be allowed with the impending new NPDES permit. SRR would have to determine the cause of the high pH during the summer months and implement a solution to remedy the problem. Fig. 1 depicts ten years of historical data from 7 May 2003 to 7 May 2013 in which the pH repeatedly is shown to rise above the 8.5 NPDES limit. The algae concentrations, the fluctuation between day and night, as well as the duration and intensity of high temperatures contribute to the variability seen with in the years of graphed pH data. Fig. 2 provides a closer view over a 4 year time span depicting the almost sinusoidal wave of pH readings, that oscillates down during the cooler months, November to February, and up above the 8.5 NPDES limit during the warmer months of the year. During the winter of 2015 the pH remained above 8.5, due to warm weather.

Fig. 1: A Decade of the 281-8H Retention Basin pH data.

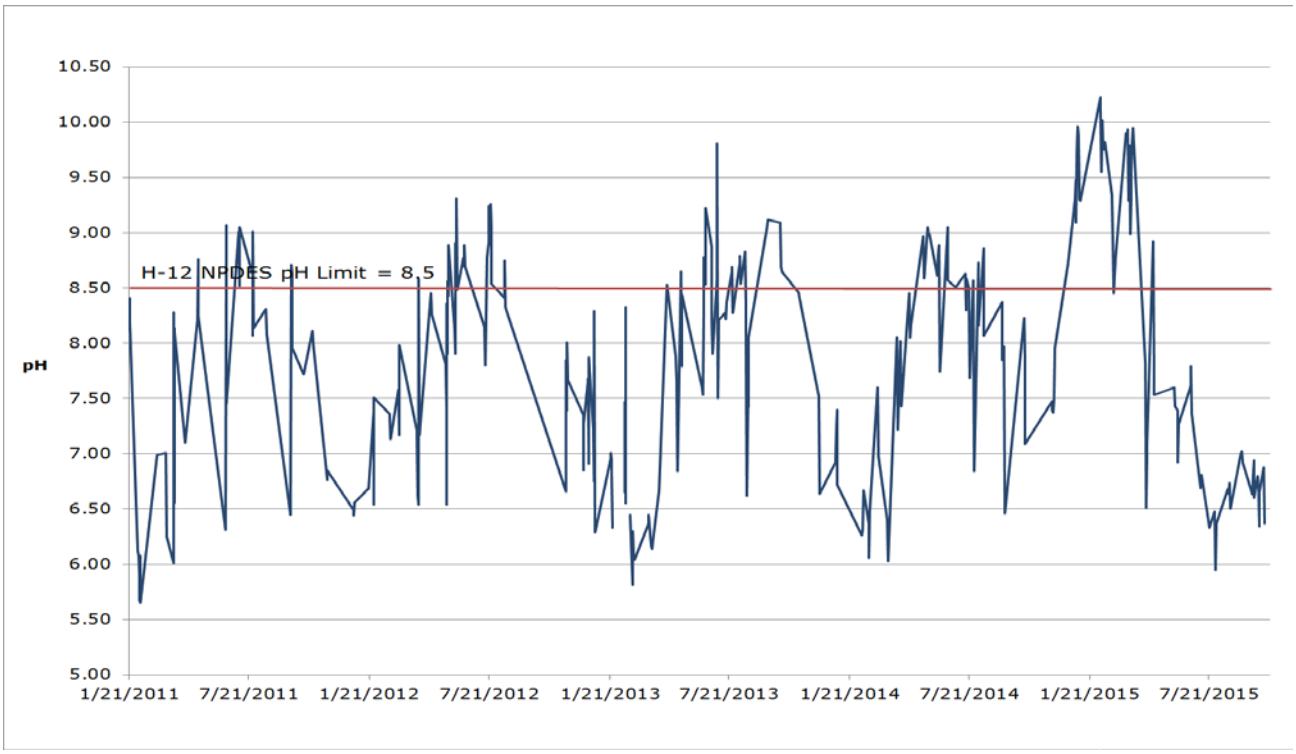
Fig. 2: 281-8H Retention Basin pH data [1]

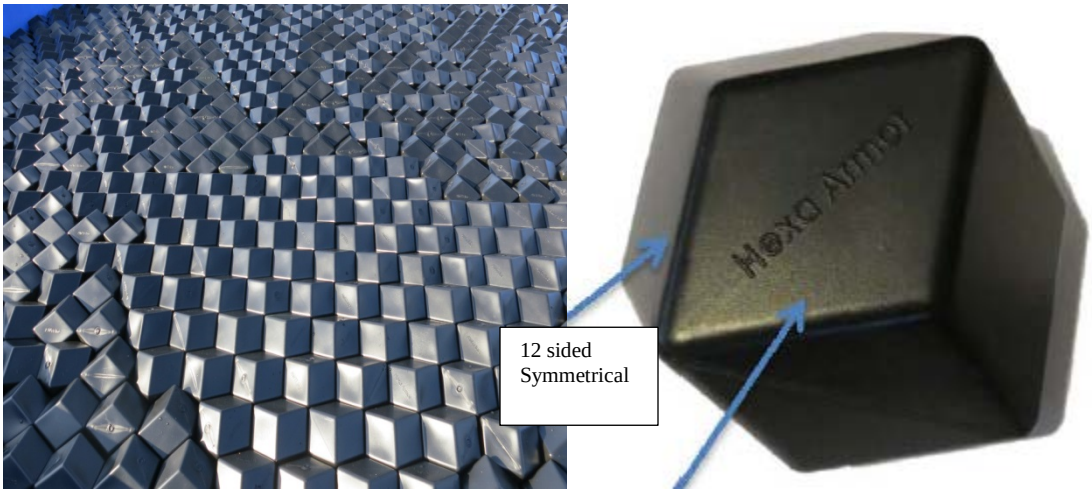
Fig. 6: [a] The Rhombo Floating Cover and Rhombo Ball

The first choice is the Rhombo 114mm size (4.5 in) floating ball cover. [2] The cover is composed of 12 sided shaped Rhombo balls that no matter which way they turn they will nest beside other Rhombo balls giving the appearance of an interlocking floating cover. The Rhombo is not really like a ball it is more like a

block. The block-like shape is due mainly because Rhombo balls are not round and do not roll. The floating cover has 99.99% coverage and 120km/hr (75 mph) wind resistance. [4] The high wind resistance is important because the basin is posted as a radiologically contaminated basin. It would not be advantageous to have windblown Rhombo balls outside of the basin and radiological postings. Some other factors that influenced the score were the 25 plus year expected life expectancy and the melting point of 129^{0}C (264 ^{0}F). [4]

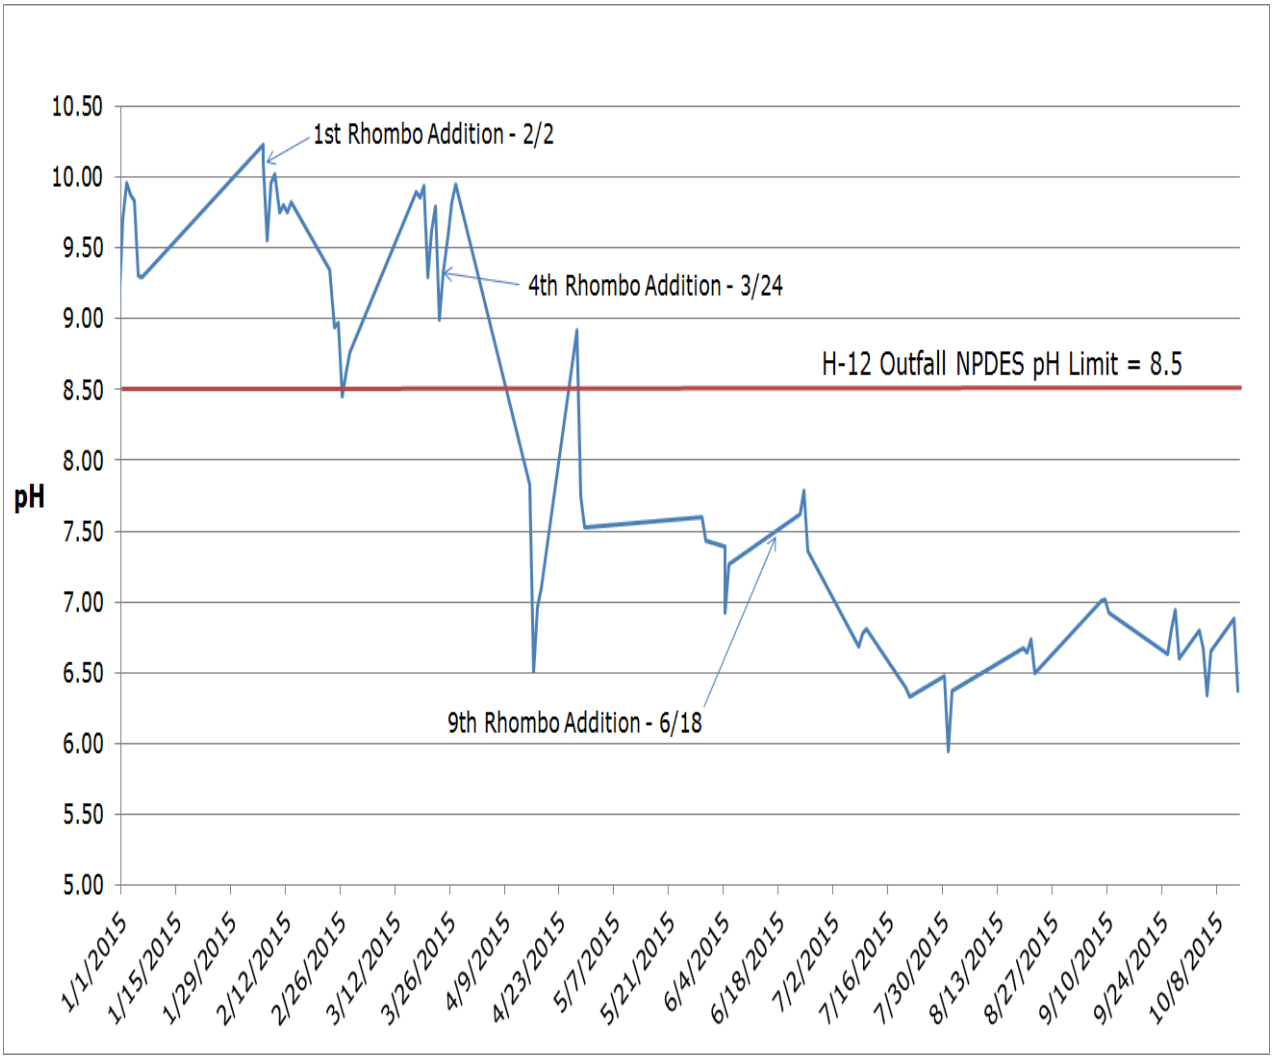
The addition of the free floating Rhombo balls took four and a half months to complete, from February 2015 to mid-June 2015. Once the basin reached approximately 44% coverage, the first significant drop in pH below the required NPDES limit of 8.5 was observed at a pH of 7.8 and then to a low of 6.5. After the initial drop below 8.5, there was a spike above this level at a pH of 9.35. It is believed that this high pH was due to a sample being captured before the basin water was adequately recirculated. The pH level since the April spike has remained consistently within the 4.8 to 8.5 NPDES limit requirement. The basin pH levels have gone from a historically high level, 10.37 during the months of March through October to a low pH recording of 5.95 in July of 2015. The average pH has been around 7. The Rhombo balls distribute themselves in response to wind and water movement in the basin. The Rhombo balls are designed to nestle together, constantly keeping their cover formation. The animal life, mainly turtles, which had been observed in the HRB prior to the addition of the Rhombo balls have vacated the covered basin. The disappearance of the turtles is a plus because it eliminates a source for continued buildup of organic matter. The biological digester was the other essential part of combating the high pH issues. It was added to the HRB once

the outside temperature reached above the minimum manufacturer's recommended temperature of 6^{0}C. The 0.45 Kg (1 pound) water soluble packets when added to the basin water disintegrated as anticipated. The basin was observably clearer by April of 2015. The basin water when seen amongst the Rhombo cover in August of 2015 remained clear. The only issue that has been noticed since the installation of the Rhombo balls, which are really block-like, is that because they do not roll, groups of the Rhombo balls tend to get hung up on the rippled sides of the basin wall liner. The loss of the few Rhombo balls that are now out of the water during low basin levels has not affected the pH levels or allowed for algae growth in the basin. Fig. 8 depicts the results of the biological digester and Rhombo ball cover installation in reducing pH in the 281-8H Retention Basin to levels to below what is required for regulatory compliance.

Fig. 8: HRB pH Results with the Rhombo Cover and Digester Addition
