Annual Radioactive Waste Tank Inspection Program - 2003^(U)

Westinghouse Savannah River Company
Savannah River Site
Aiken, SC 29808

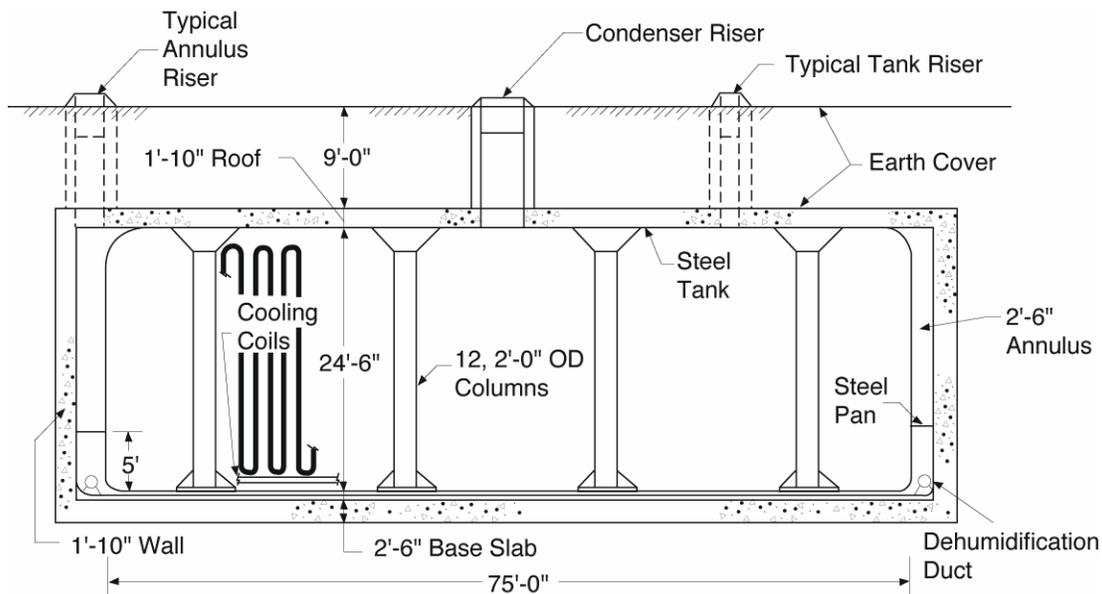
Figure 1. Cooled Waste Storage Tank, Type I (Original 750,000 Gallons)

The 12 original storage tanks constructed between 1951 and 1953 are designated Type I tanks. Tanks 1 through 8 are in F Area and Tanks 9 through 12 are in H Area. Each primary tank has a capacity of 750,000 gallons, and is 75 feet in diameter and 24 1/2 feet high. Figure 1 shows the essential features of Type I tanks, including the primary tank, the secondary pan, and the concrete support structure.

The primary container is a closed cylindrical tank with flat top and bottom constructed from 1/2-inch-thick steel plates. The top and bottom are joined to the cylindrical sidewall by curved knuckle plates. The primary tank is set within a circular pan of 1/2-inch-thick steel plates. The annulus pan is 5 feet deep and 5 feet larger in diameter than the primary tank, thus forming an annular space 2 1/2 feet wide. The tank and pan are set on a 30-inch-thick base slab and are enclosed by a cylindrical 22-inch-thick reinforced concrete wall and a flat concrete roof, also 22 inches thick. There are twelve 2-foot-diameter concrete columns within the primary tank to support the roof. Each column has a flared capital and is encased in 1/2-inch-thick steel plate.

A dehumidification duct in the annulus of each tank is routed from the tank top to the bottom of the annulus where it encircles all but 8 feet of tank. The duct has distribution outlets and its cross-sectional area decreases as the distance from the air supply increases. Access to the tank interior is provided at eight locations, and to the annular space at four locations, through riser pipes. Each of the 12 riser pipes is capped at the top with a concrete plug. Each plug is provided with two 5-inch-diameter ports equipped with removable plugs unless equipment has been installed to support waste removal or tank closure activities. The center plug port may provide

All welds in the pan and primary tank were radiographically inspected, defects were corrected, and the welds were rechecked radiographically. The welds in the flat bottoms of both the pan and the tank were vacuum-tested for leaks. Additionally, both vessels were hydrostatically tested. The water was maintained at full height in the tank for 24 hours before inspection for leaks was made. Cooling water piping was hydrostatically tested at 300 psig and then leak-tested with 100 psig air pressure in the piping.

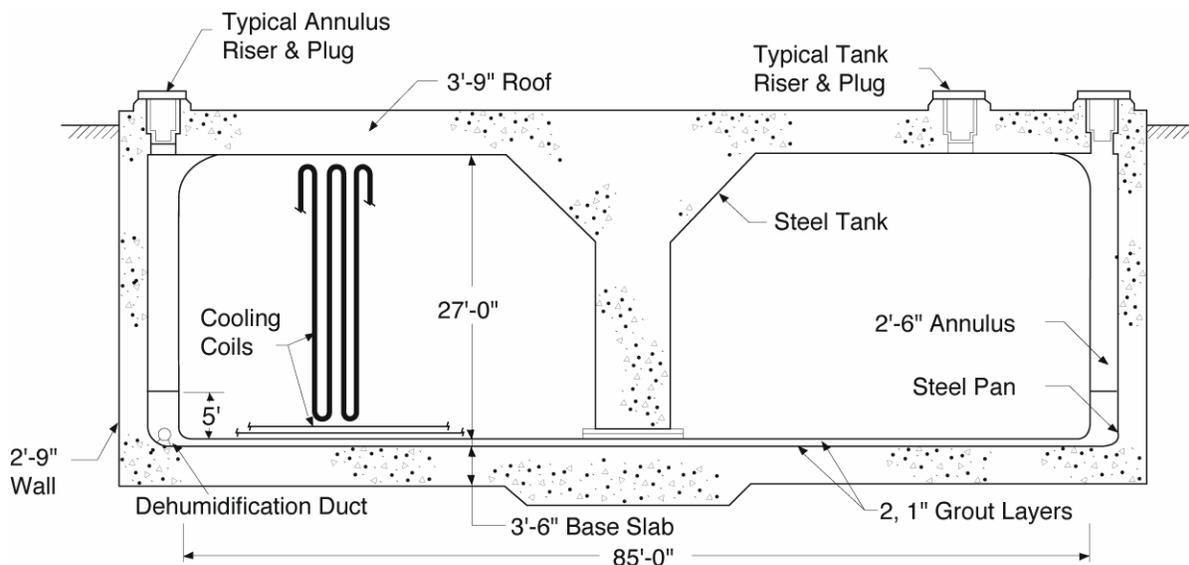
Figure 2. Cooled Waste Storage Tank, Type II (Original 1,030,000 Gallons)

Tanks 13 through 16, constructed in H Area in 1955 and 1956, are designated Type II tanks. Figure 2 is a cross section of this type. Each primary tank has a capacity of 1,030,000 gallons and is 85 feet in diameter and 27 feet high.

The primary container for Type II tanks consists of two concentric steel cylinders assembled with a flat bottom and a flat top into a form somewhat like a doughnut. The top and bottom are joined to the outer cylinder by rings of curved knuckle plates. The inner cylinder is flared at the top to accommodate the roof support column. This cylinder is joined to the flat steel top with a continuous butt weld and to a base fastened to the bottom with a continuous T-weld. Steel thicknesses are:

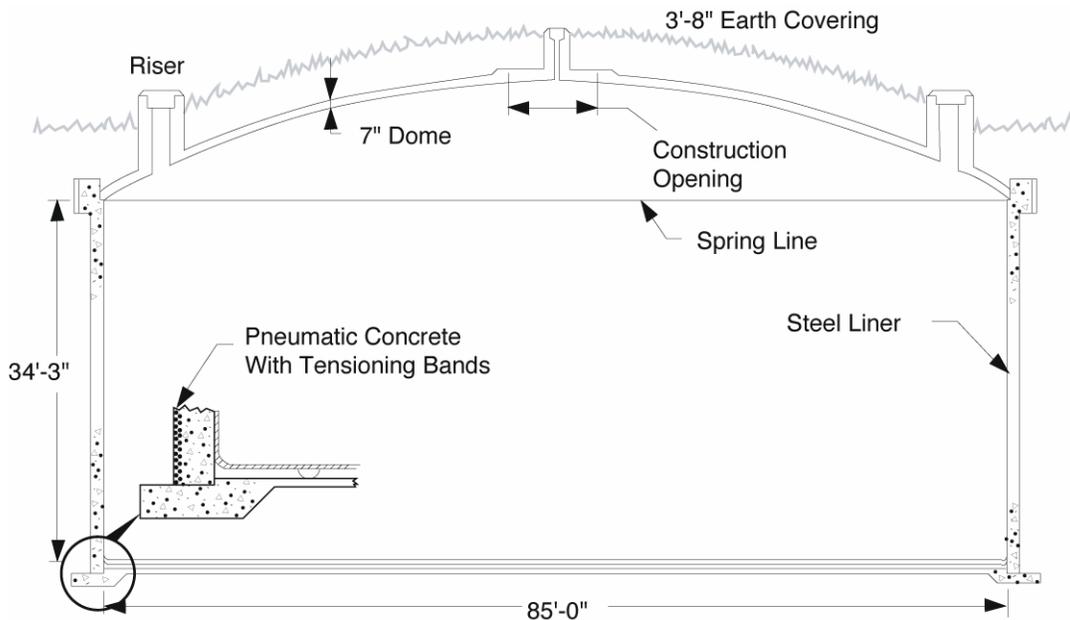
Figure 3. Uncooled Waste Storage Tank, Type IV (Prestressed Concrete Walls, 1,300,000 Gallons)

Tanks 17 through 24 are single-wall-uncooled tanks. These tanks were designed for storage of waste that does not require auxiliary cooling. Tanks 17 through 20 were constructed in F Area in 1956 and Tanks 21 through 24 were constructed in H Area in 1960. Each tank has a capacity of 1,300,000 gallons and is 85 feet in diameter and 34 feet high (Figure 3).

Each Type IV tank is basically a steel-lined, prestressed-concrete tank in the form of a vertical cylinder with a domed roof. Carbon steel plates, 3/8 inch thick, were used to form the cylindrical sides and flat bottom portion of the steel liners. The knuckle plates at the junction of the bottom and the sidewall are 7/16 inch thick. Concrete was built up around the steel vessel by the "shotcrete" technique.

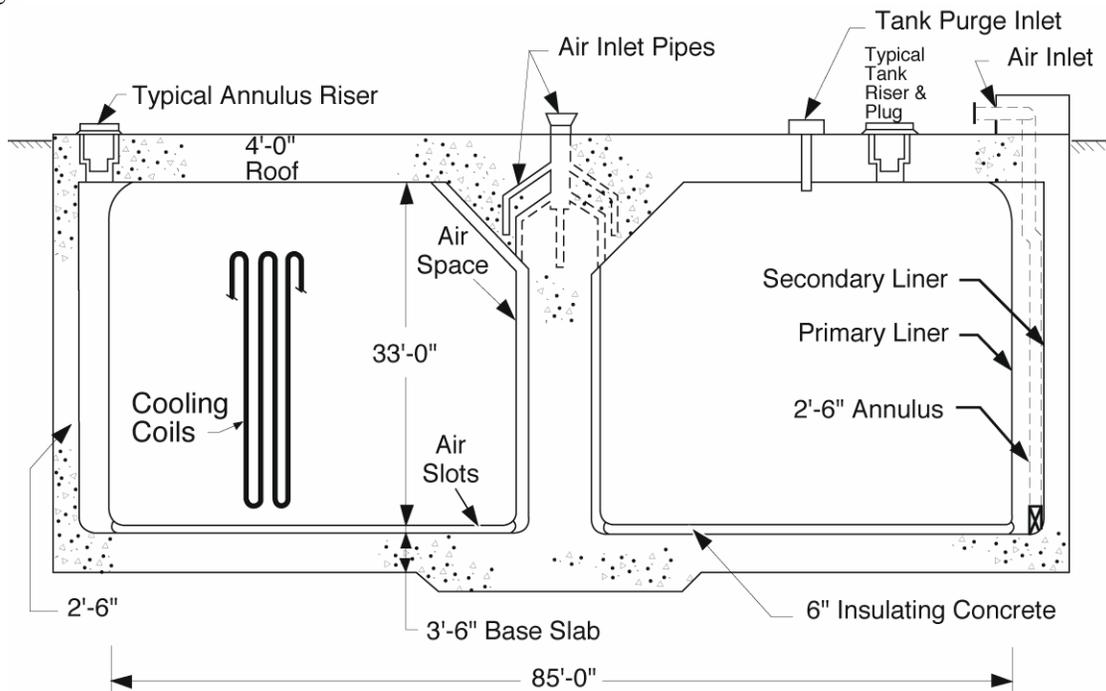
Figure 4. Cooled Waste Storage Tank, Type III (Stress Relieved Primary Liner, 1,300,000 Gallons)

The most recently constructed tanks are designated as Type III tanks (Figure 4). Twenty-seven tanks were built between 1966 and 1981. Tanks 25 through 28, 33 and 34, and 44 through 47 are located in F Area. Tanks 29 through 32, 35 through 43 and 48 through 51 are located in H Area.

The Type III tank design was developed after an investigation into the causes of the leaks from the primary vessel of the Type I and Type II tanks. The study concluded that the leak-producing mechanism was nitrate-induced, stress-corrosion cracking at sites in or near the weld seams, and that stress relieving after fabrication should eliminate the cracking. For the Type III tanks, means were provided for heating each finished tank to relieve the stresses generated during fabrication. In addition, some stress patterns were avoided, or minimized, by mounting the roof supporting column on the foundation pad rather than on the bottom of the primary tank (as in Types I and II), and by providing an annular clearance around the roof supporting column. Each primary tank holds 1,300,000 gallons and is 85 feet in diameter and 33 feet high.

Plate	Thickness, inch
Top and bottom	1/2
Top knuckle	1/2
Outer wall (tanks 29 through 34)	
Top plate	1/2
Middle plate	5/8
Lower plate	3/4
Outer wall (tanks 25-28 and 35-51)	
Top plate	1/2
Middle plate	5/8
Lower plate	7/8
Inner wall	
Upper plate	1/2
Lower plate	5/8
Bottom knuckle	
Outer (tanks 29 through 32)	1
Outer (tanks 25-28 and 33-51)	7/8
Inner	5/8
