Estimation of Leak Rate from the Emergency Pump Well in L-Area Complex Basin

Andrew J. Duncan
Savannah River National Laboratory
Washington Savannah River Company

Publication Date: December, 2005

DOCUMENT: WSRC-TR-2005-00558, Rev. 0

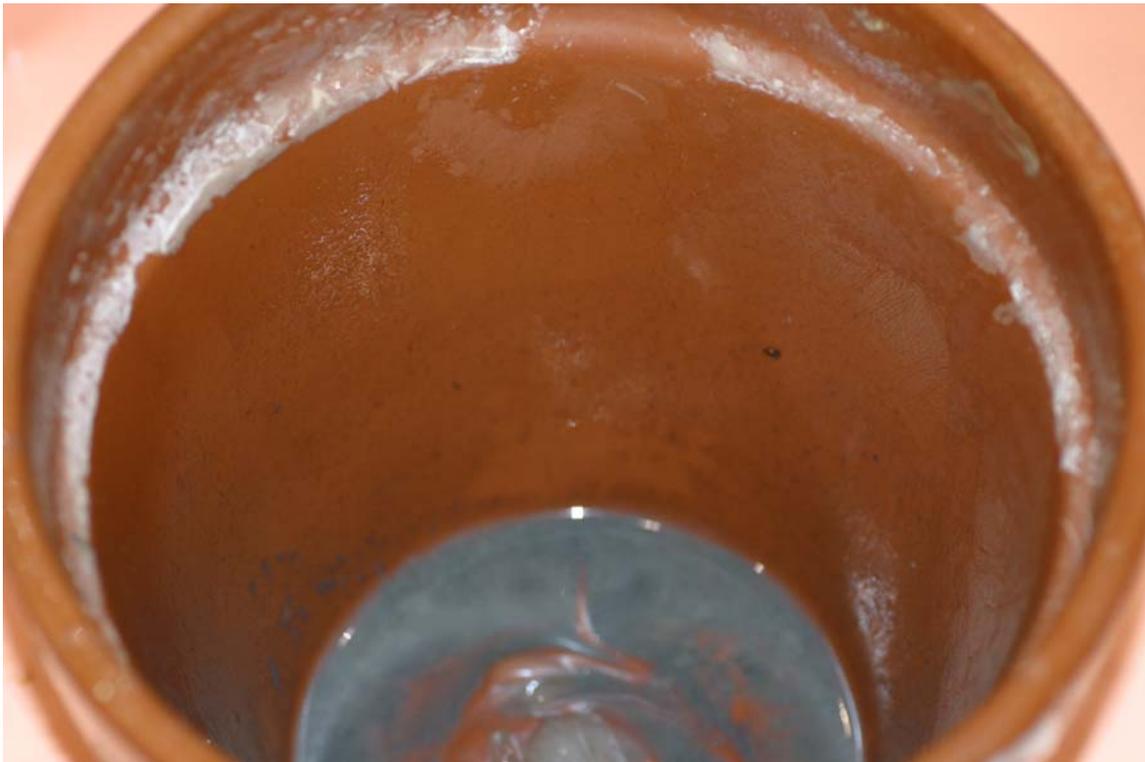
Figure 2: Clay pot after 10 days of Bacteria Incubation

organisms associated with complex biofilm formation. Samples of the residue remaining on the surface were taken and placed on sterile Petri plates. After three days of incubation, the plates showed active growth from the swipe taken off the surface of the removed grout and from the inside of the pot. Biofilm thickness after the pot was grouted was estimated to be about 50 μm (0.002 inch). This was determined by examination of the inside of the pot using the DAPI stain after the grout had been removed.

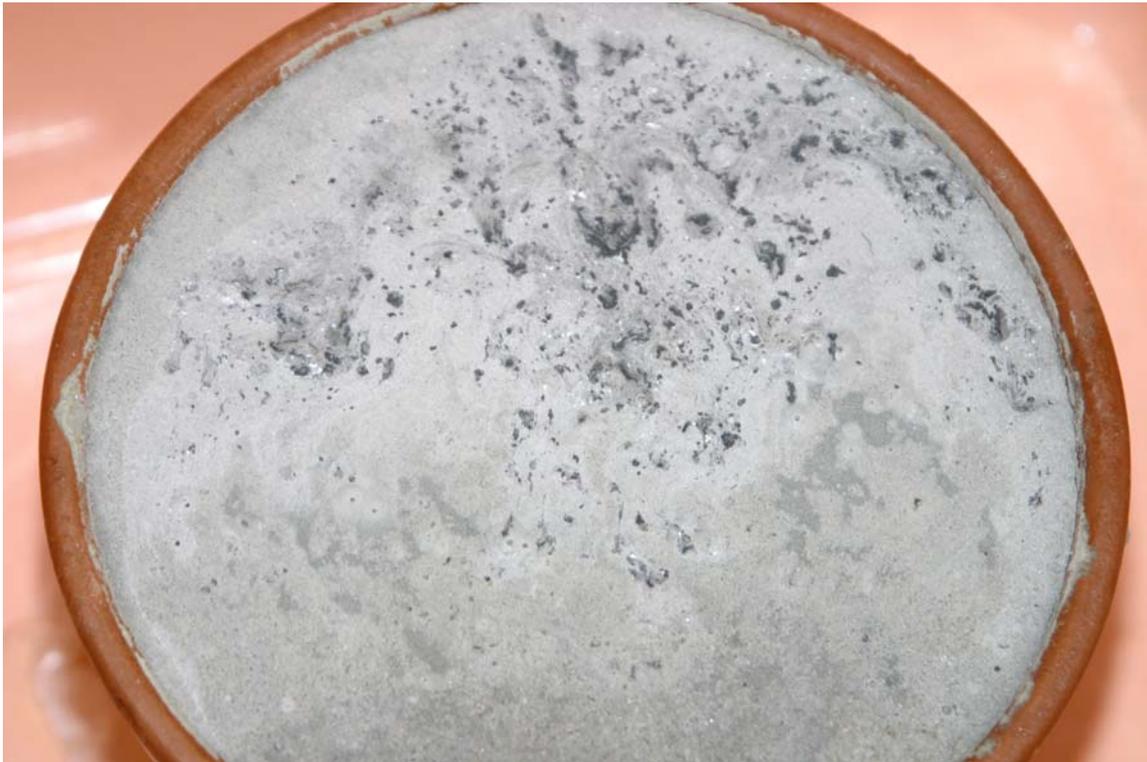
Figure 3: Clay pot after filling with CLSM type grout

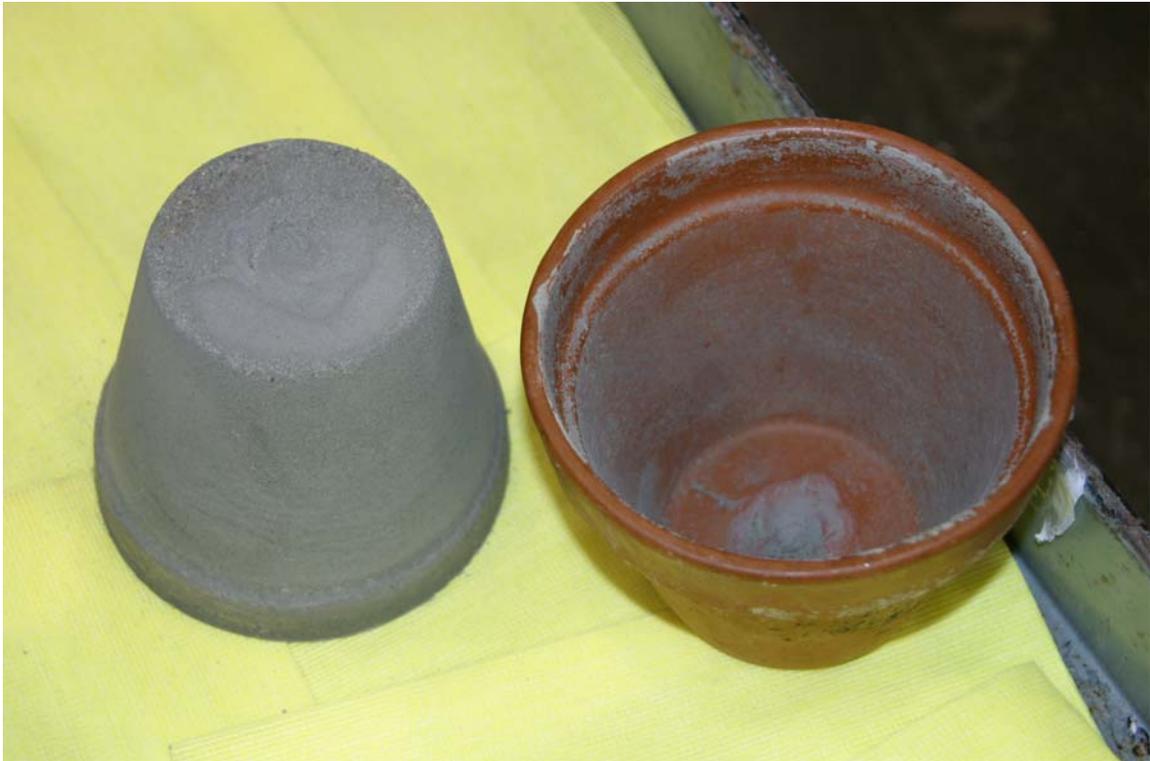
Figure 4: CLSM grout and Clay pot after separation
