SR19036 – TRP Cutter Head Improvement

The current Target Rod Preparation (TRP) Cutter Head suffers from overheating problems during TPBAR breaching operations. The overheating leads to work stoppage due to the periodic need to allow the TRP Cutter Head motor to cool. This work stoppage and allowance for cooldown of the motor leads to a very inefficient TPBAR breaching process. Due to the increased need for Tritium gas, the system must be improved to increase the efficiency of the TPBAR breaching process.

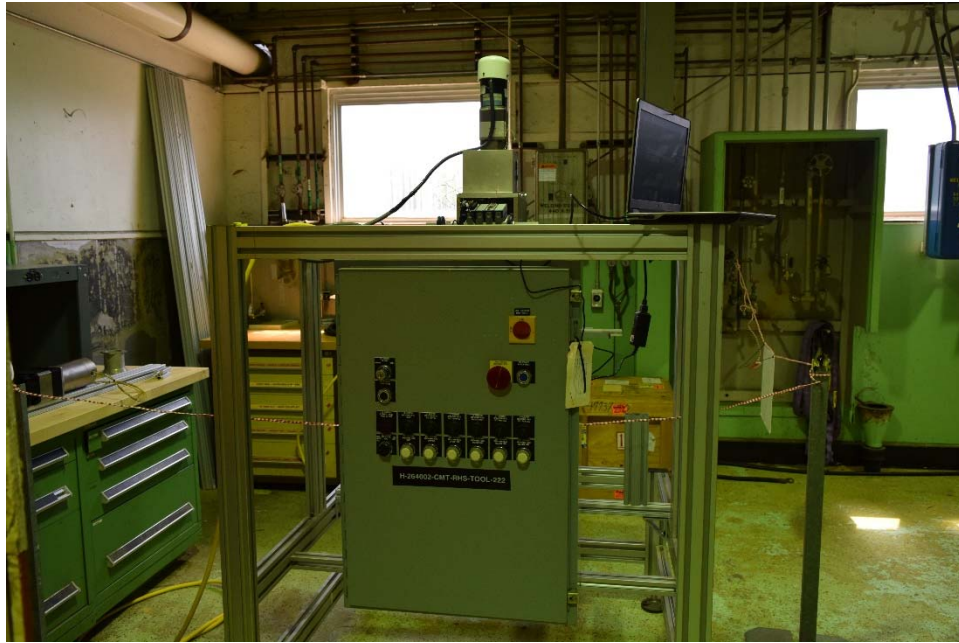
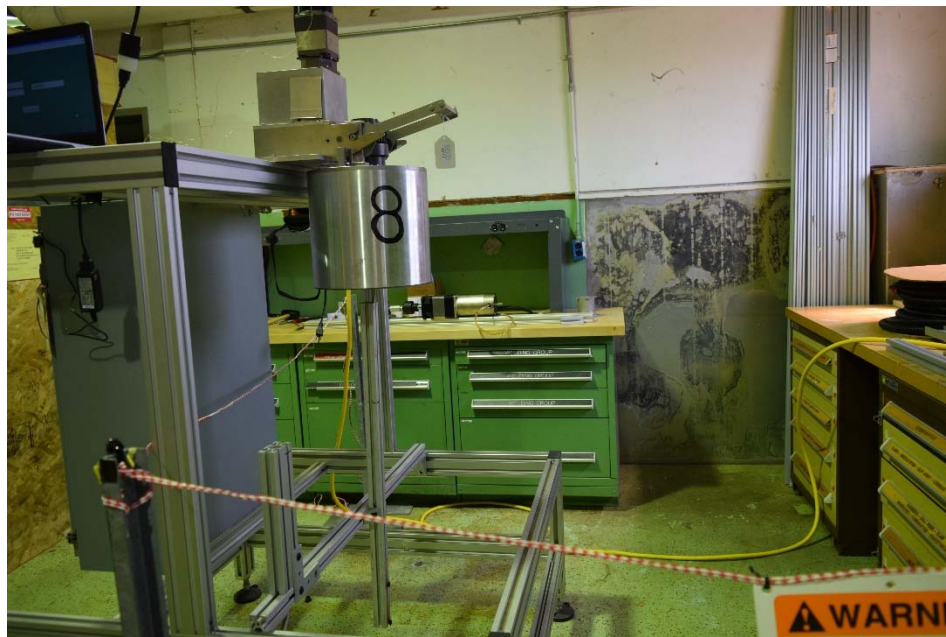
Figure 1. TRP Test Stand

Figure 2. TRP Test Stand

The TRP cutter test stand was acquired from the Tritium Extraction Facility (TEF) to provide the necessary equipment to accurately perform mock-up testing. The test stand was relocated to the mechanical lab located in building 723-A. Tritium personnel provided guidance and applicable procedures to set up and operate the TRP test stand. Pictures of the test stand are shown in Figures 1 and 2.
