### WEAR RATE TO STAINLESS STEEL PIPE FROM LIQUID-SOLID SLURRY

Mark R. Duignan, Marissa M. Reigel, Kenneth J. Imrich,  
Michael L. Restivo and Mark D. Fowley  
Savannah River Nuclear Solutions  
Savannah River National Laboratory  
Aiken, South Carolina, USA

The United States Department of Energy is building a Waste Treatment Plant (WTP) at the DOE Hanford Site in the state of Washington to process stored radioactive wastes for long-term storage and disposal. The Savannah River National Laboratory (SRNL) is helping resolve technical concerns with the WTP, which are related to piping erosion/corrosion (wear). SRNL is assisting in the design of a flow loop to obtain long term wear that will use prototypic simulant chemistry, operating conditions, and materials for total wear rate. The challenge is to accurately measure slurry wear to a pipe wall thickness tolerance of ~47 microns/year anywhere in the test flow loop in a timely manner. To help in the design of the flow loop a test was performed with a smaller loop, which contained many of the pipe fittings expected in WTP to determine where high wear locations exist. One aspect of this test was to understand the rate of wear to stra

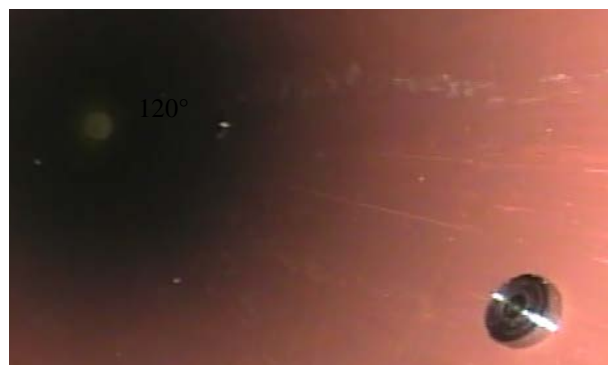
Figure 8. Coupons in place with Coupon No 11 in the forefront.

Figure 8 shows a close up of coupon No. 11, as looking from the downstream side of the tube. All 12 coupons were exactly the same as the one shown in Figure 9, which is a photograph of one coupon after it was modified from a 316L stainless steel set screw. Note that while both the slurry pipe and the screw material were of 316L they are different. That is, off-the-shelf pipe metal is generally annealed, so the wear coupons should have been, too. However, the method used to fabricate the screw is partially through cold working, i.e., the threads are cold rolled, which causes work hardening.

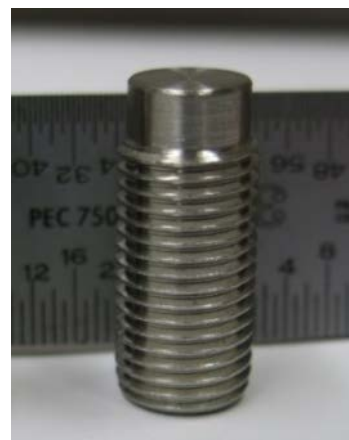
Figure 9. Coupon was made from a 316L stainless steel set screw and was machined to 7.94-mm diameter.

Furthermore, the metal stock to make the screw is probably first extruded, which elongates the grain structure. That diameter was chosen based on the set screws that were available. The exposed head of the screw was machined to a 0.794-cm diameter with a 32 micro-inch surface finish<sup>3</sup>. By machining the top threads off the top of the screw and cutting

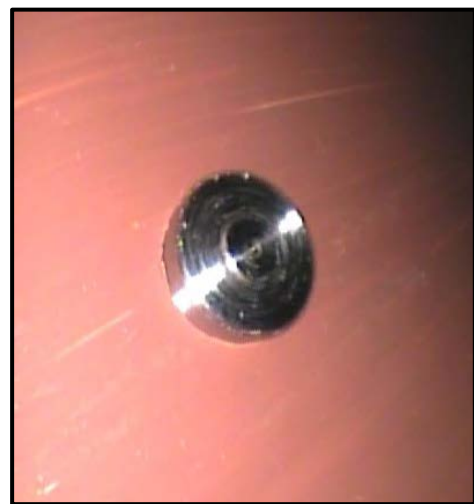
Figure 17. Coupon No. 11 before test.

Figure 17 and Figure 18 show close-ups of Coupon No. 11 seen in Figure 14, before and after the test.
