Performance of Vapor Corrosion Inhibitors for Localized Corrosion Mitigation of Double Shell Storage Tanks at Hanford

Pavan K. Shukla, Roderick E. Fuentes, Bruce J. Wiersma
Savannah River National Laboratory®
Aiken, South Carolina, 29808
USA

ABSTRACT

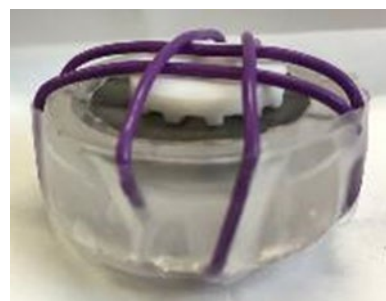
(a) Top view

(b) Side View

Figure 2: Image of a coupon used in the study. (a) Top, and (b) side views of the partially covered coupon. The coupon's surface is partially covered with a white crevice former, which is held in place using purple wire and tape.

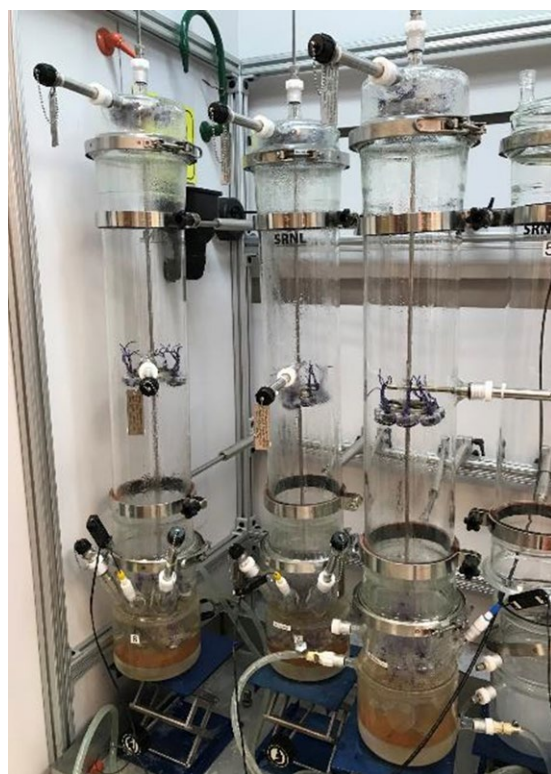
Figure 3: Images of the (a) experimental configuration, and (b) steel rod to suspend the coupons inside the vessel containing electrolyte.

Level 1: Bottom or low level. Coupons were dipped in the simulant for five minutes prior to testing. The coupons were hung at the bottom fixed ring of the rod shown in Figure 3(b). These coupons were suspended approximately 25 mm (1 inch) above the liquid level of the simulant. Every two weeks, the coupons were lowered into the simulant for 5 minutes. This level is representative of the situation when the secondary liner bottom plate experienced periodic wetting/drying.
