**Overcoming Waste Removal Challenges at Savannah River Site:  
A Case Study of Tank 15 – 16198**

**ABSTRACT**

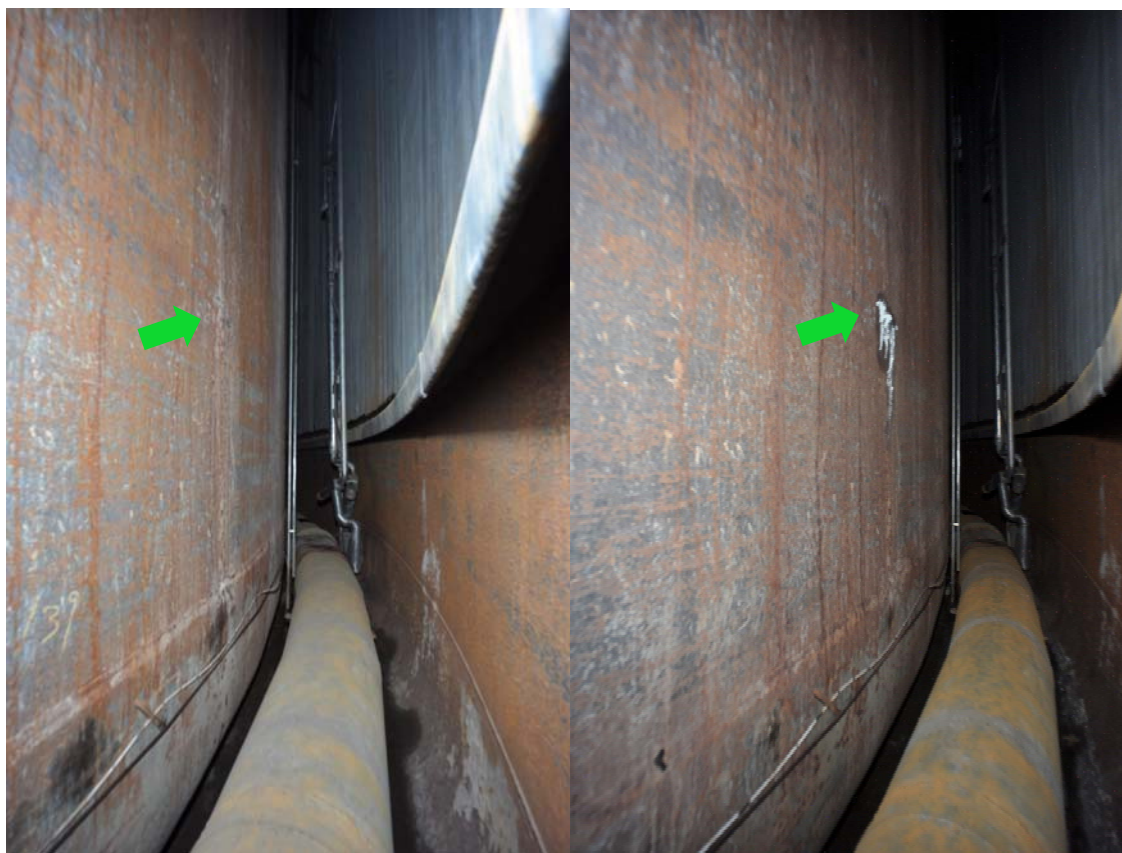
Figure 2. Known Leak Site Before and After Liquid Additions

Upon completion of a readiness assessment, liquid additions commenced for rehydrating the sludge in Tank 15. The expected volume of liquid required to rewet the sludge was estimated to be between 326 m<sup>3</sup> (86,000 gal) and 757 m<sup>3</sup> (200,000 gal) with a best estimate of 568 m<sup>3</sup> (150,000 gal). The wide estimate range was due to the sloped topography of the sludge and the unknown interstitial void space volume. The sludge was covered with liquid and the sludge was declared to be rewet after 697 m<sup>3</sup> (184,000 gal) of liquid had been added to Tank 15.[10] Known leak sites reactivated near the end of the liquid additions; however, the leak rate was extremely small. Visual monitoring of the tank wall also identified four new leak sites as condensation wept through the flaws located above the liquid level.[11] Only one of the newly discovered leak sites is currently below the liquid level. As expected, however, continued use of annulus ventilation resulted in sealing a majority of the leak sites. Figure 2 shows a known leak site (a) before liquid additions, then (b) after a leak formed and plugged with salt. The leak rate has slowed to the point that the seepage evaporates before reaching the annulus pan for those sites that have not been completely sealed. The CTS was never deployed.
