# Regulatory Strategies to Minimize Generation of Regulated Wastes from Cleanup, Continued Use or Decommissioning of Nuclear Facilities Contaminated with Polychlorinated Biphenyls (PCBs) - 11198

Nancy J. Lowry Savannah River Nuclear Solutions Savannah River Site Aiken, South Carolina 29808

# CASE STUDY: MANAGEMENT OF PCB CONTAMINATION AND PCB WASTE MINIMIZATION IN THE FORMER SRS PRODUCTION REACTORS

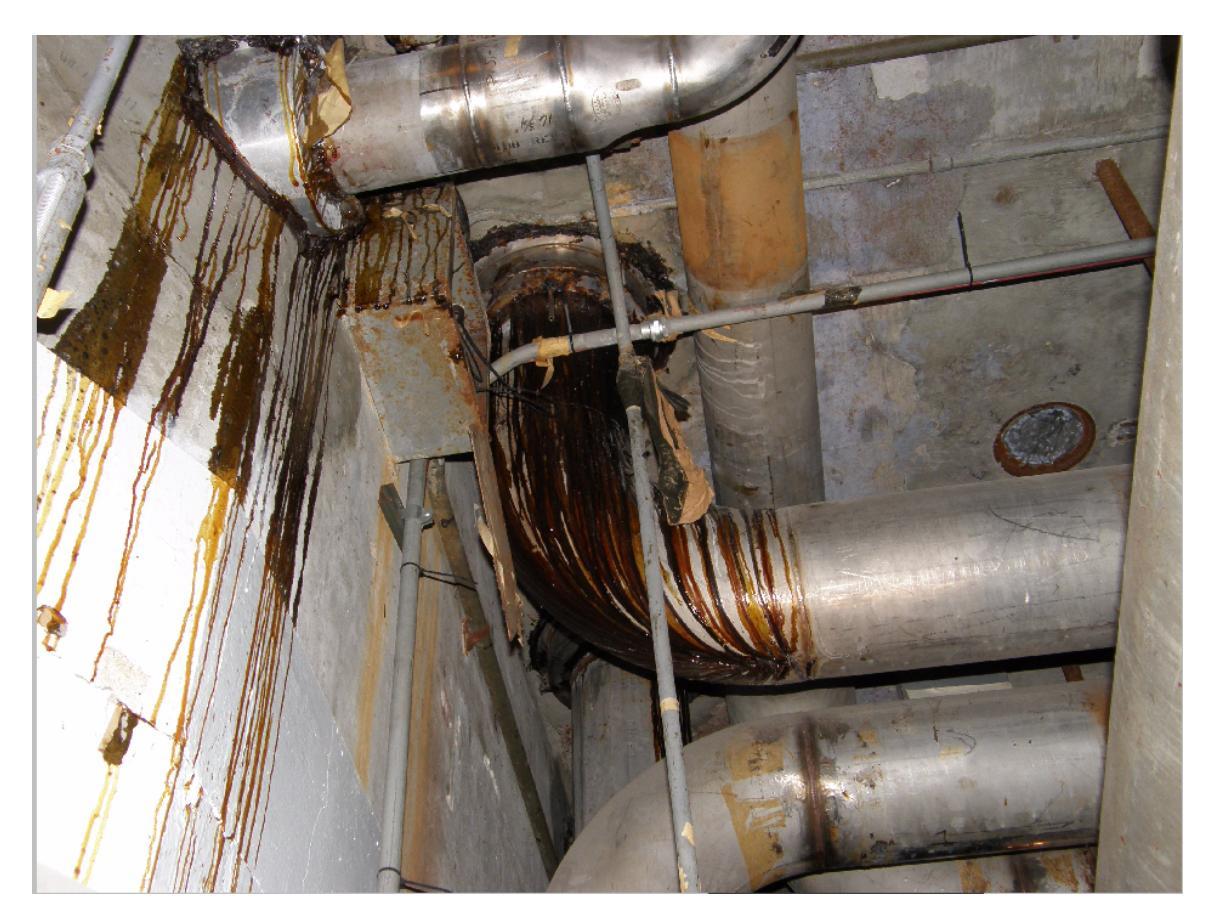
During the walk down inspections, it was observed that the degraded sealant had accumulated on the floor near open grating in several locations. The open grating provides a direct pathway for liquids to migrate downward to successive lower levels of the facility. In a few locations, the sealant had in fact traveled through the grating onto surfaces below. No sealant has migrated to building sumps or the environment. Photographs were taken of the affected areas to document the situation and facilitate communication and evaluation. Photographs of the seepage are shown in figures 1 and 2.

Figure 1. Photograph of degraded sealant leaking from piping penetrations in the reactor biological shield wall.

The desired approach for the 105-C and 105-L facilities was based upon the provisions of 40 CFR 761.30(p), "continued use of porous surfaces contaminated with spills of liquid PCBs." SRS believed that these provisions could be applied in a manner that fits the circumstances and controls the PCB contamination. SRS determined that the surfaces were not safely accessible for purposes of performing a double wash/ rinse procedure due to the high potential for liquids to spill downward through the open grating Instead, SRS staff desired to perform limited manual removal (i.e., scraping) of the PCB-contaminated sealant from horizontal surfaces that could be accessed safely. This would be followed by installation of floor coverings, berms to control vertical seepage, and barricades. These engineering controls would be supplemented with administrative controls, including continuing limitations on personnel entry. This approach would greatly minimize personnel exposure to radiation and other hazards, reduce the risk of further spreading contamination throughout the facility, and avoid the generation of large volumes of liquid radioactive PCB waste. SRS determined that the occupational exposure to PCBs could be maintained within applicable limits (both during and after the partial PCB removal work) as required by 10 CFR 851. SRS believed that these actions, which focused on controlling the PCB material, constituted the most appropriate management approach for the PCB-Contaminated sealant, taking into account the three applicable regulations (40 CFR 761, 10 CFR 865 and 10 CFR 851). These actions were believed to meet the requirements and intent of 40 CFR 761.30(p) for continued use of porous surfaces contaminated with liquid PCBs. They would prevent any unreasonable risk to health and the environment. The actions would meet the 10 CFR 865 radiological ALARA program requirements pertaining to limitation of personnel radiation exposure, particularly with respect to minimizing the time spent in radioactively contaminated areas. The actions also would meet the requirements in the 10 CFR 851, Worker Safety and Health rule to control all non-radiological occupational exposure hazards.

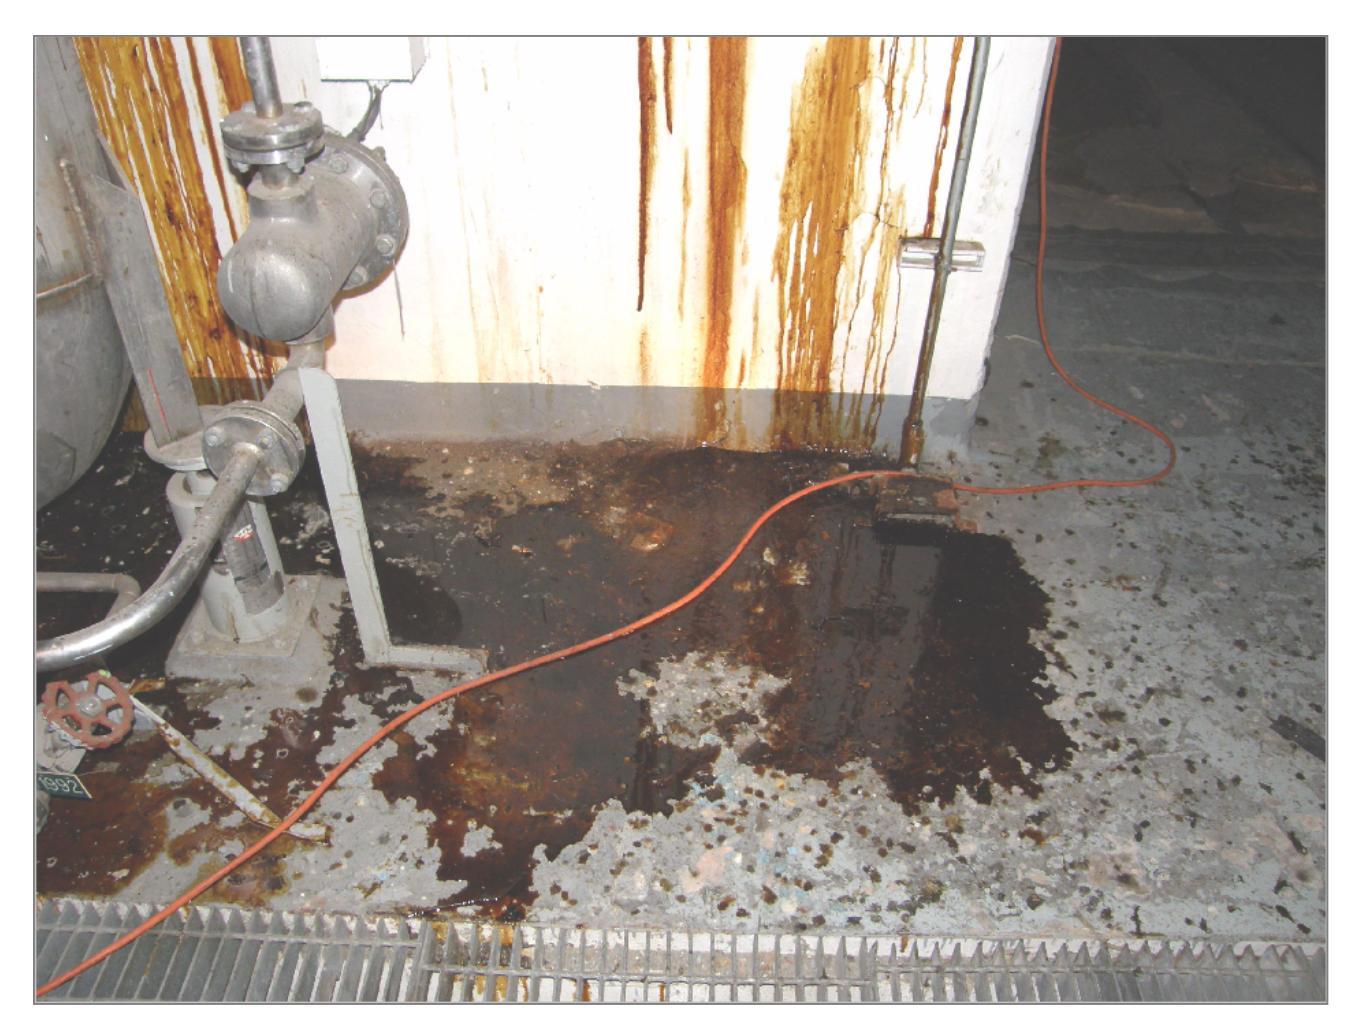
Figure 2 Photograph of sealant that has seeped to the floor next to open grating.

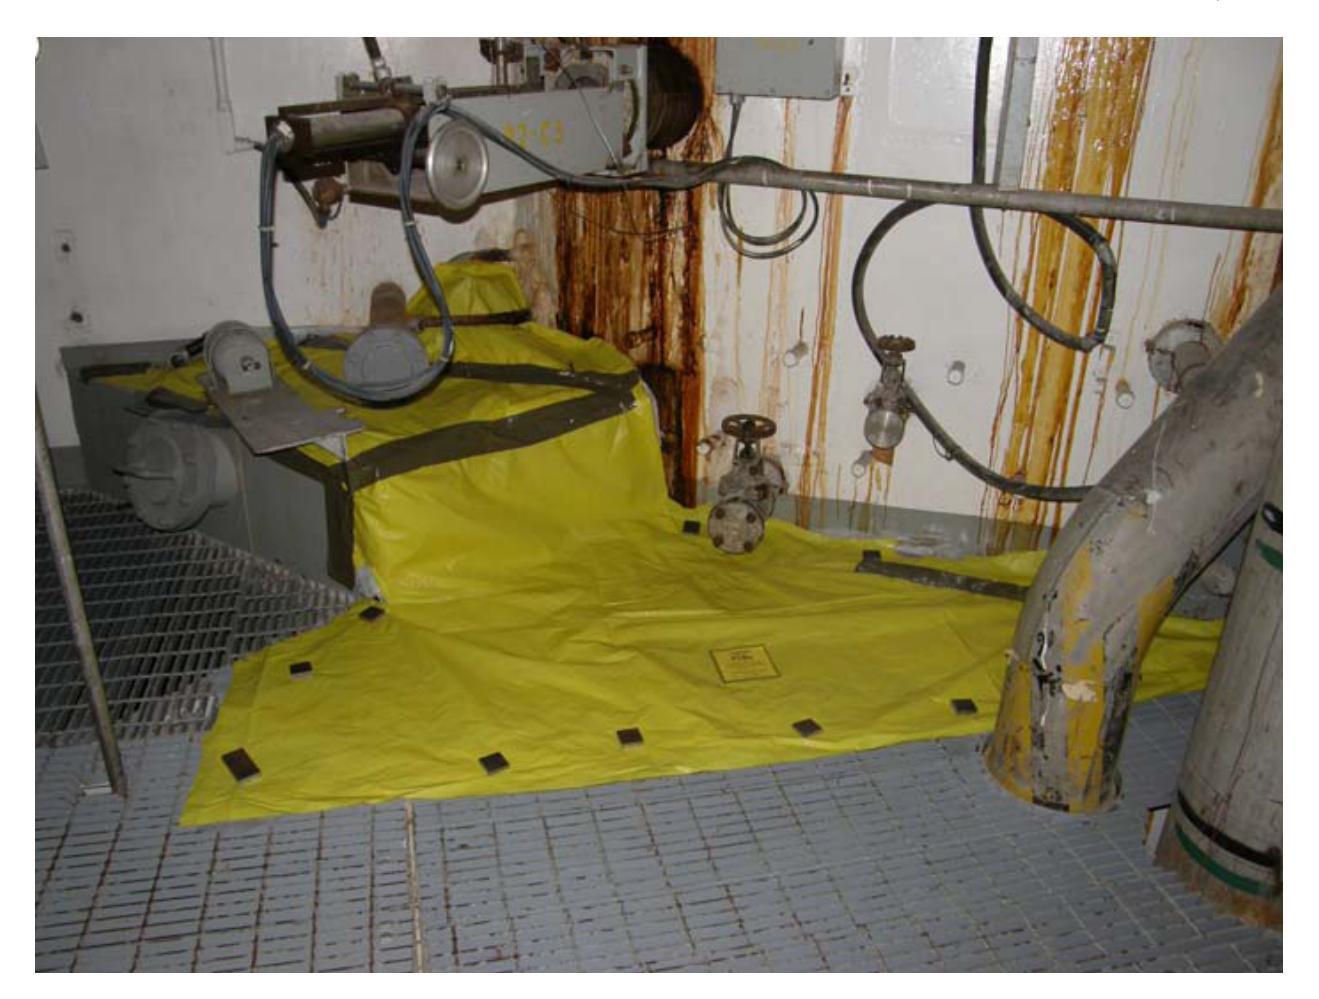
Figure 3. Location in building 105-L at -20 elevation that has been cleaned, covered and labeled. Photo does not show the barricade.

The process of scraping the horizontal surfaces and installing floor coverings and barricades began in the L-Reactor on October 4, 2010. The process was completed on October 14, 2010. The C-Reactor cleanup was completed on October 28, 2010. Photographs of the completed actions are provided as figures 3 and 4.

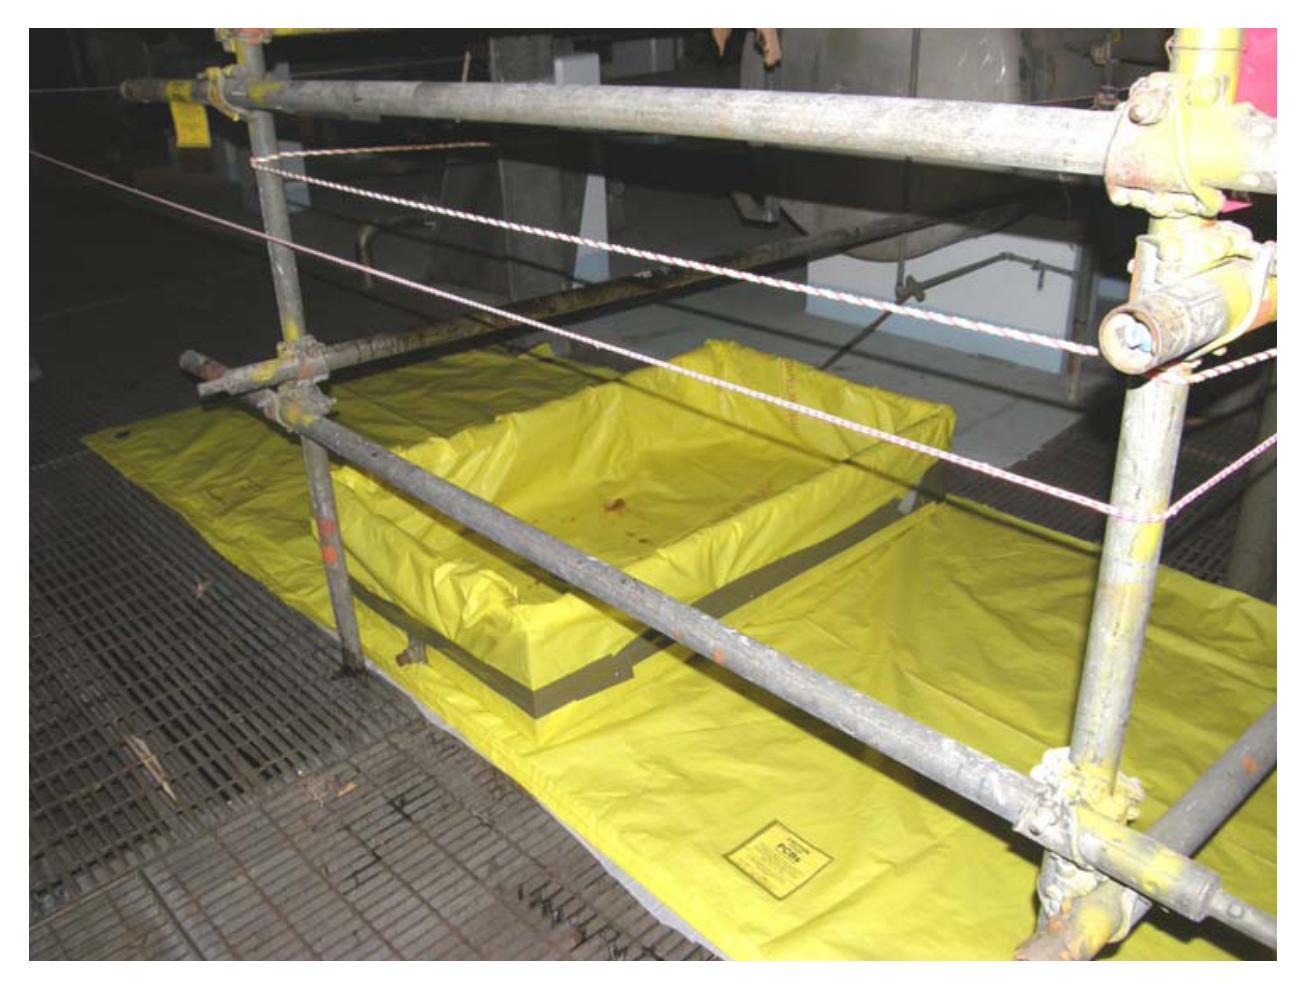
Figure 4. C-Reactor, -20 Elevation location that has been cleaned, covered, labeled and barricaded.
