Decommissioning and Environmental Cleanup of a Small Arms Training Facility -13225

Karen M. Adams*,
Thomas F. Kmetz**,
Sandra B. Smith and**,
Gerald C. Blount**

ABSTRACT

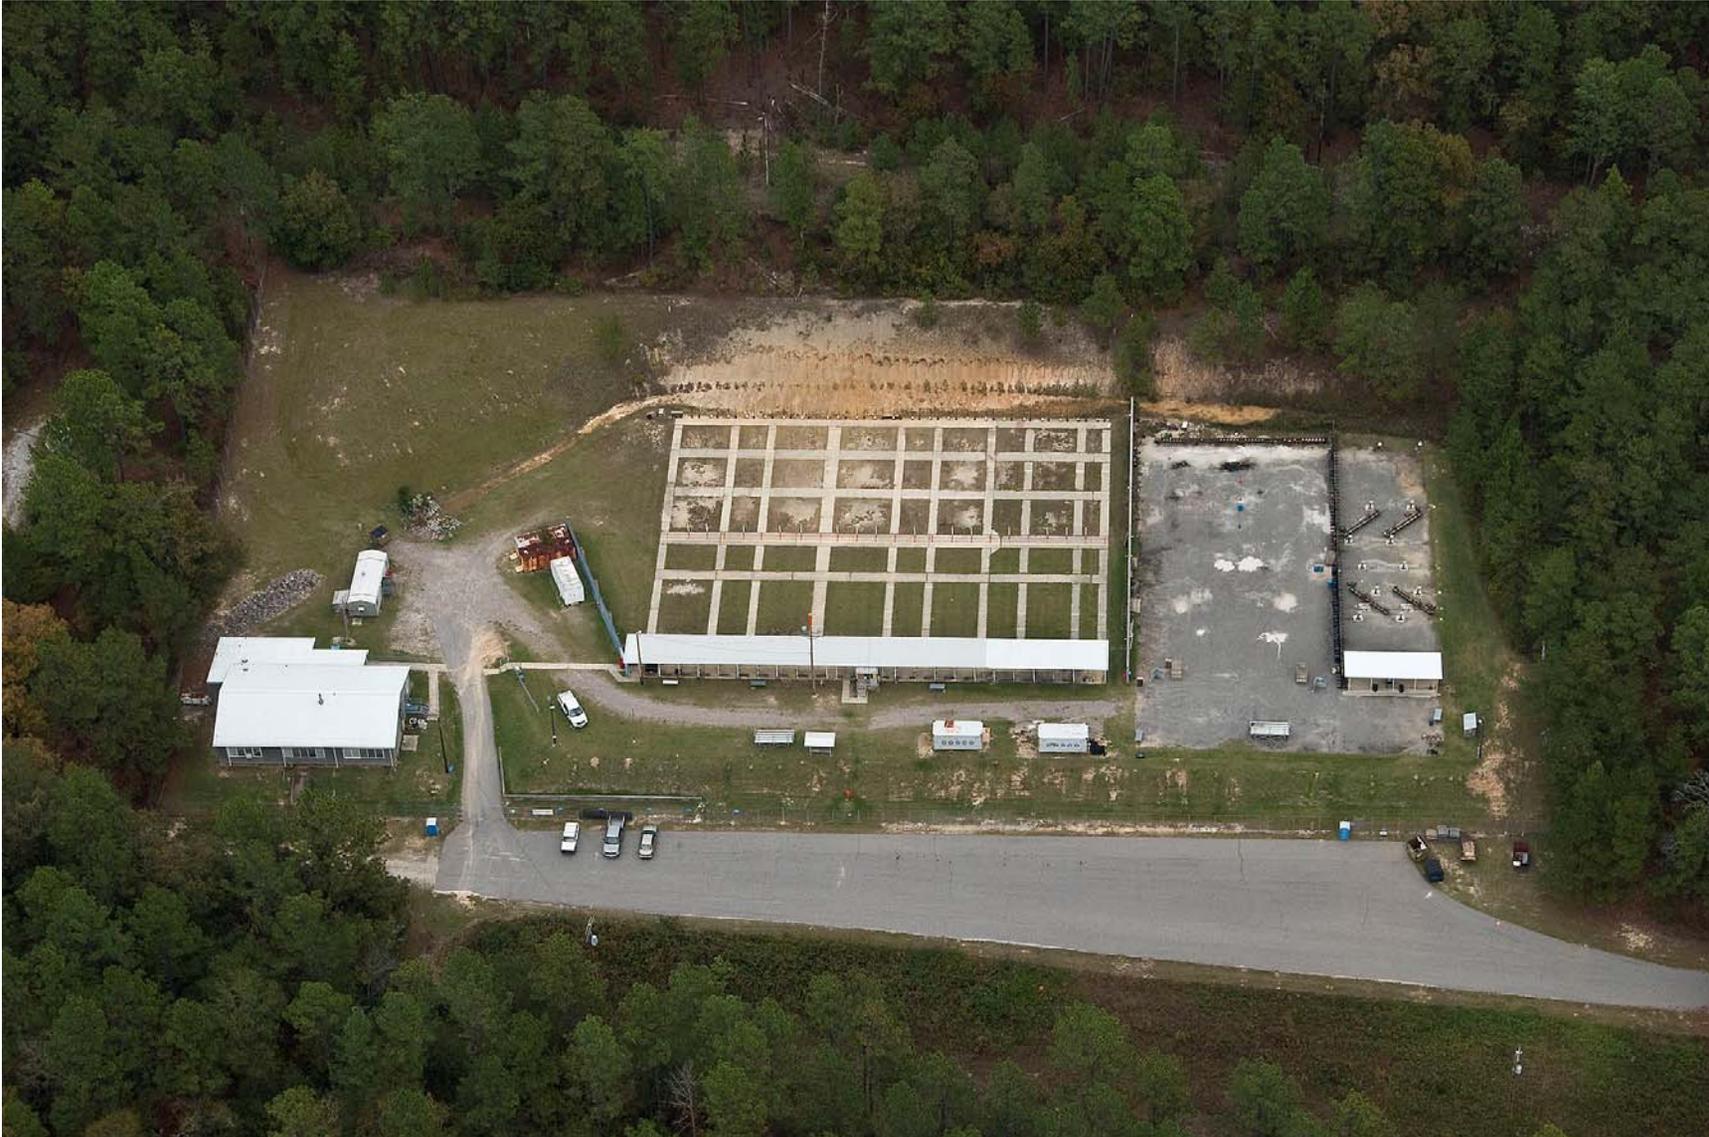
Figure 2. Aerial Photo of the SATA SEA Prior to the Removal Action

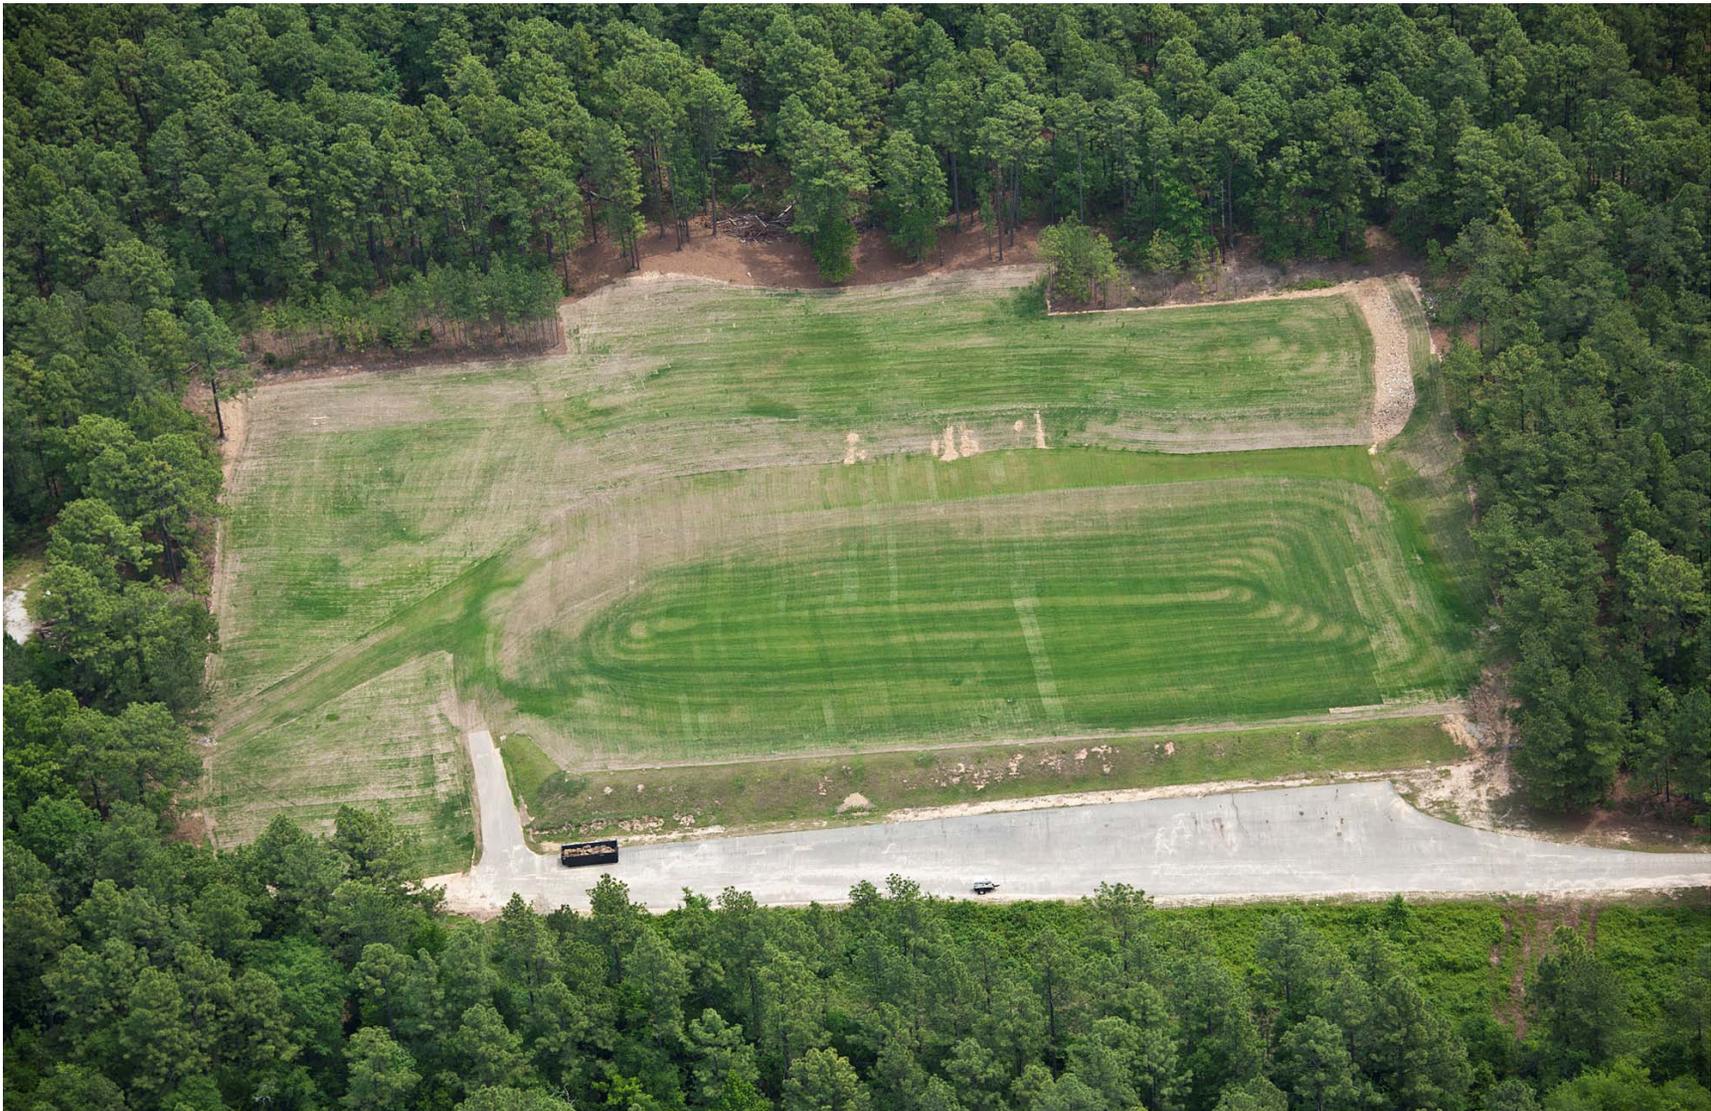
Figure 3. Aerial Photo of the SATA SEA After the Removal Action

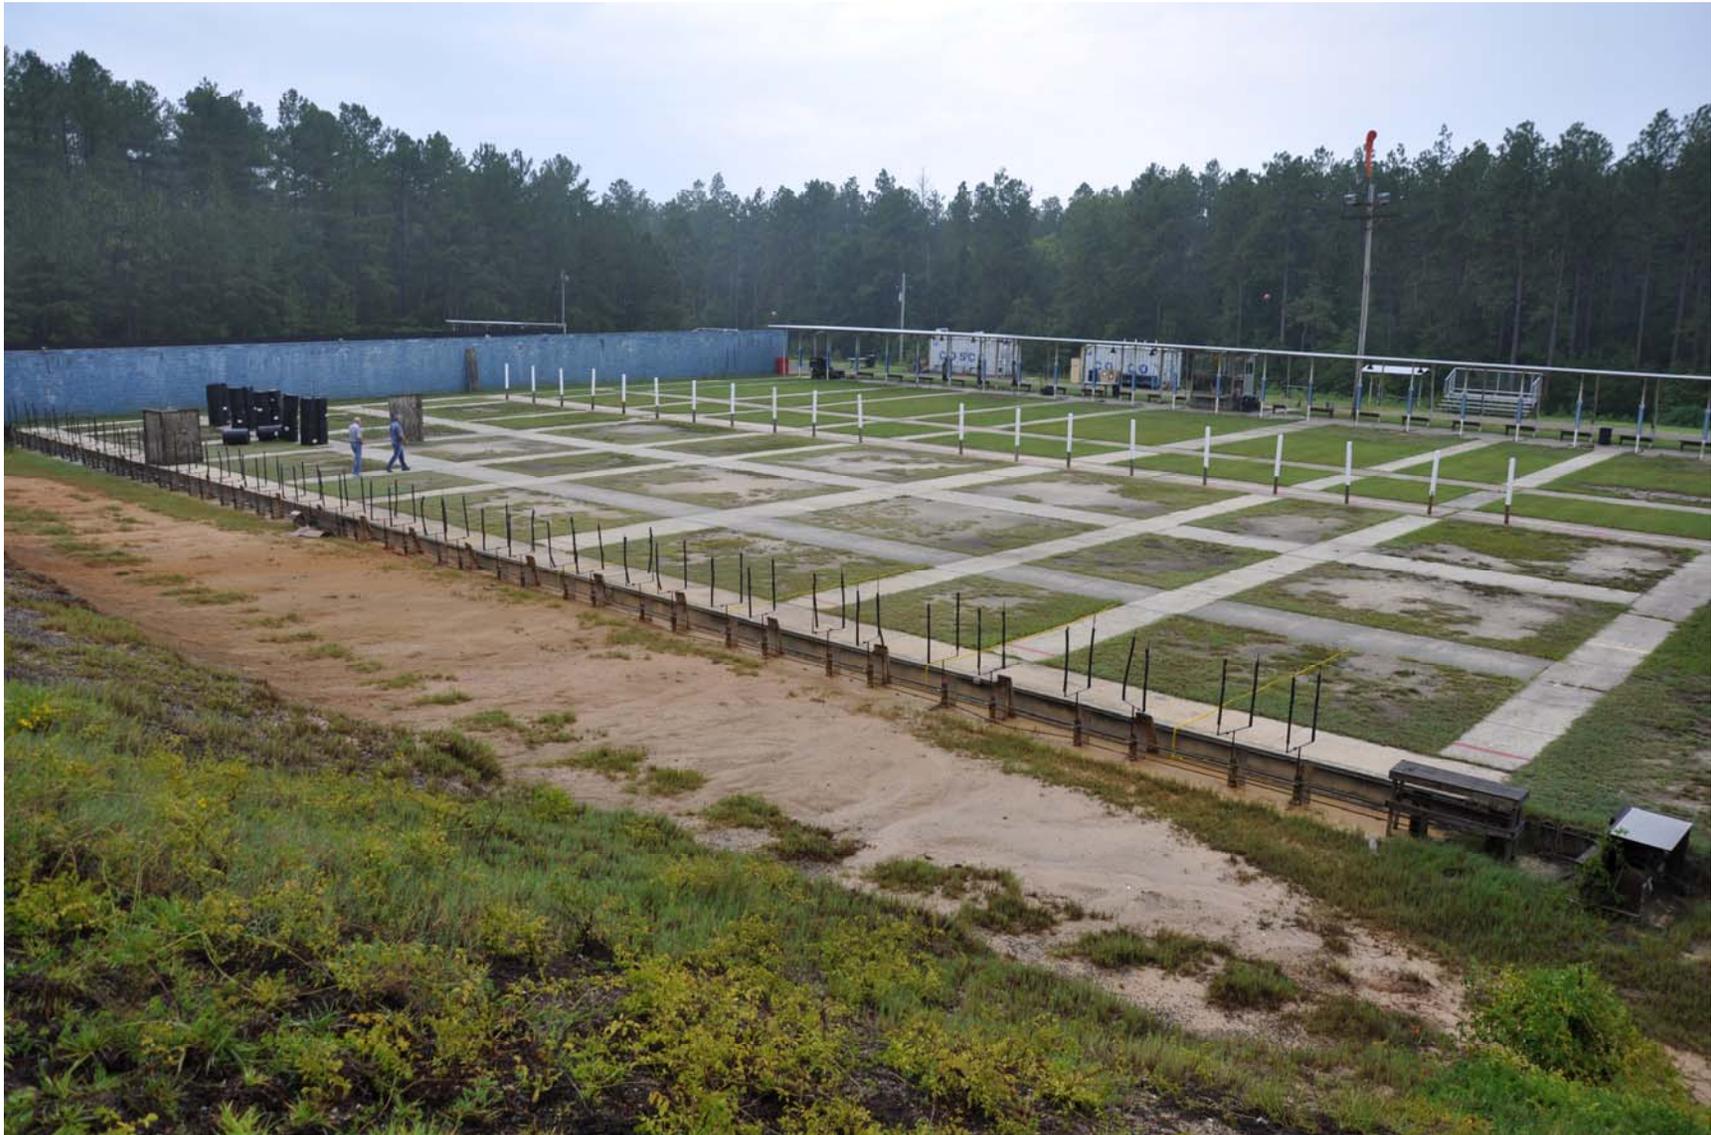
Figure 4. View of Range Area 1 from the Northeast Prior to Removal Action

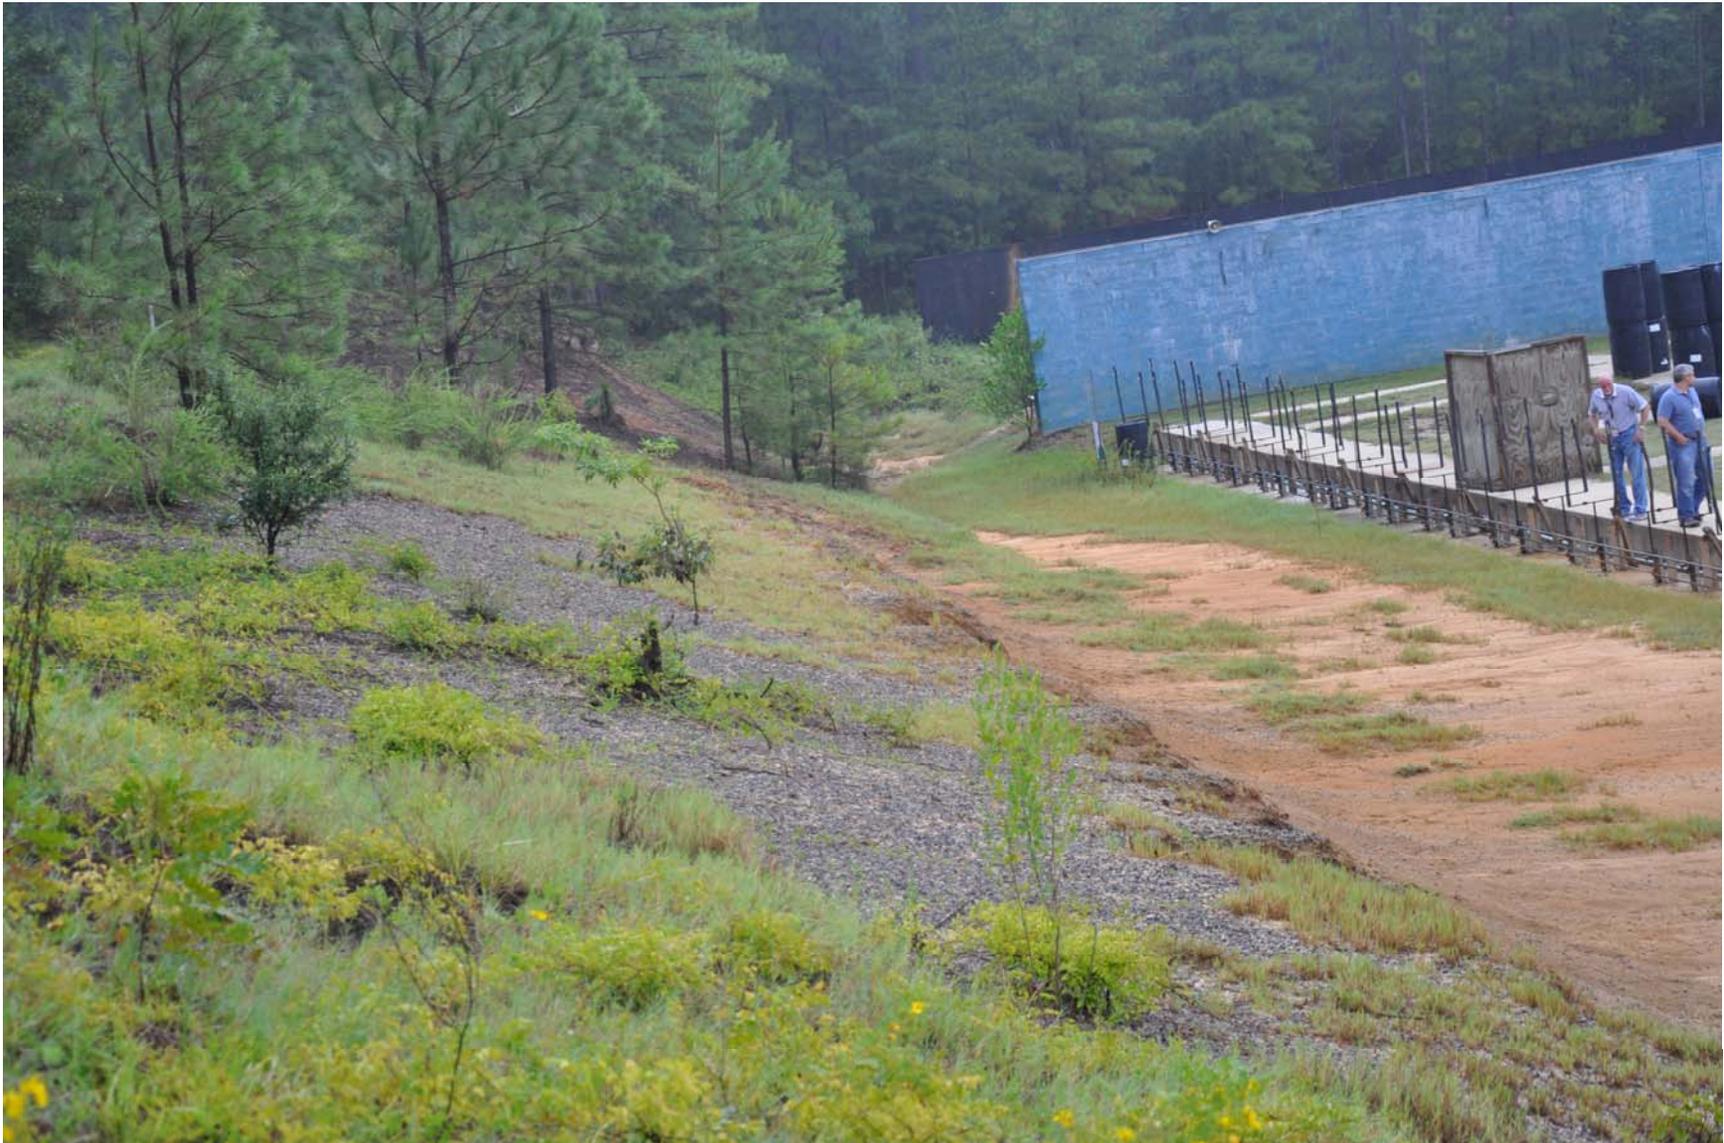
Figure 5. View of the Berm Area Prior to the Removal Action

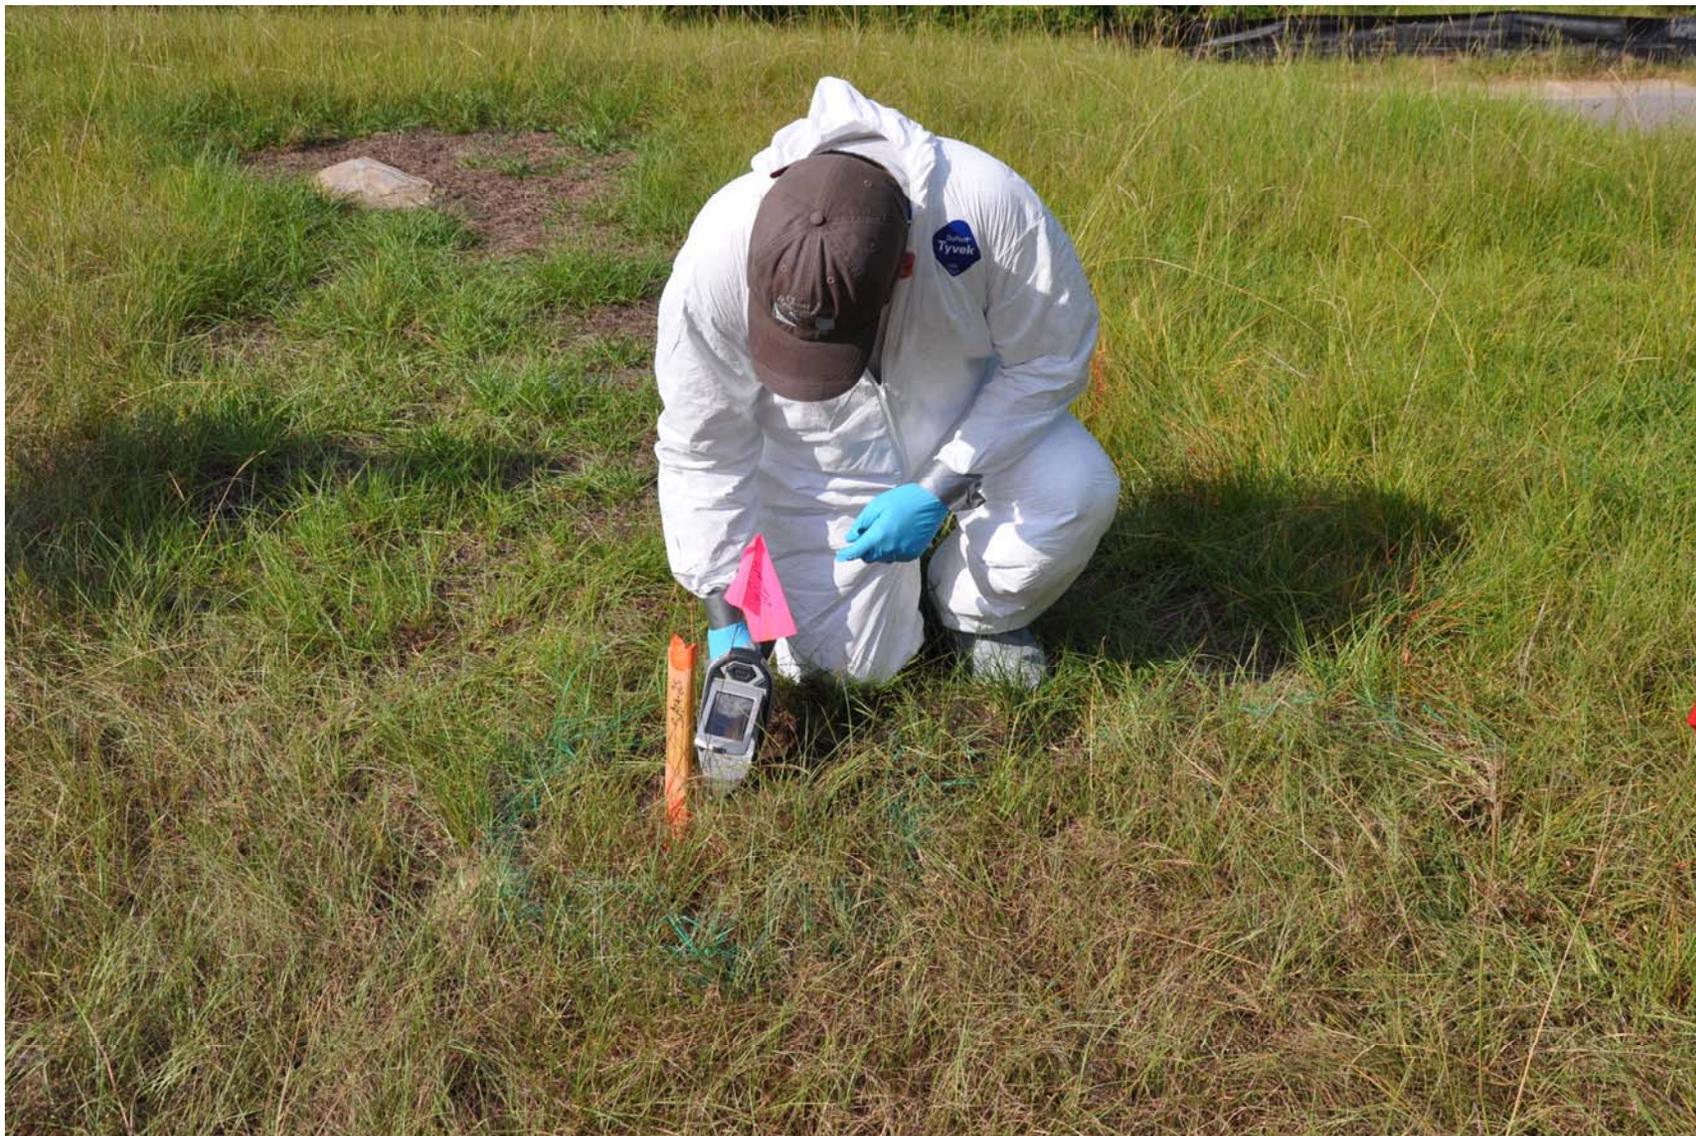
Figure 7. XRF Extent Characterization Field Screening

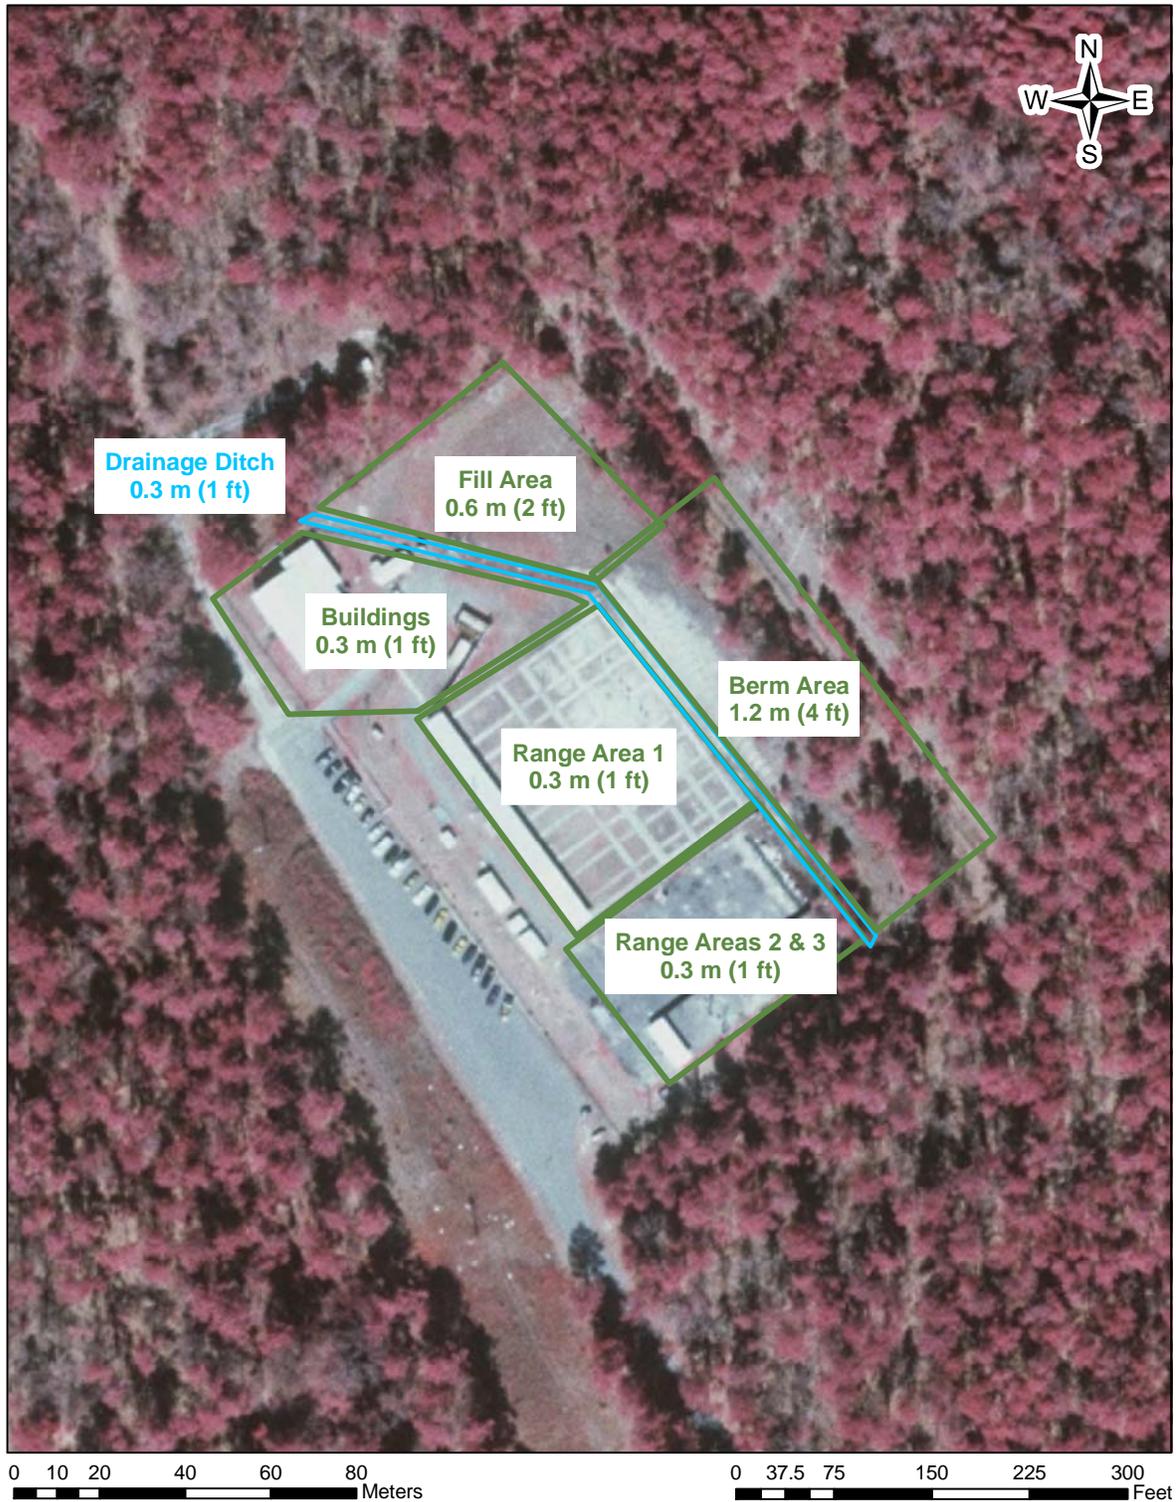
The surface area of the SATA SEA footprint was approximately 16,027 m² (172,500 ft²). The areas removed included the expanded extent of the SATA which had an additional footprint area of approximately 2,206 m² (23,750 ft²) (Figure 8).

Figure 8. Soil Removal Area at SATA

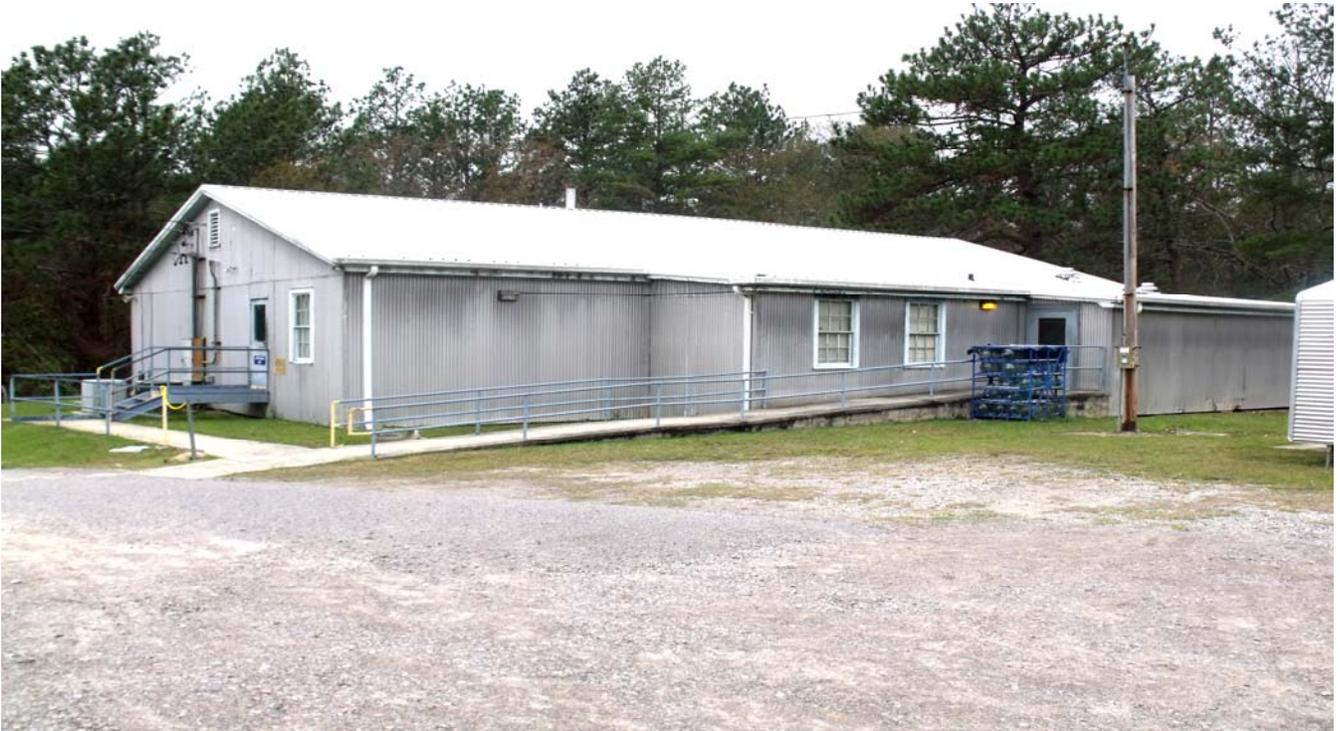
Figure 9. 661-G, Patrol Training Building, View Looking Northwest Before Demolition

The end state for 661-G facility was demolition of the structure to grade. The decommissioning of a building is intended to reduce landlord costs, increase safety by removing excess facilities, and reduce the potential for release of hazardous substances to the environment.

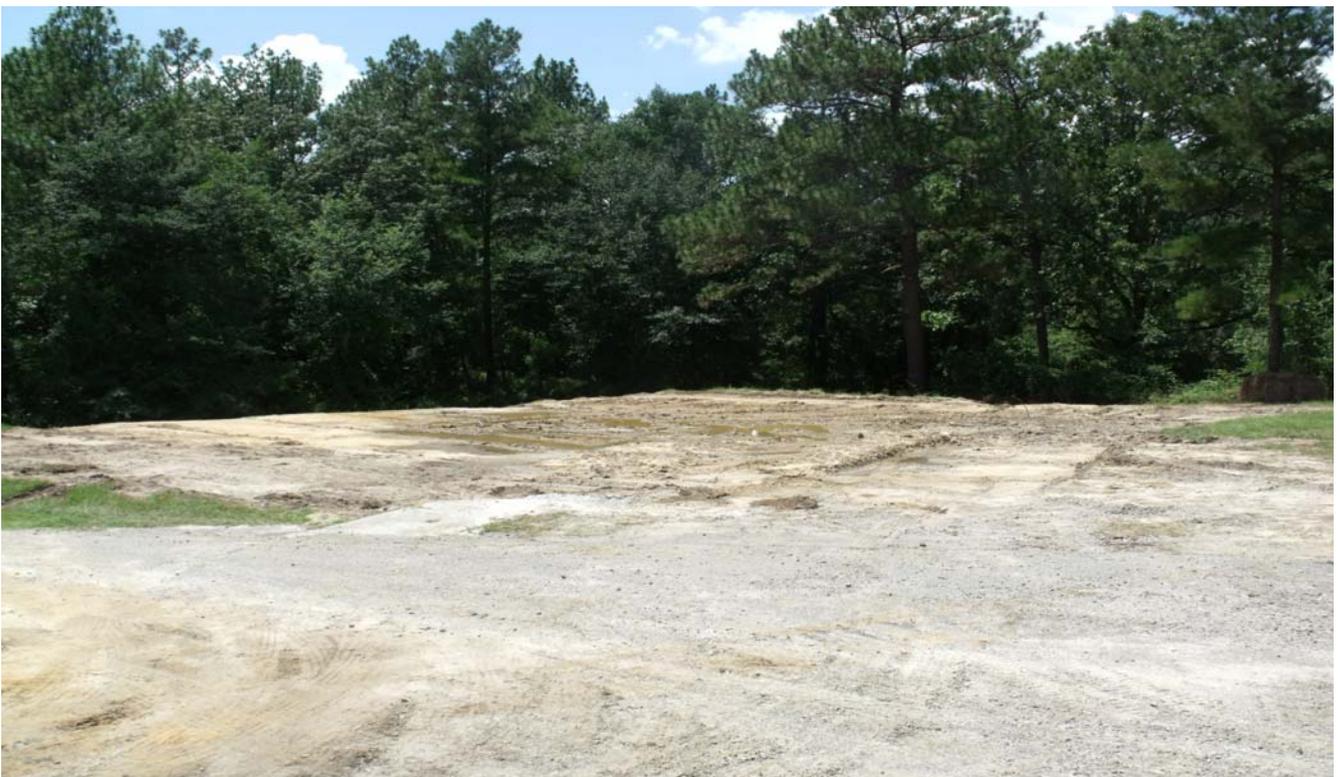
Figure 10. 661-G, Patrol Training Building, View Looking Northwest, After Demolition

Building 661-G was mechanically demolished into rubble which was placed into multiple 30-yd³ containers for disposal in the SRS Construction and Demolition (C&D) Landfill. In addition, non-friable asbestos containing material in Building 661-G were abated and disposed of in the C&D Landfill.

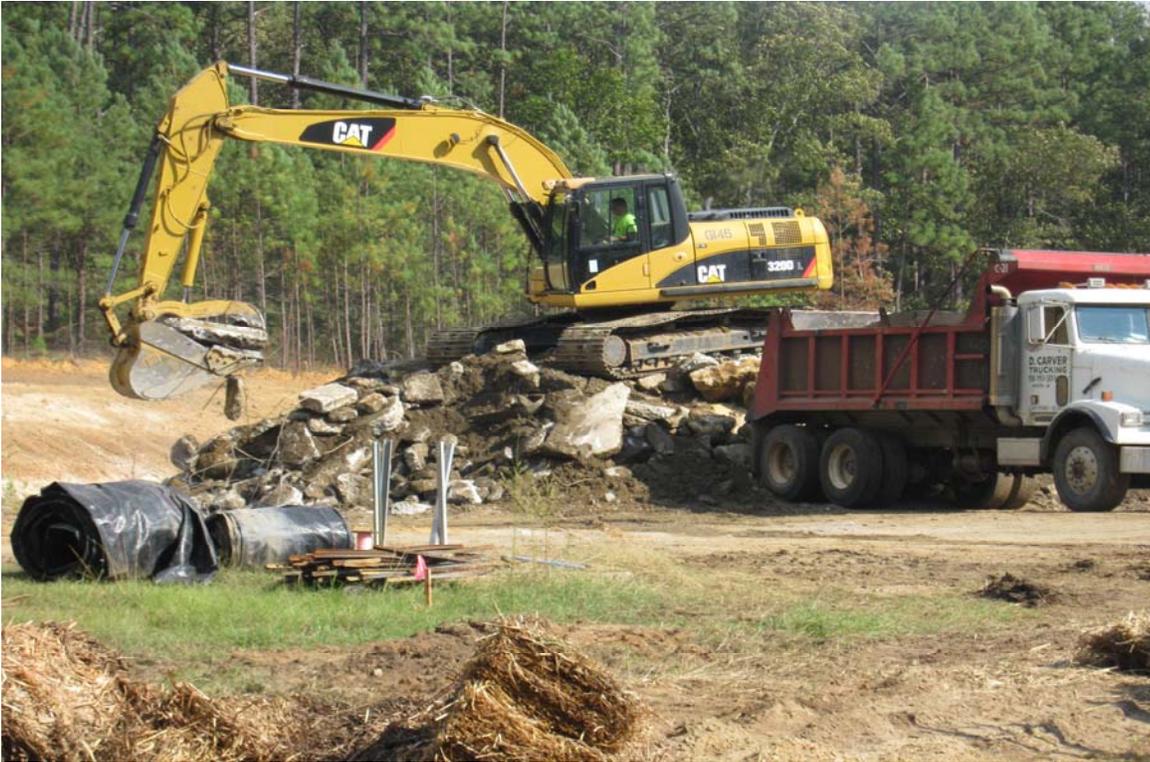
Figure 11. Loading of Concrete Debris into Dump Trucks at SATA

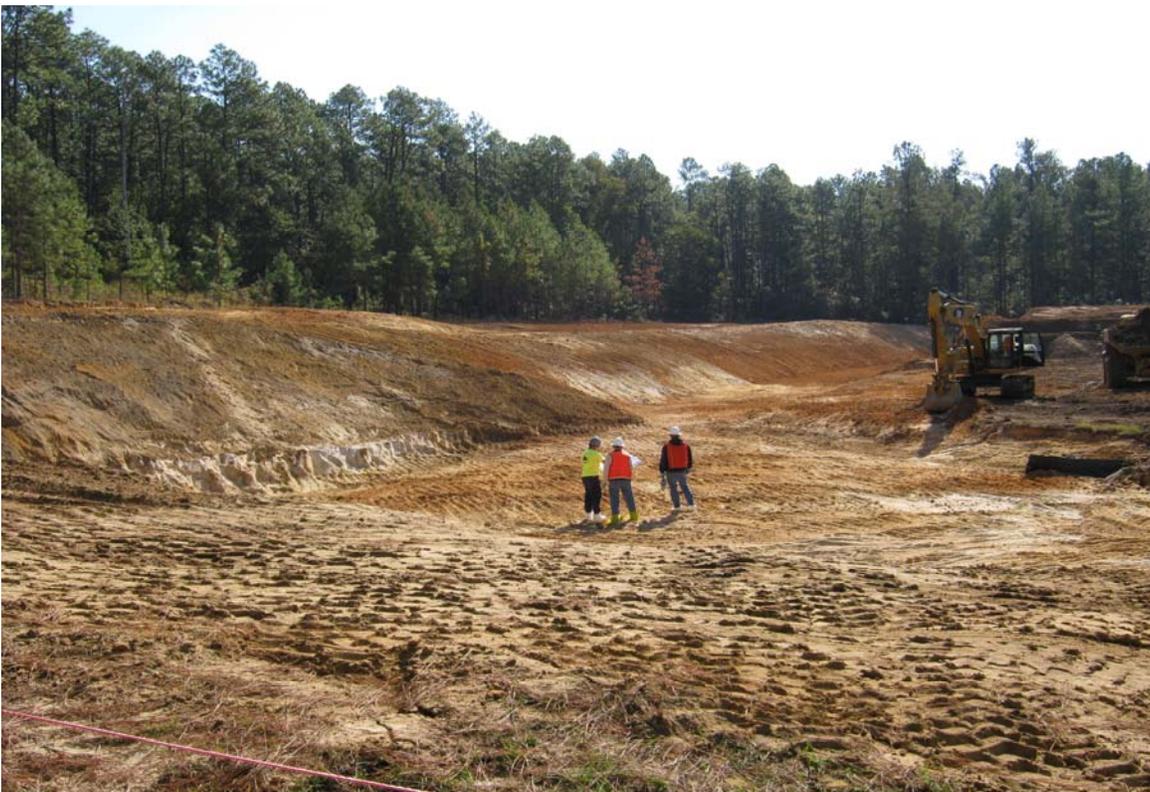
Figure 12. Removal of Lead and Lead Contaminated Soil

All earthwork was completed with standard construction equipment (i.e., trackhoe, bulldozer, etc.). During excavation activities, primarily sediment and bullet fragment waste was identified at the SATA SEA. A total of 12,092 m³ (15,816 yd³) of hazardous and nonhazardous wastes were removed. Under this action, 11,796 m³ (15,429 yd³) of hazardous waste (spent bullets and lead-impacted soil) was removed from the SATA and transported to the Lone Mountain Landfill Facility (A Clean Harbors Disposal Site in Oklahoma) and 296 m³ (387 yd³) of nonhazardous waste (primarily concrete debris) was transported to Three Rivers Landfill for long-term disposal. No unforeseen wastes were generated.

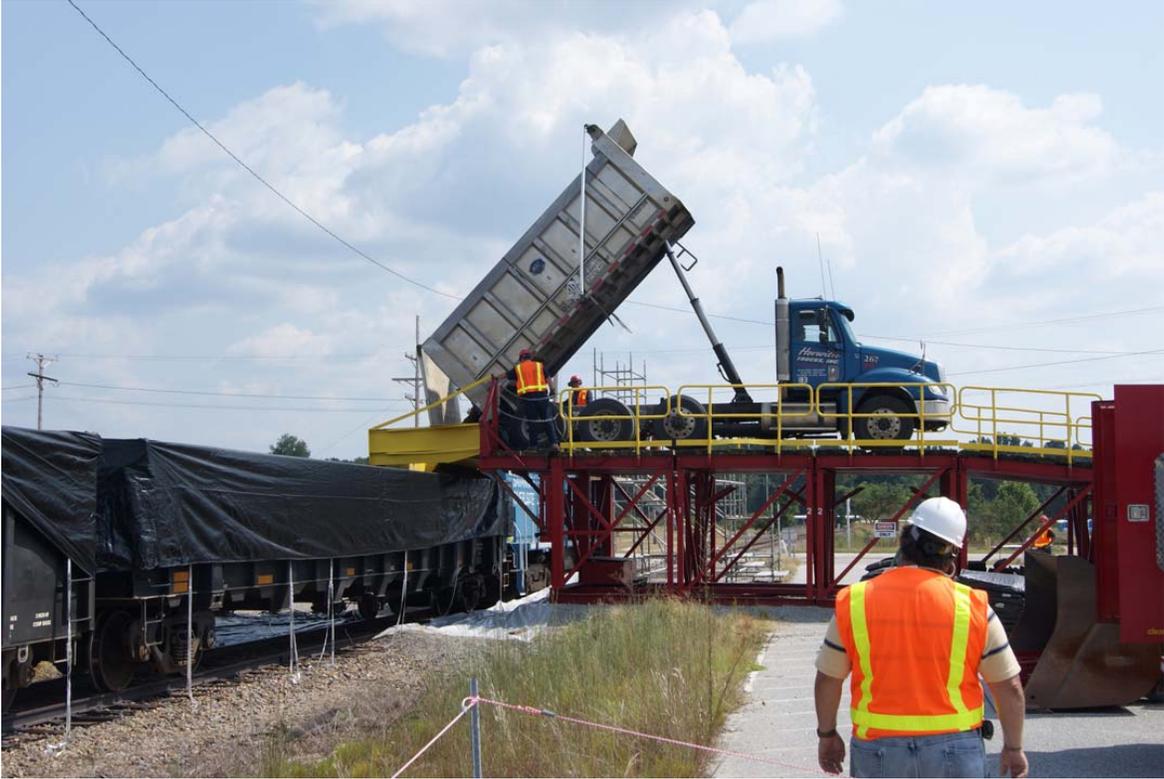
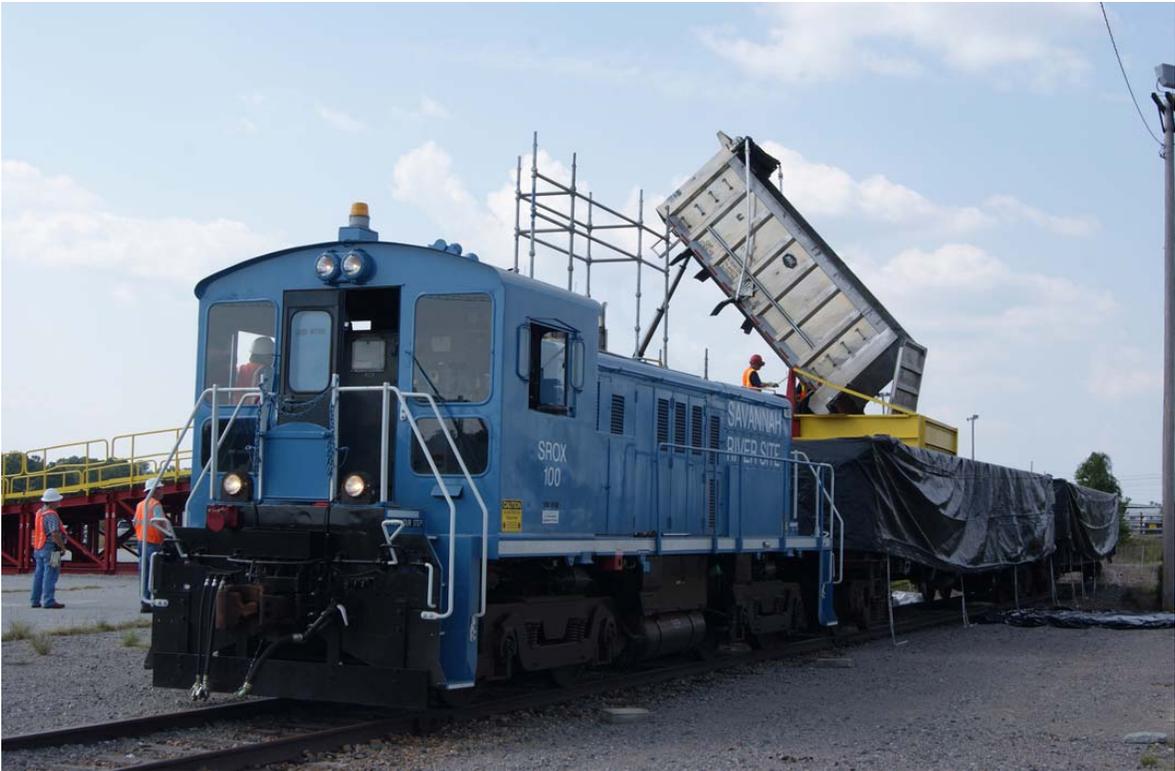
Figure 13. Loading of Rail Cars

Figure 14. Loading of Rail Cars

The waste streams generated from the NTCR action were dispositioned as hazardous waste and nonhazardous waste in accordance with state and federal laws and the SRS waste management procedures. Hazardous waste/impacted soil was transported to the Lone Mountain Landfill Facility (a Clean Harbors Disposal Site in Oklahoma). Nonhazardous/secondary waste was transported to Three Rivers Landfill for disposal. Secondary waste materials consisted primarily of personal protective equipment and small amounts of paper, plastic, rubber goods, cardboard, tape, etc. Since the volume of this secondary waste was small, it was included with the excavated soil and debris and disposed of at the Three Rivers Landfill.
