DESIGN AND OPERATION OF A REMOTELY OPERATED PLUTONIUM
WASTE SIZE REDUCTION AND MATERIAL HANDLING PROCESS

John A. Stewart, III and David L. Charlesworth

E. I. du Pont de Nemours and Company
Savannah River Laboratory
Aiken, South Carolina 29808

A paper proposed for presentation at the
Waste Management '86 Meeting
Tucson, Arizona
March 2-6, 1986

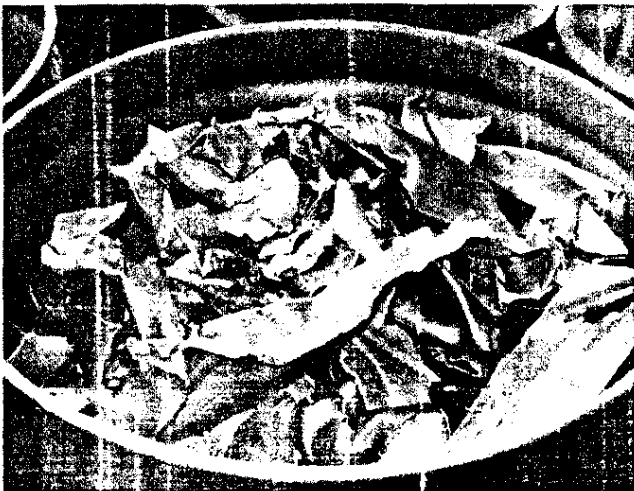
Photo 3. Shredded Material from Test #5

In tests #4 and #5, the scrap materials closely resembled glove boxes typically found in TRU waste. Both items were constructed of 1/8"-thick stainless steel. Fabrication was both bolted and welded, corner and side bracing were found on the interior, and they were enclosed on 5 of 6 sides. In both cases, the items shredding times were within acceptable levels (2 hours), piece size was very good (5" long), volume reductions of 10:1 were achieved, and material flowed smoothly through the material handling system. Before and after shots of test #6 are shown in Photographs 2 and 3, respectively.

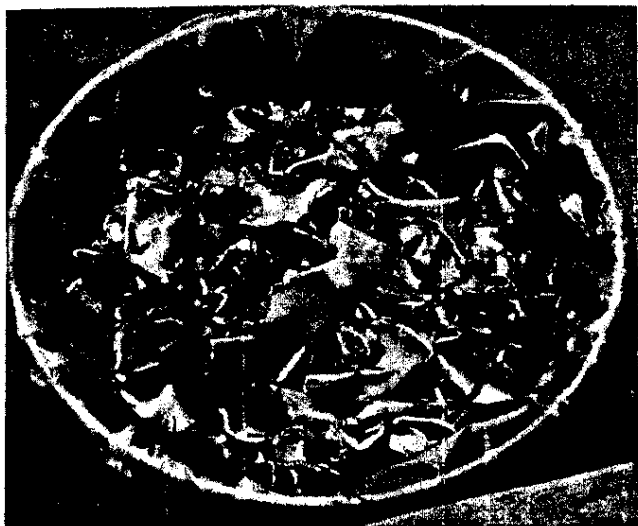
Photo 5. Shredded Material from Test #10

TEST #6	
Size:	3' x 4' x 4'
Material:	1/8" carbon steel
Shredding Time:	2 hours 15 minutes
Final Volume:	1 (3/4 full) lined 55-gallon drum
Piece Size:	2" x 6"
TEST #7	
Size:	3' x 4' x 5' (reinforced)
Material:	1/8" carbon steel
Shredding Time:	3 hours 10 minutes
Final Volume:	1-1/3 (3/4 full) lined 55-gallon drums
Piece Size:	2" x 6"
TEST #8	
Size:	3' x 4' x 5'
Material:	1/4" carbon steel
Shredding Time:	1 hour 10 minutes (time spent trying to grab box, then discontinued and used for Test #4)
Piece Size:	2" x 5"
TEST #9	
Size:	3' x 4' x 5' with a 2' x 3' window and 2" - 7" diameter holes cut in one side
Material:	1/4" carbon steel
Shredding Time:	2 hours 30 minutes (discontinued after 15% of box had been shredded due to slow shredding speed)
Piece Size:	2" x 5"
TEST #10	
Size:	3' x 4' x 4'
Material:	1/8" stainless steel
Shredding Time:	5 hours
Final Volume:	1 (3/4 full) lined 55-gallon drum (shown in Photo 5)
Piece Size:	2" x 5"

In tests #10, #11, and #12, 1/8" and 1/4" stainless steel boxes were used. Although the piece size and volume reduction were very good (1/8" material), with 85% of the material less than 5" long, the shredder jammed frequently. The shredder was unable to shred 1/4" material. Unjamming of the shredder was performed remotely by pulsing the motors in the reverse direction until the steel which jammed the blades backed out.
