## PVP2007-CREEP8-26049

### THERMAL TESTING OF 9977 GENERAL PURPOSE FISSILE PACKAGE USING A POOL FIRE

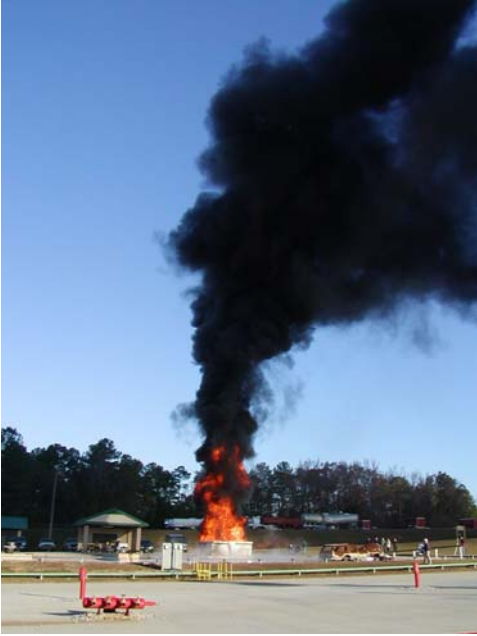
Figure 1. Fire Test of Package P-2.

The fire produces an orange-red flame with a large amount of soot. The visible flame extends about 45 ft, or more, above the wind fence. The fuel flow was controlled so that the flame “filled” the wind fence. That is, the fire extended to all four corners of the wind fence enclosure. The cooling water for the wind fence discharged onto the concrete pad surrounding the prop. The radiant heat from the flame resulted in rapid evaporation of this surface water. Following securing of the fuel flow, about two minutes were required for the fire to drop to the bottom of the package. At this point, the flame does not fill the wind fence area and the fire rapidly burns down. The last of the surface flame extinguished at around 2 mins. Typically, about 471 gal were consumed in the test.

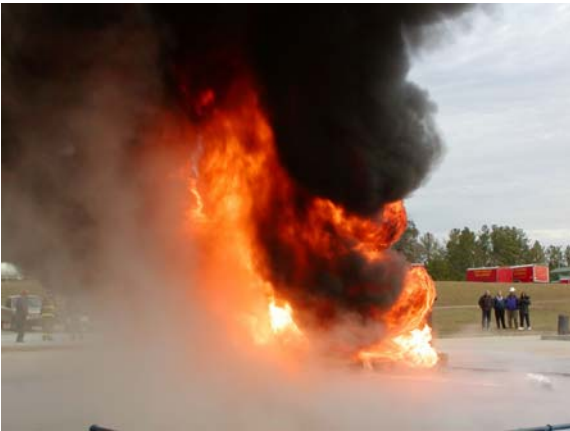
Figure 2. Fire Test of Package TP-3.

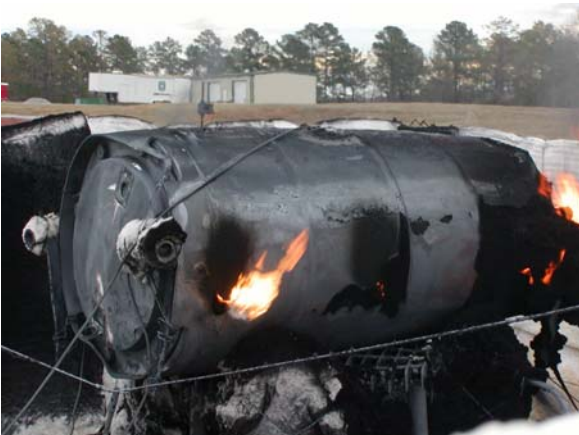
Figure 3. Package TP-3 cooling after fire.

Following the thermal exposure, all packages self extinguished.

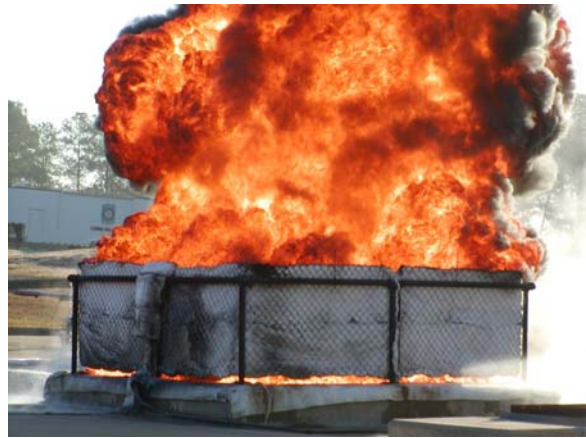
Figure 4. Fire Test of Package TP-5.

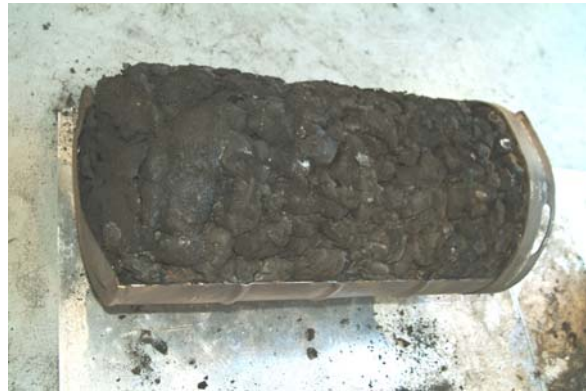
Figure 5. Under fire conditions, polyurethane foam intumesces and produces a low density charfoam decomposition product. The package shown is TP-3.

The urethane foam intumesces as it undergoes thermal degradation, producing a voluminous, very low density char-foam decomposition product. In preliminary furnace tests of urethane foam overpacks, the char-foam was found to flow out of the fill and vent holes in the package and accumulate in large clumps in the furnace, which was an oxygen starved environment. In the fire tests, material exiting the package was burned away immediately. Combustible gaseous decomposition products jetted from the vent holes in the packages during and immediately after the fire exposure. These jets burned with a bright flame, which could be detected occasionally in the midst of the fire. The expanding char-foam material pushing against the bottom of Test Package 3, opened the tear formed in the crush test (without increasing its length). This resulted in the increased loss in foam mass (ca. 20%) compared to the other packages, which was noted above. This behavior had been seen previously in the development package furnace tests. Because of the restricted venting of some of the packages, their bottoms were bulged by the intumescent of the degrading urethane foam.

The structure of the char-foam was similar in all cases. The degraded material varied from plastic rich material immediately adjacent to the undegraded foam, to frangible, carbonaceous or coked material on the outer surface, against the drum wall. When the outer shell was removed, the outer surface of the char-foam was convoluted with nodules of char-foam separated by deep channels or fissures.

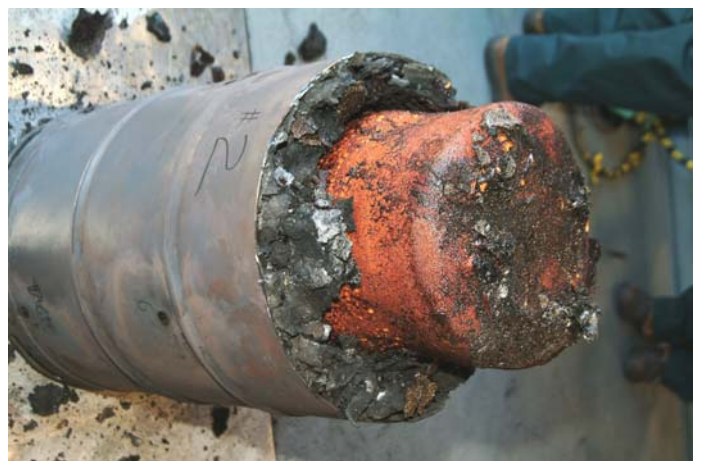
Figure 6. The undegraded foam remains as an unaffected layer surrounding the liner. The package shown is TP-2.

Following each test in the sequence, the packages were digitally radiographed to document the cumulative effects of the tests on the packages. Following completion of all the tests and final radiographs, the packages were cut open and the interior components examined. As part of this process, the containment vessels were removed for leak testing. For Test Package 3 it was possible to remove the containment vessel by opening the lid in the normal manner. In the other 3 cases, the containment vessel removed by cutting the bottom off of the liner. In all cases the fire test resulted in degradation of much of the urethane foam, with a residual cocoon of un-degraded urethane foam remaining attached to the FiberFrax blanket.

The residual, un-degraded foam in Test Package 3, the package subjected to horizontal drop and crush, was almost separated in two lobes, rather than completely enclosing the liner. This was the result of accelerated thermal degradation of the foam in the regions where crushing and breakage of the foam had occurred from the drop and crush tests.
