**Plume Delineation Using
Membrane Interface Probe (MIP)
Savannah River Site
Aiken, South Carolina**

Westinghouse Savannah River Company, LLC
P.O. Box 6809
Aiken, South Carolina 29804-6809

COLUMBIA Technologies, LLC
1450 South Rolling Rd.
Baltimore, Maryland 21227
410-536-9911

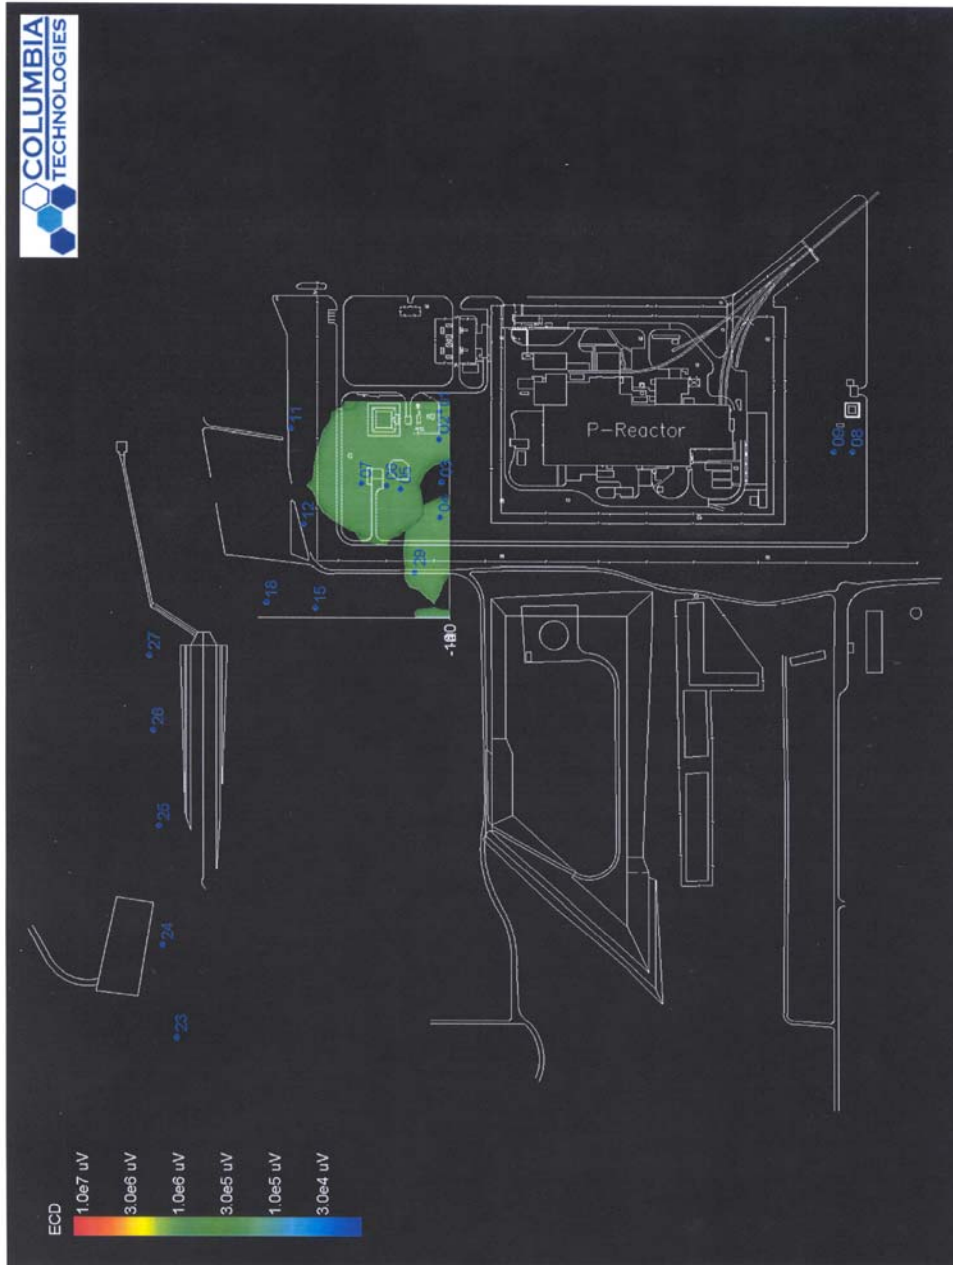
Figure 2
ECD Response, 1.0E+06uV and Above,
Plan View of the Entire Site
Westinghouse Savannah River Company, LLC
Savannah River Site
September 18th, 2002 – October 4th, 2002

The ECD responded significantly at a number of locations at this site, which indicate the presence of chlorinated compounds at depth (Figures 2, 3 and 4). The ECD is very sensitive to chlorinated compounds. At high concentrations, the detector becomes saturated at the value of $1.2\text{E}+07$ microvolts (uV). This occurred at several locations. When this occurs, the PID can be used to determine relative contamination concentration, as it also responds to chlorinated compounds. Saturation of the ECD occurred at locations PGCPT-01, PGCPT-02, PGCPT-04, PGCPT-07, and PGCPT-09. The PID response at these locations measured $2.0\text{E}+05\text{uV}$, $3.0\text{E}+05\text{uV}$, $1.25\text{E}+06\text{uV}$, $1.25\text{E}+06\text{uV}$, and $5.0\text{E}+05\text{uV}$, respectively, thus the highest levels of contamination detected by the MIP at the site occurred at locations PGCPT-04 and PGCPT-07.

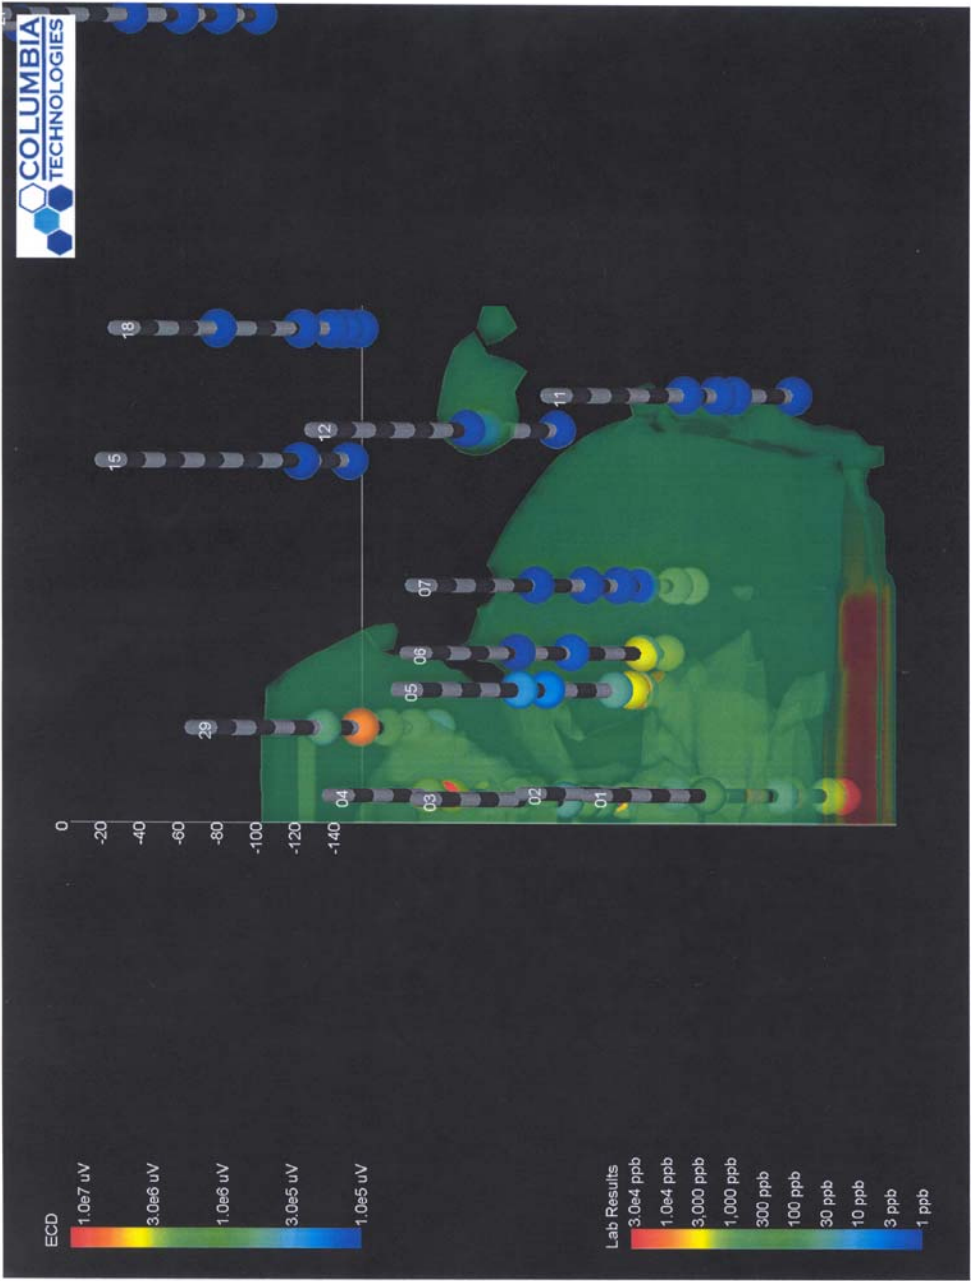
Figure 5
ECD Response, 5.0E+05uV and Above,
Aerial View from the East, With Laboratory Results
Westinghouse Savannah River Company, LLC
Savannah River Site
September 18th, 2002 – October 4th, 2002

In general, correlation between MIP detector results and laboratory data was high, as can be seen on Figures 5, 6, and 7. Figure 5 is an aerial view from the east. It illustrates the strong correlation of non-detect water samples (blue spheres) with areas shown by the MIP profiling to be uncontaminated (areas not filled in by green, yellow and red colors). Figure 6 is a view directly from the east. This figure
