**9W-12W, 8H and 10H Cell, Rack Pan, and**  
**Air Tunnel Inspections**  
**For the Safe Deactivation NCSE**

**WSRC-TR-2004-00510**

**September 2004**

Westinghouse Savannah River Company  
Closure Business Unit  
Aiken, SC 29808

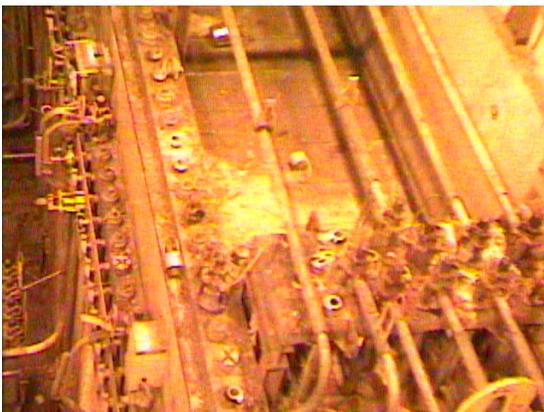
10W-5) 10W rack pan south of expansion table

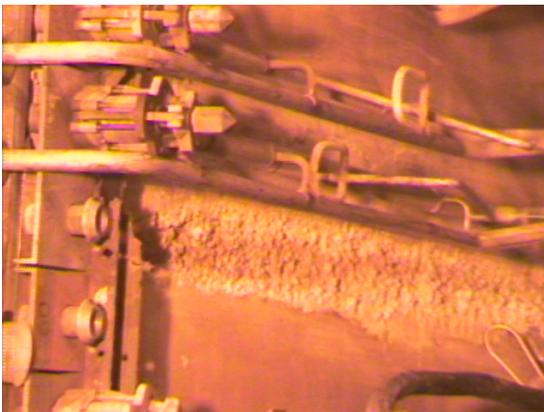
11W-5) Wall erosion under nozzle 59(11W)

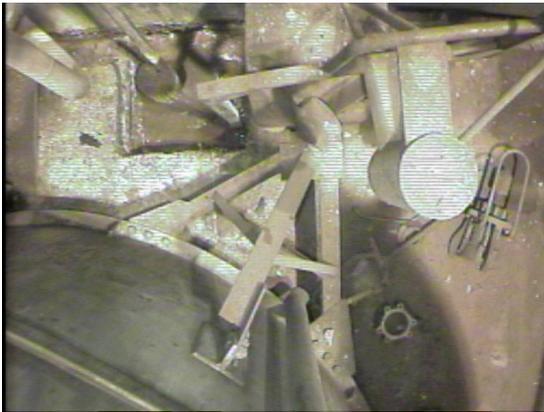
The cell floor in 12W had the most trash and debris of the four Warm Canyon cells and several areas of the walls were corroded [pictures 12W-1, -2, and -3]. This cell was the only one with the concrete defaced on the cold wall. It looked as though acid had been sprayed on the cold wall east of vessel 12.5, as the erosion started mid-wall and appeared wider at the top than the bottom. The walls under each of the rack pan drains exhibited corrosion and erosion, though no exposed re-bar was noted. The floor contained a scattered assortment of gaskets, dust covers, dummies, a hook, nuts, concrete chunks, etc. The added equipment litter is most likely due to equipment handling and storage in the pump storage rack in module 12.7. The floor also seemed dustier and grimmer than the previous cells, possibly due to a combination of corrosion caused by the higher acidities of the solutions and chemical reactions during valence adjustment, and the organic washed in washer 12.8. Over the life of the cell, tank 12.5 has erupted and overflowed several times because of uncontrolled nitrite reactions.

12W-3) 12W sump

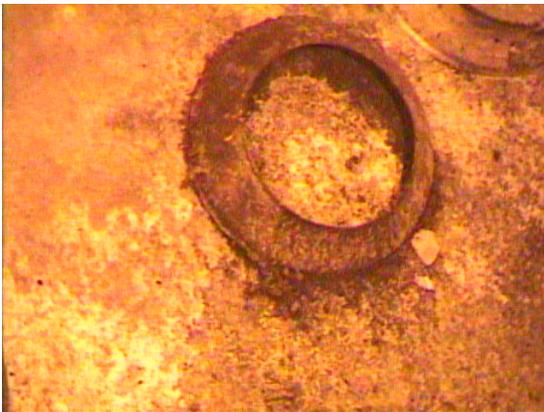
In the rack pan near the expansion loop table, on the table, and several of the nozzles, evidence of white, crystalline deposits were noted. The material was most likely sodium carbonate, considering the location and the solutions processed on that side of the cell. No other build-ups were noted in the rack pan [pictures 12W-4 and -5]. The usual assortment of gaskets was observed.

12W-5) Crystals in 12W rack pan

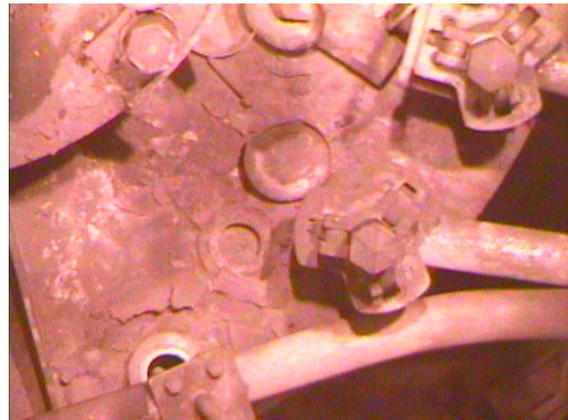
10H-4) Top of Tank 10.1 tank southeast corner

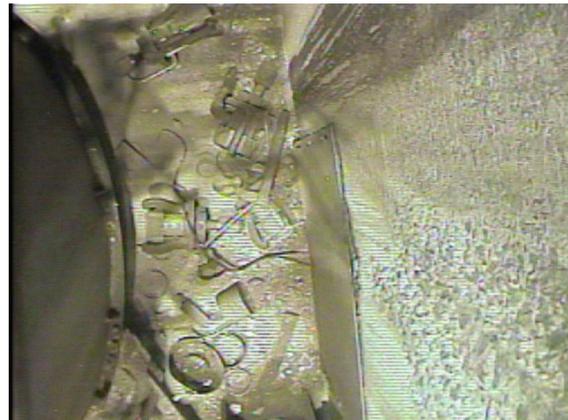
10H-10) Floor and air duct east of Tank 10.4

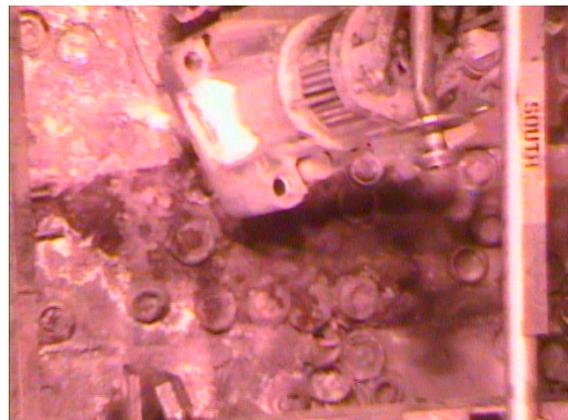
10H-12) Close up of stored contactor motor

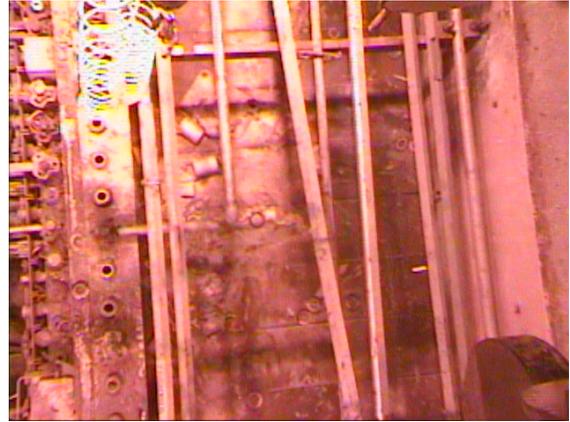
10H-14) 10H rack pan nozzles 62-55(10H)

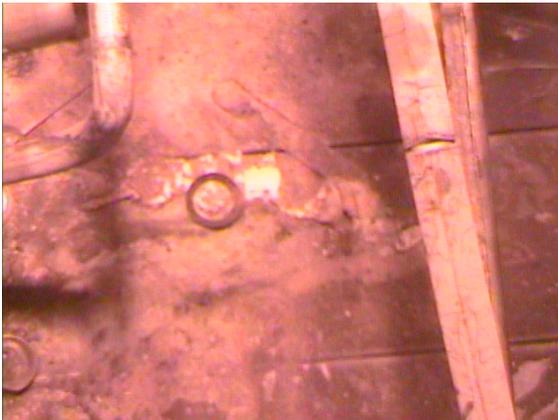
10H-15) Stuff in the middle of the rack pan opposite nozzle 58(10H)

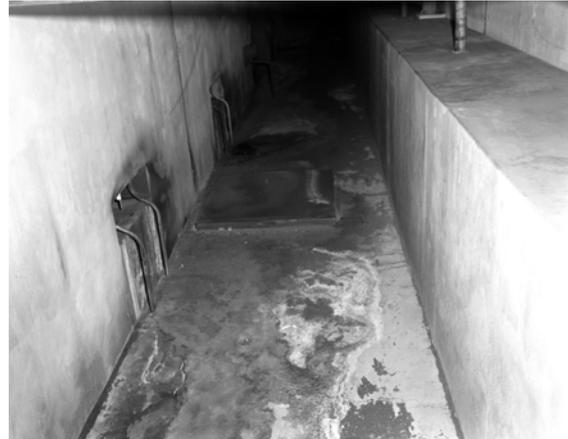
10079-002 Section 9W looking South toward module 9.5

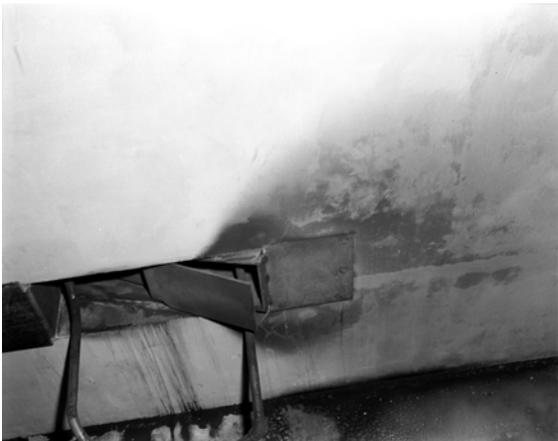
10079-003 Section 9W looking at center duct

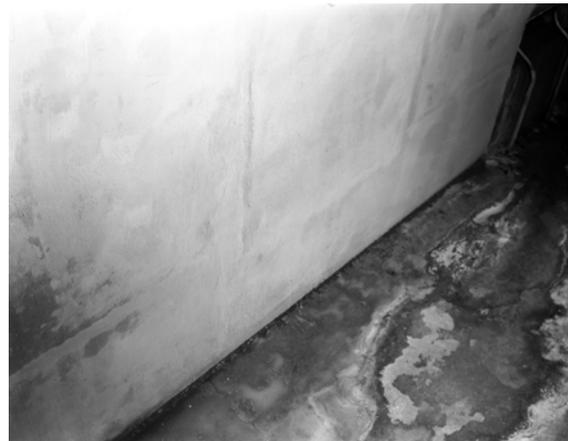
10079-004 Section 9W looking South toward module 9.5

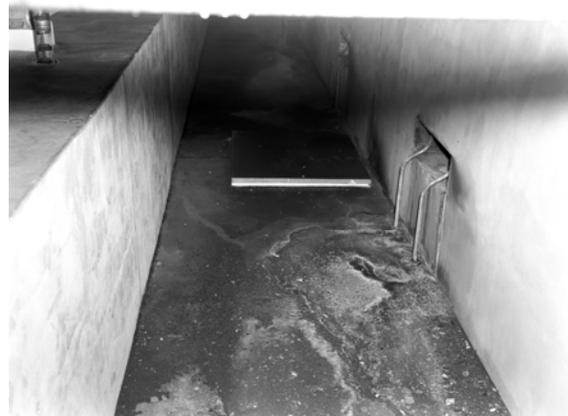
10079-006 Section 10W looking north toward modules 10.8 and 11.5
