L Basin Corrosion Surveillance Program – Evaluation of 2014 Surveillance Coupons

December 2017

SRNL-TR-2017-00415, Revision 0

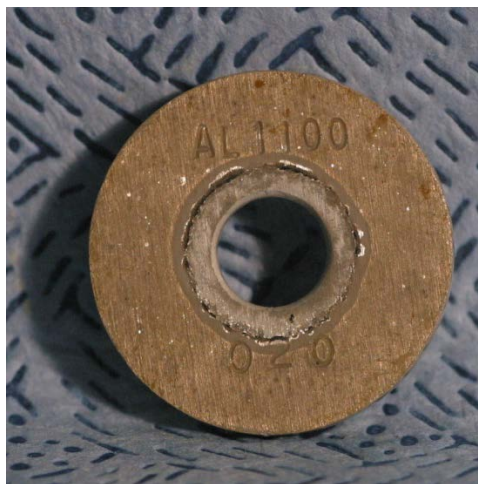
Al 1100 #020

As-received from L Baisn

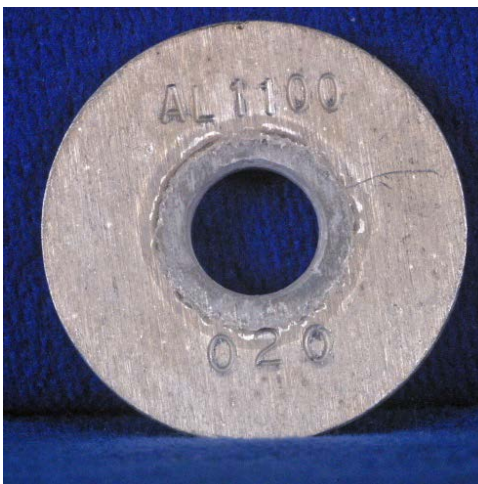
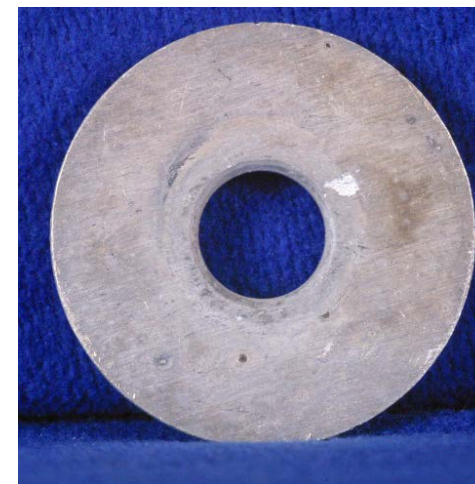
After cleaning in nitric acid solution

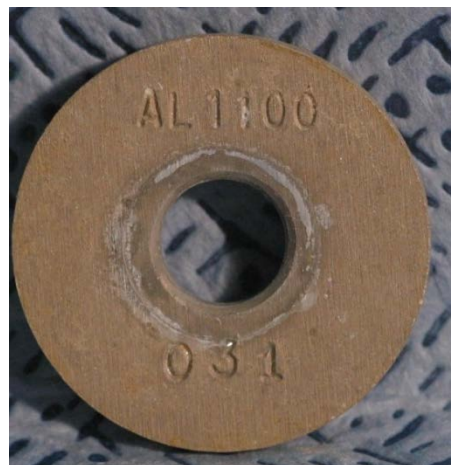
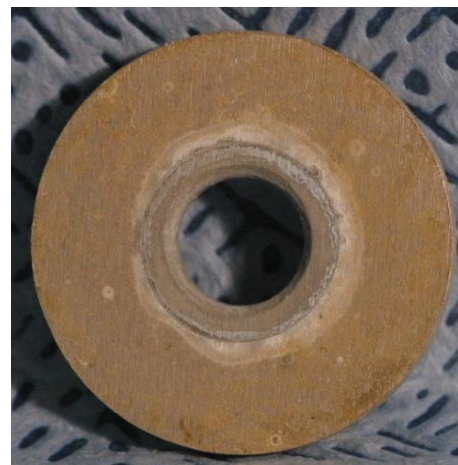
Al 1100 #031

As-received from L Baisn

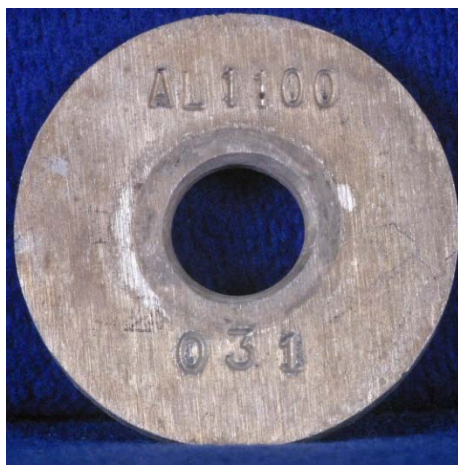
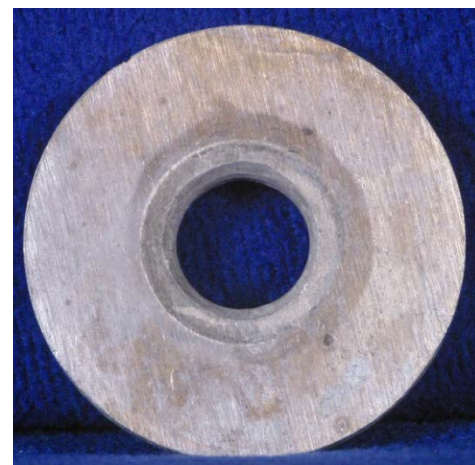
After cleaning in nitric acid solution

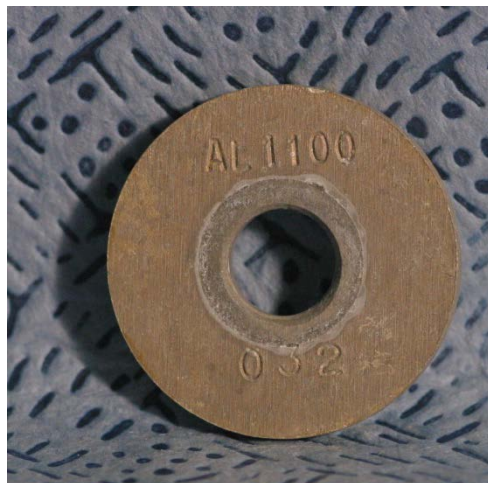
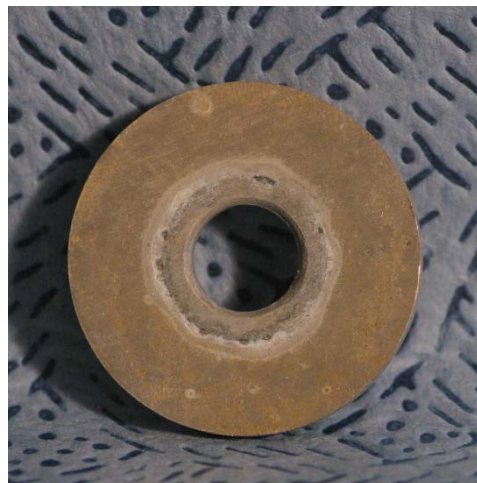
Al 1100 #032

As-received from L Baisn

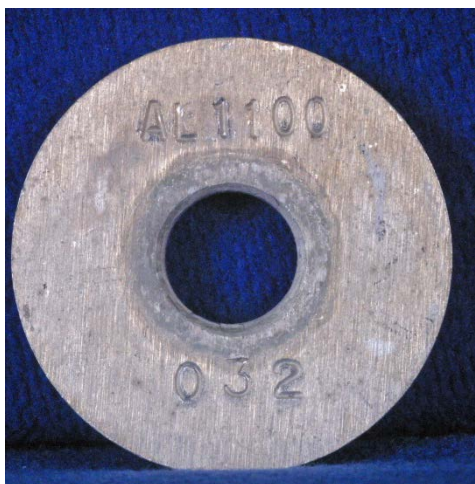
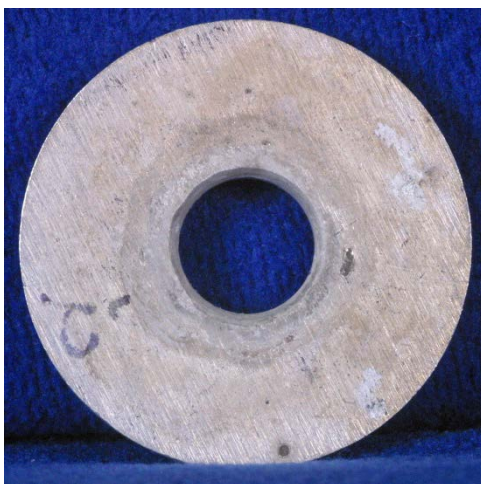
After cleaning in nitric acid solution

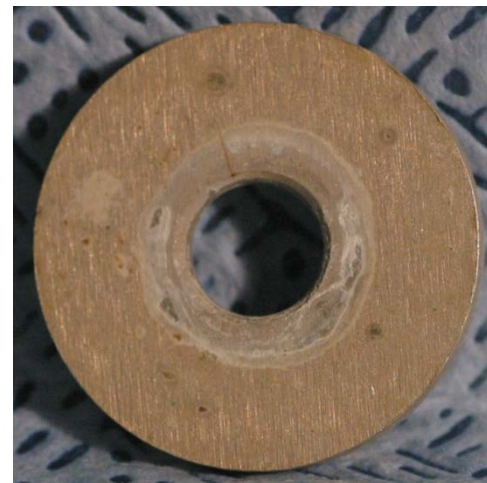
Al 1100 #033

As-received from L Baisn

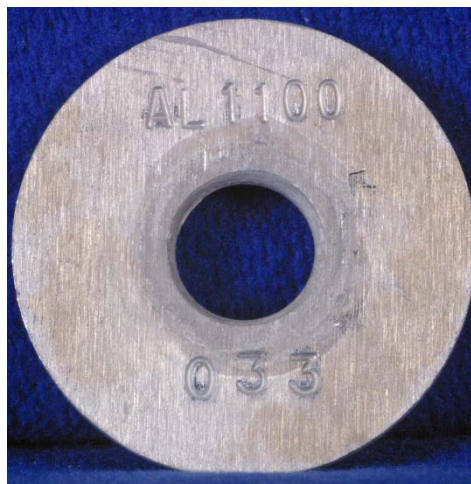
After cleaning in nitric acid solution

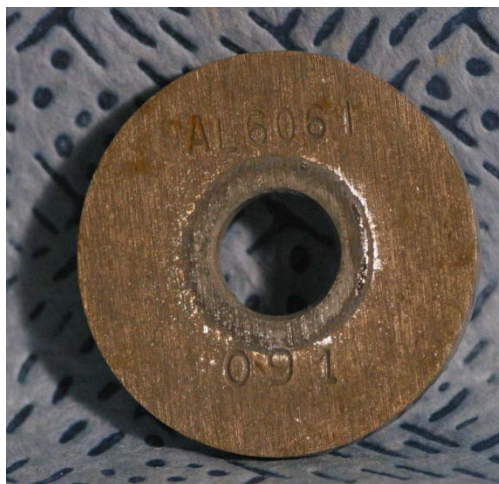
Al 6061 #091

As-received from L Baisn

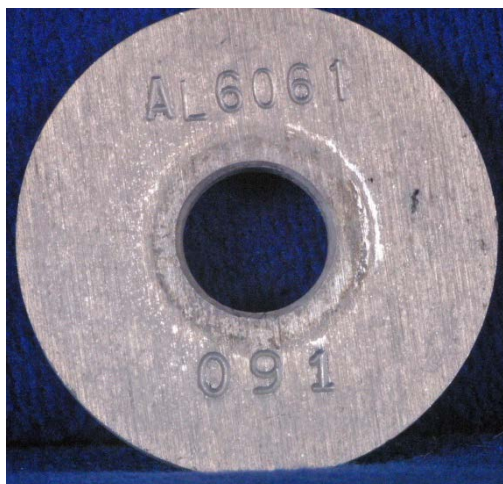
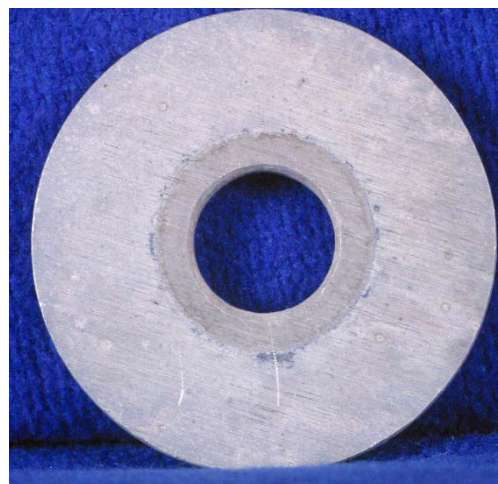
After cleaning in nitric acid solution

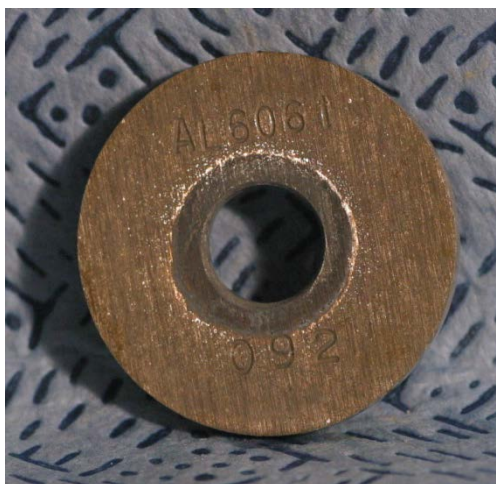
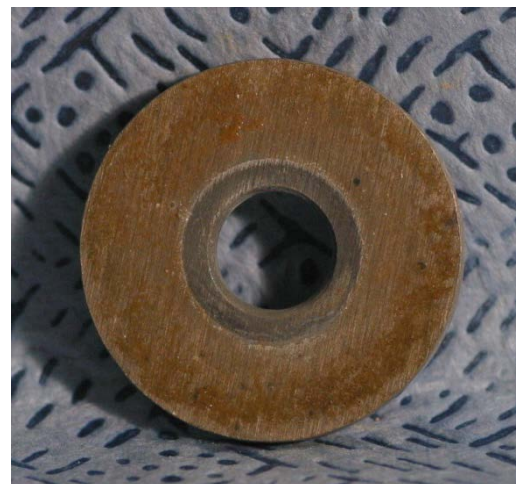
Al 6061 #092

As-received from L Baisn

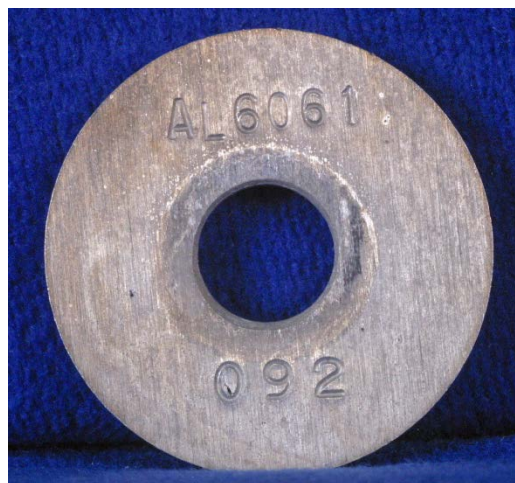
After cleaning in nitric acid solution

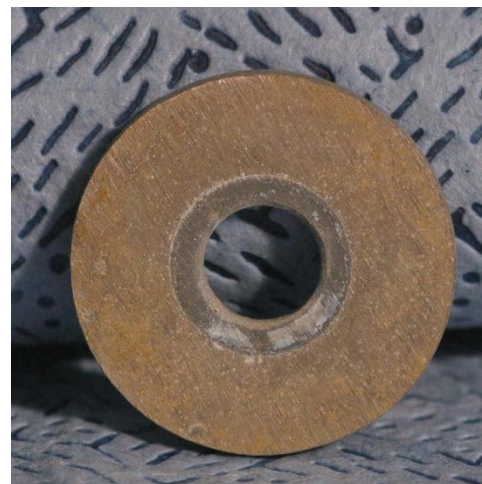
Al 6061 #093

As-received from L Baisn

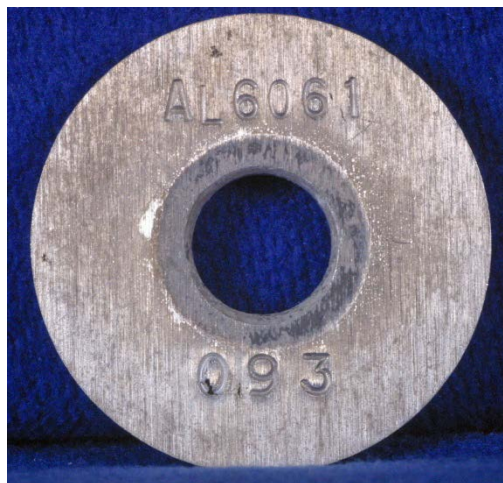
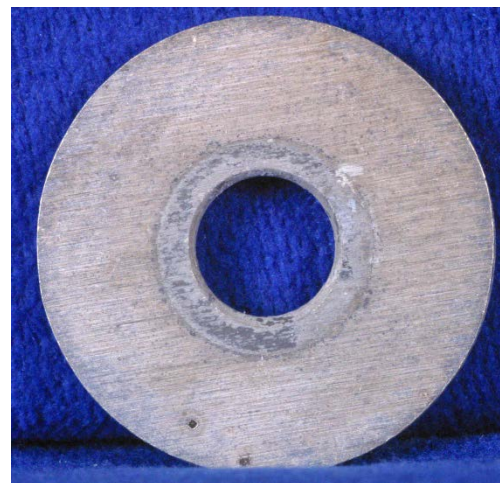
After cleaning in nitric acid solution

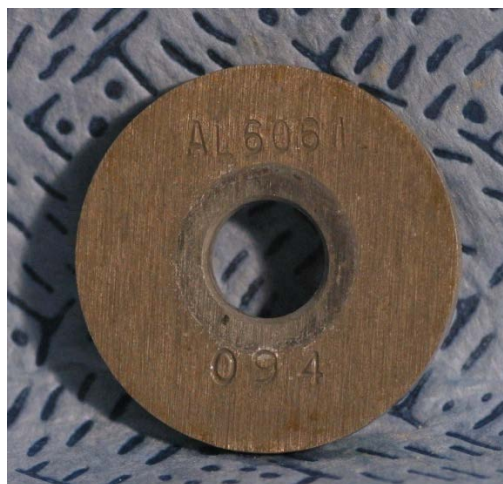
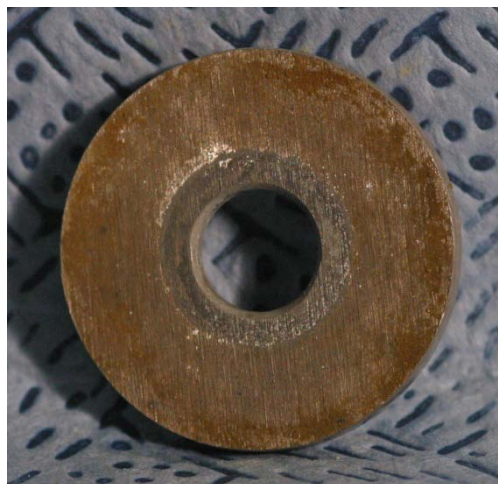
Al 6061 #094

As-received from L Baisn

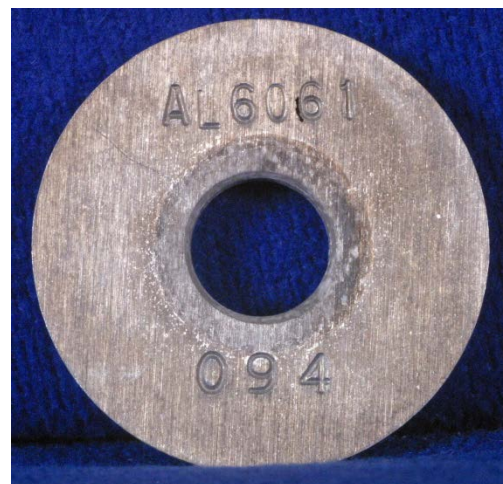
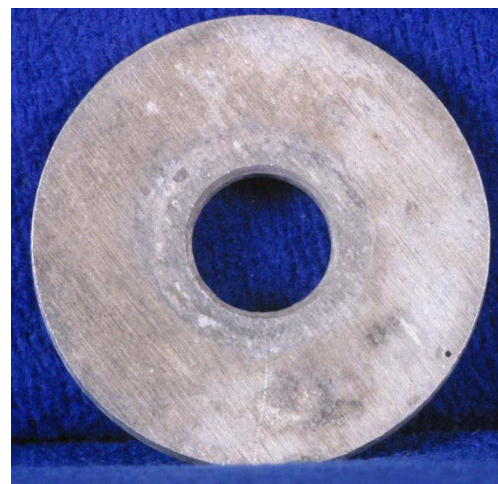
After cleaning in nitric acid solution

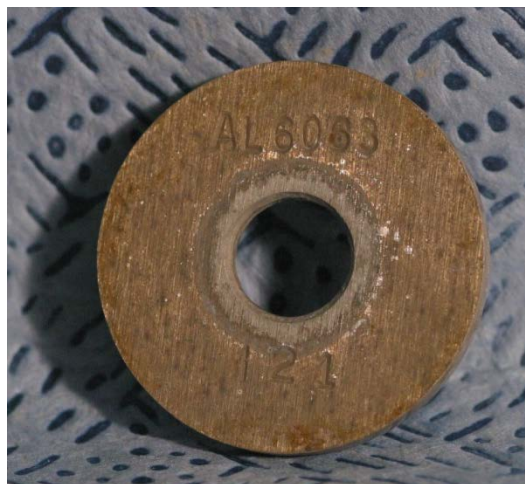
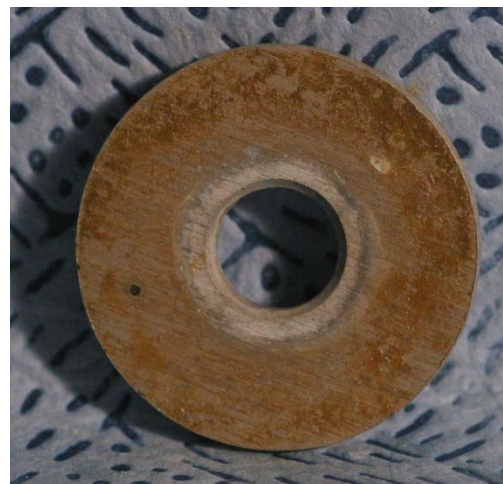
Al 6063 #121

As-received from L Baisn

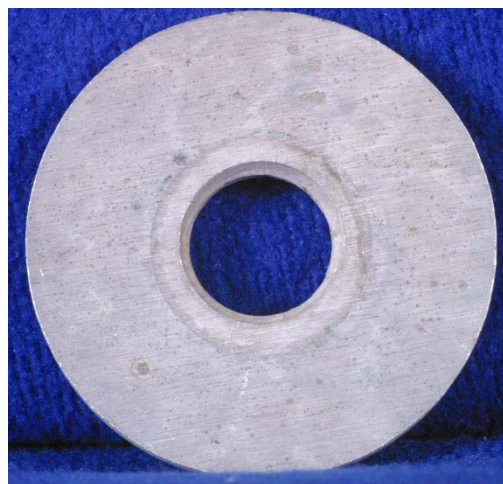
After cleaning in nitric acid solution

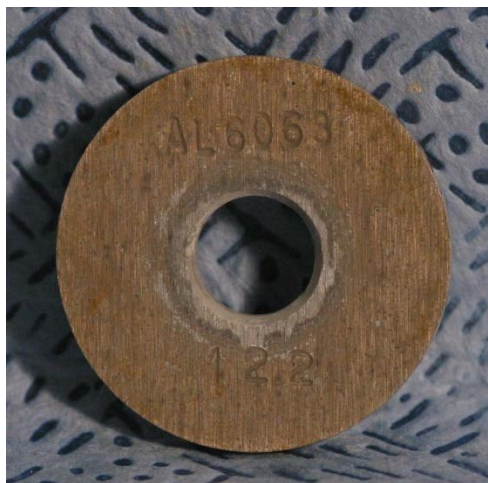
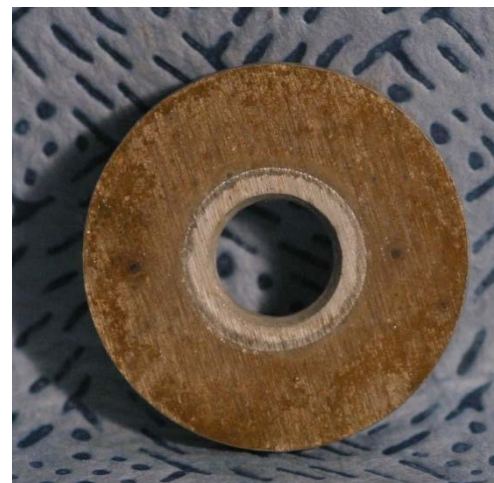
Al 6063 #122

As-received from L Baisn

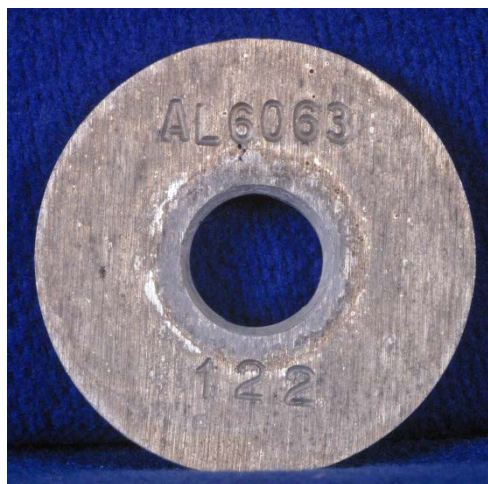
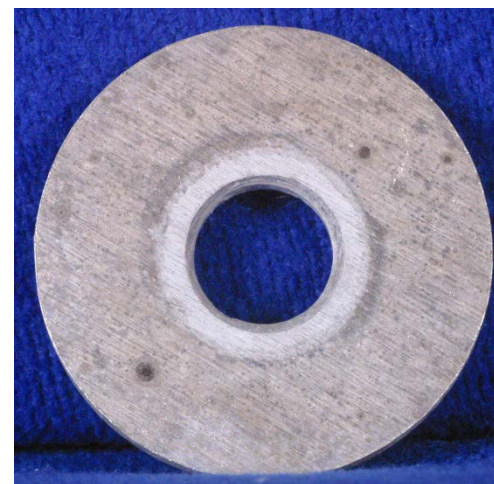
After cleaning in nitric acid solution

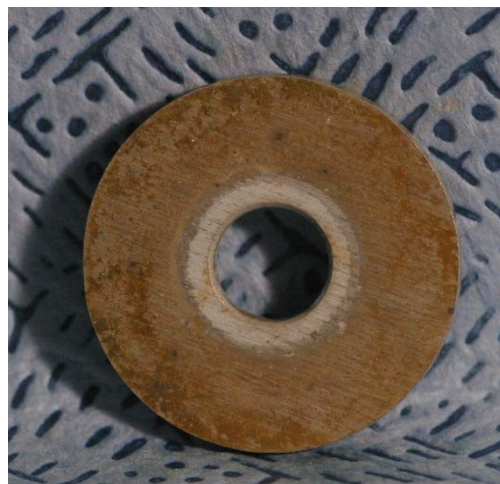
Al 6063 #123

As-received from L Baisn

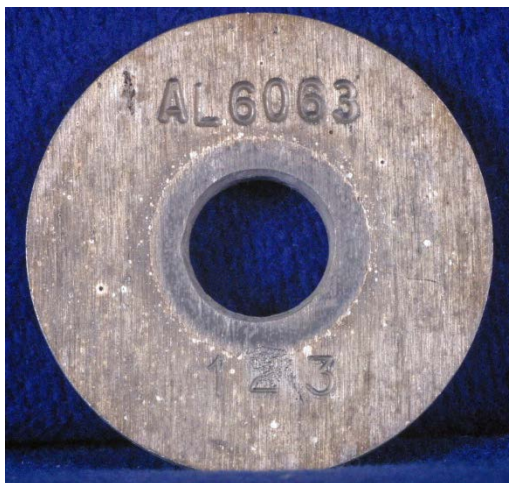
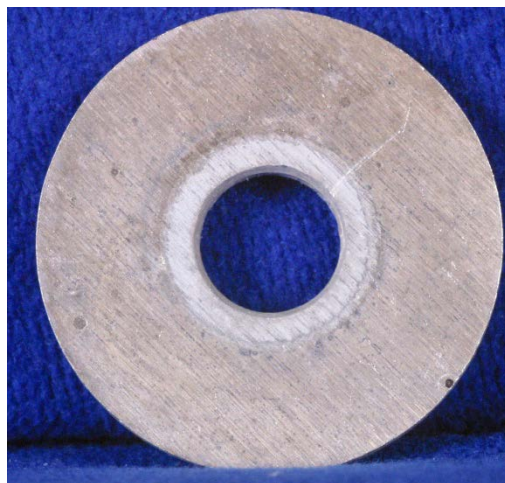
After cleaning in nitric acid solution

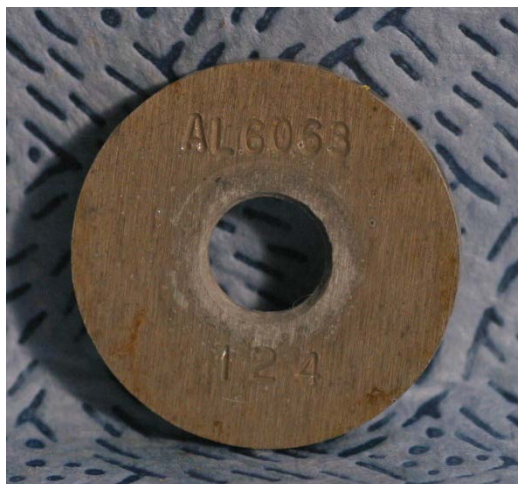
Al 6063 #124

As-received from L Baisn

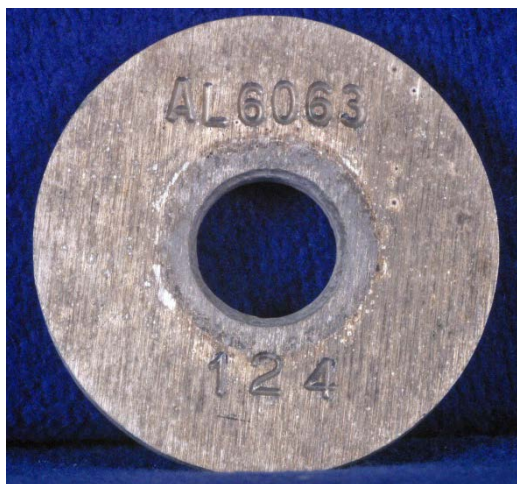
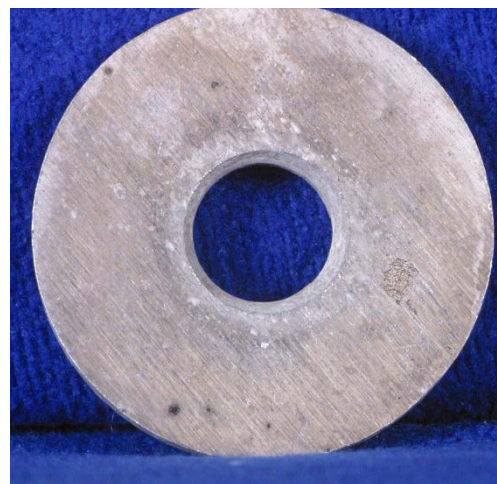
After cleaning in nitric acid solution

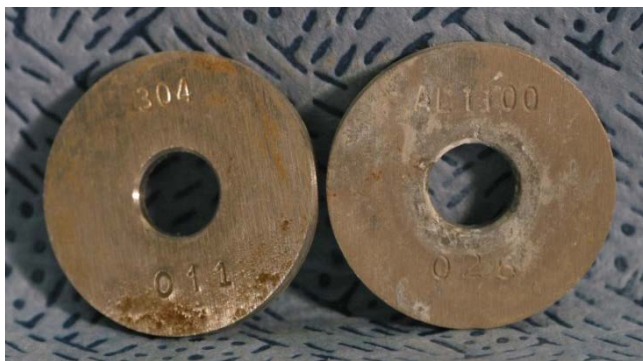
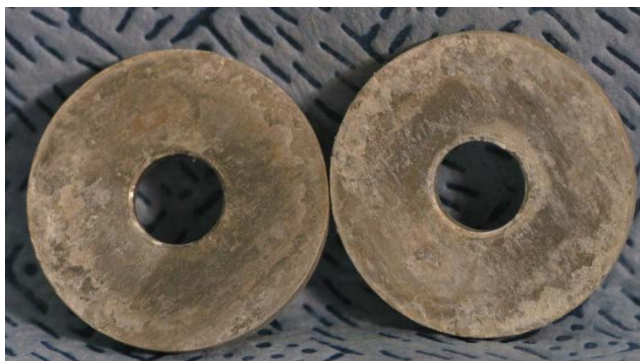
304 #011/Al 1100 #026

As-received from L Baisn

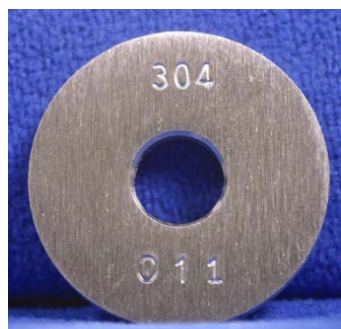
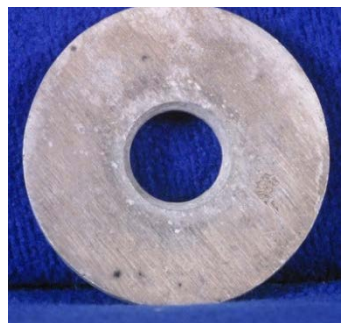
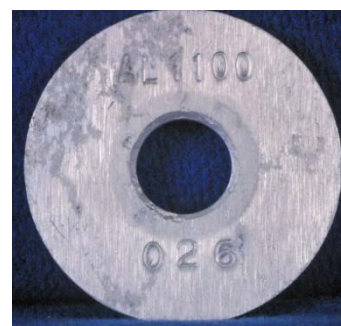
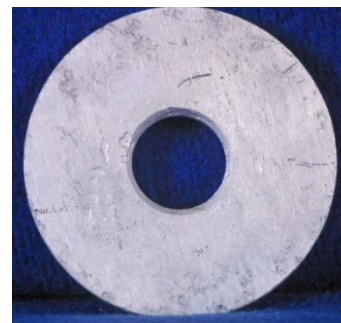
Coupled Surfaces-304/1100

After cleaning in nitric acid solution

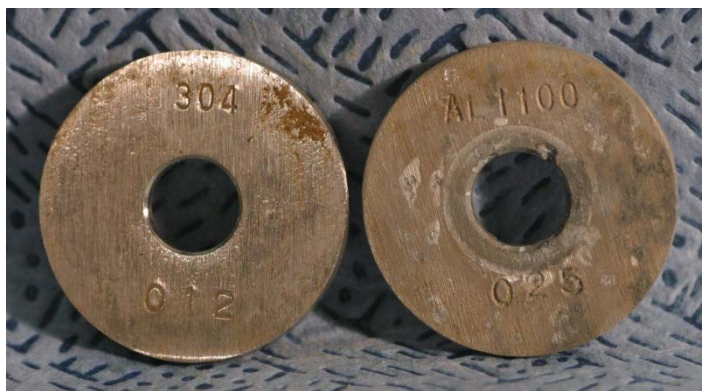
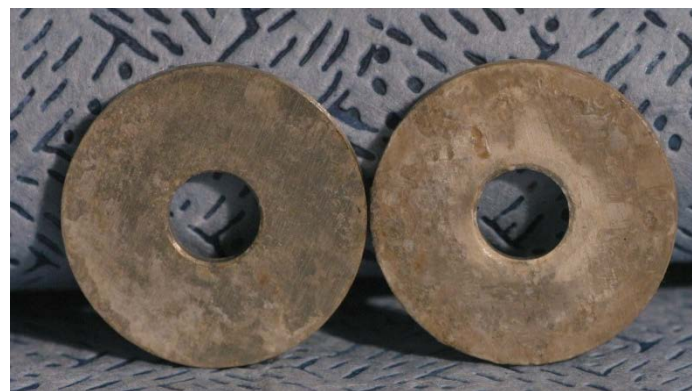
304 #012/Al 1100 #025

As-received from L Baisn

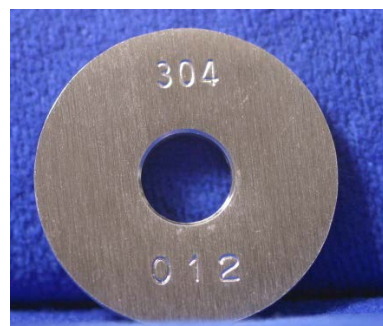
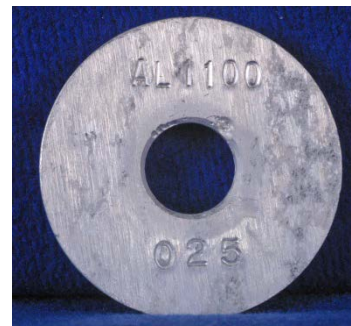
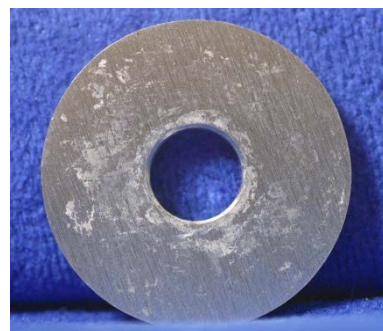
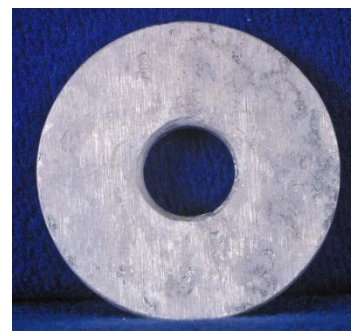
Coupled Surfaces-304/1100

After cleaning in nitric acid solution

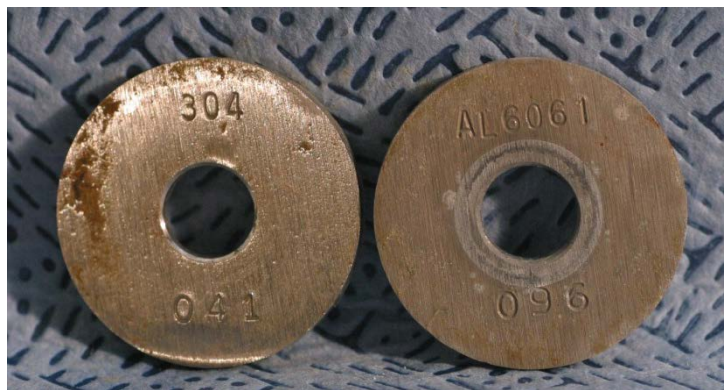
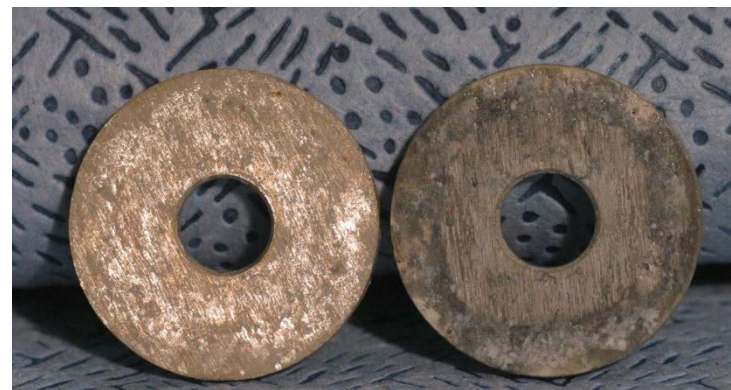
304 #041/Al 6061 #096

As-received from L Baisn

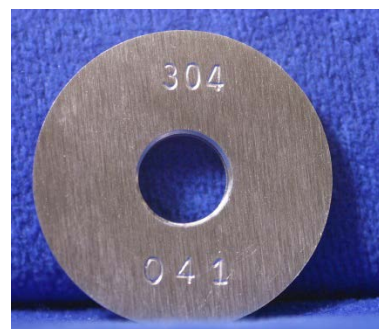
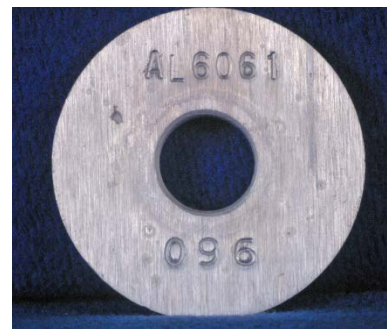
Coupled Surfaces-304/6061

After cleaning in nitric acid solution

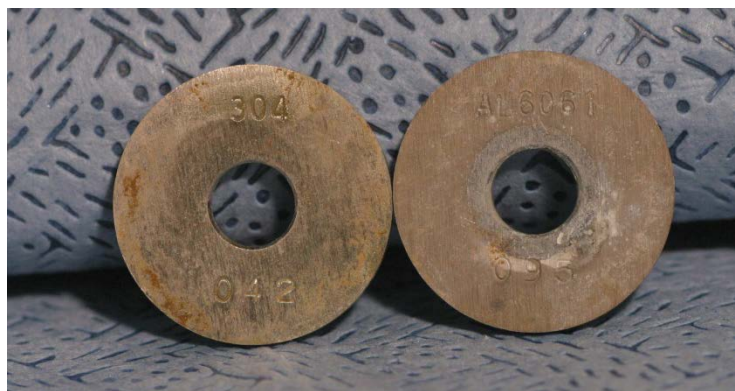
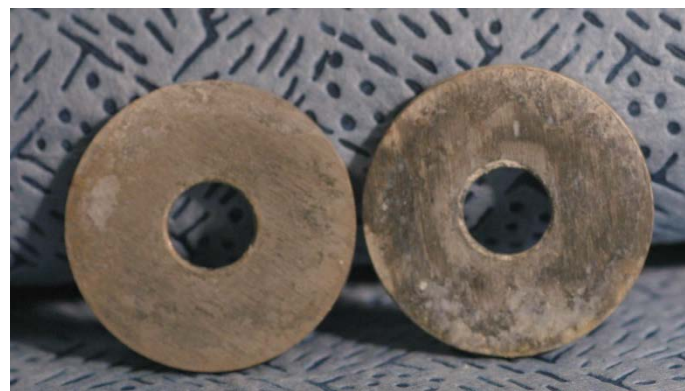
304 #042/Al 6061 #095

As-received from L Baisn

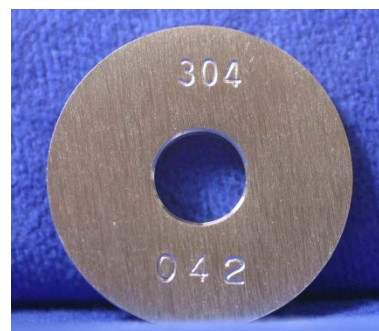
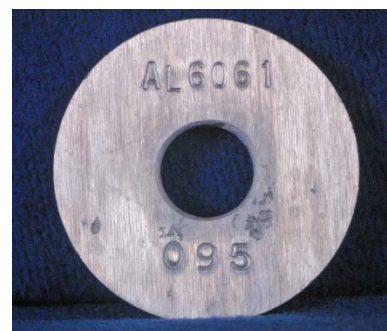
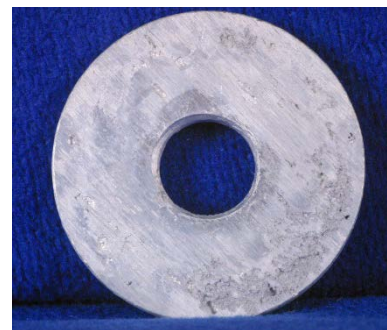
Coupled Surfaces-304/6061

After cleaning in nitric acid solution

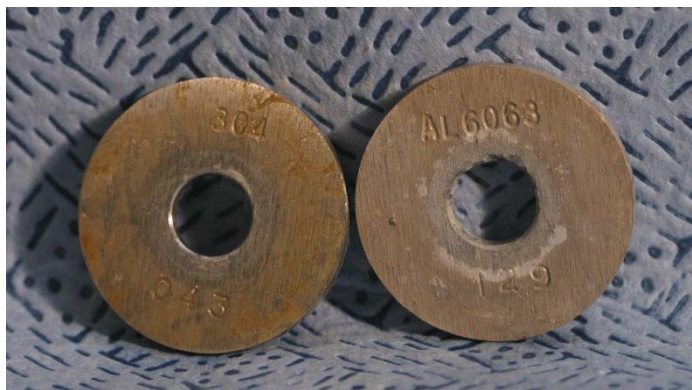
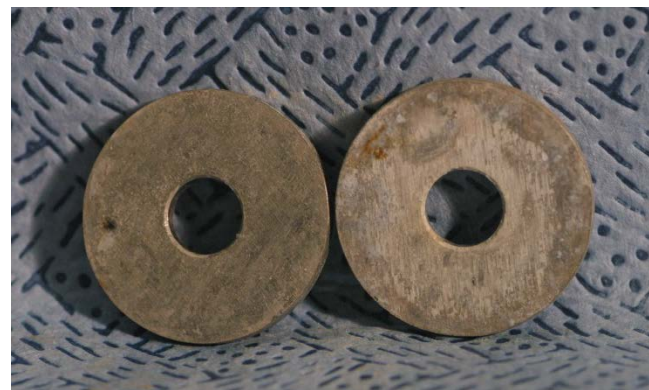
304 #043/Al 6063 #129

As-received from L Baisn

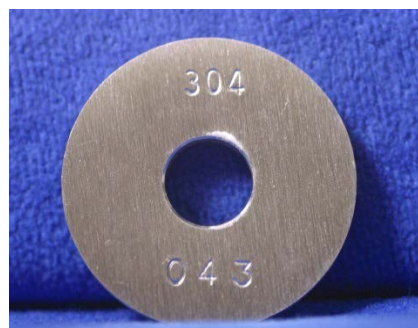
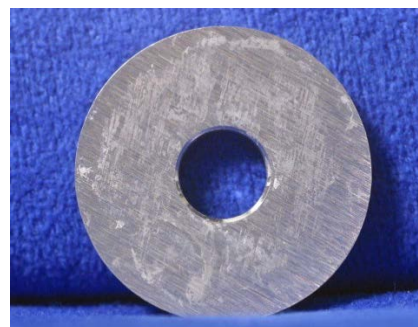
Coupled Surfaces-304/6063

After cleaning in nitric acid solution

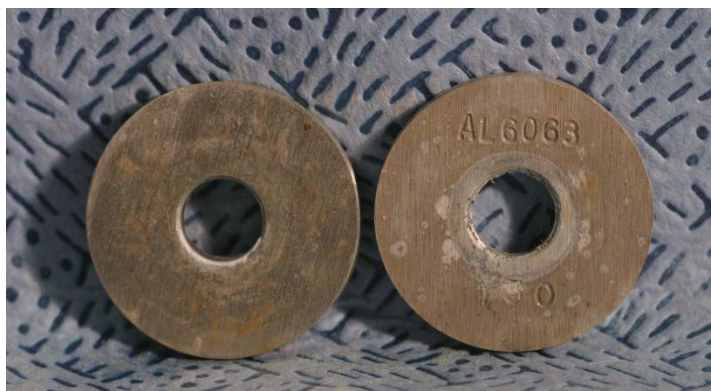
Upward/Downward

As-received from L Baisn

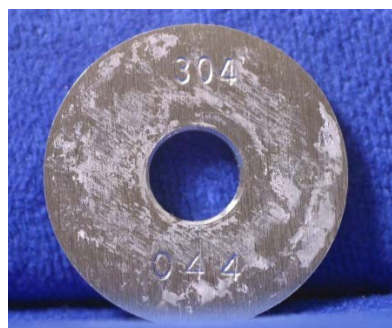
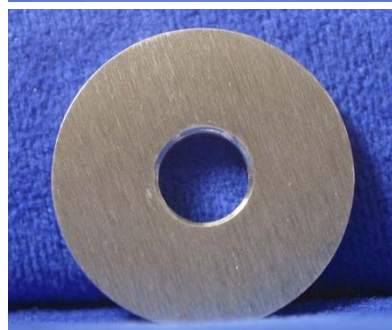
304 #044

After cleaning in nitric acid solution

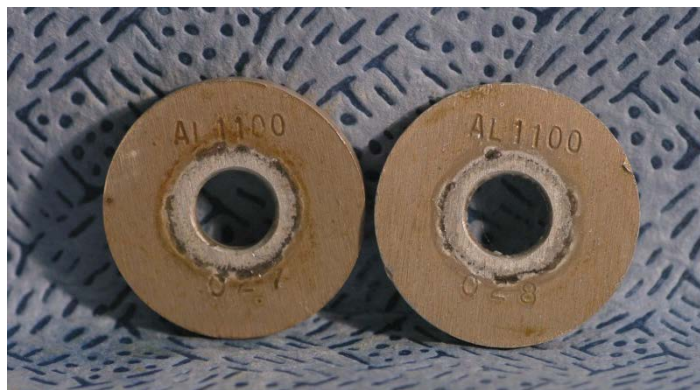
Upward/Downward

As-received from L Baisn

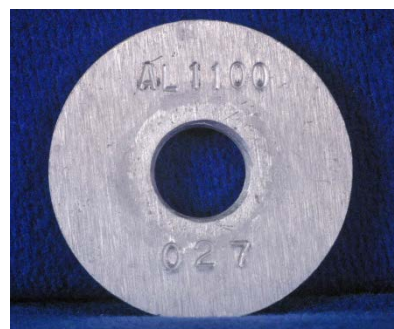
Al 1100 #027

After cleaning in nitric acid solution

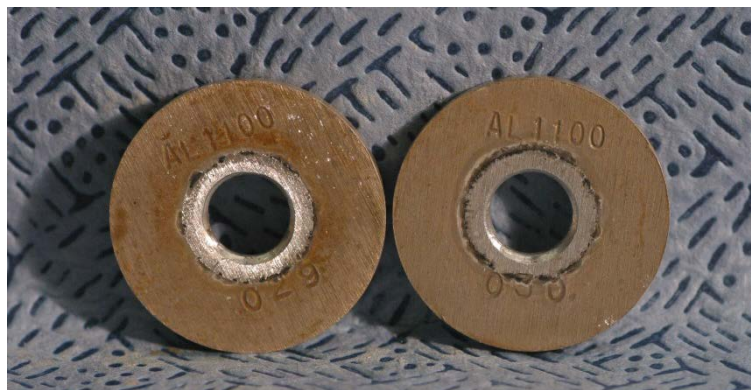
Upward/Downward

As-received from L Baisn

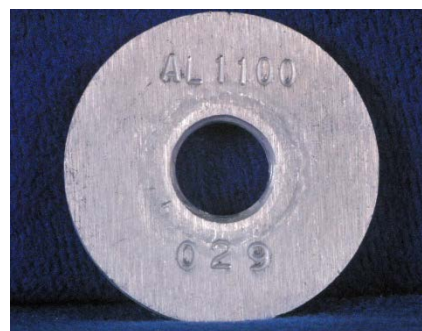
Al 1100 #029

After cleaning in nitric acid solution

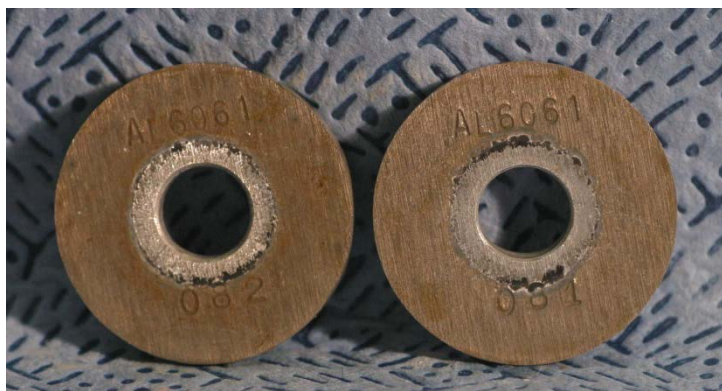
Upward/Downward

As-received from L Baisn

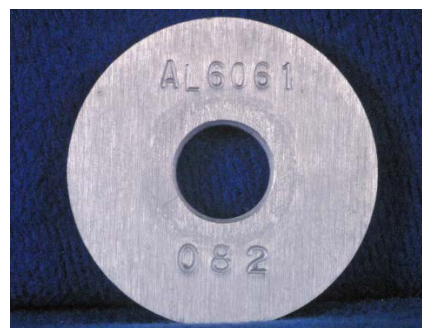
Al 6061 #082

After cleaning in nitric acid solution

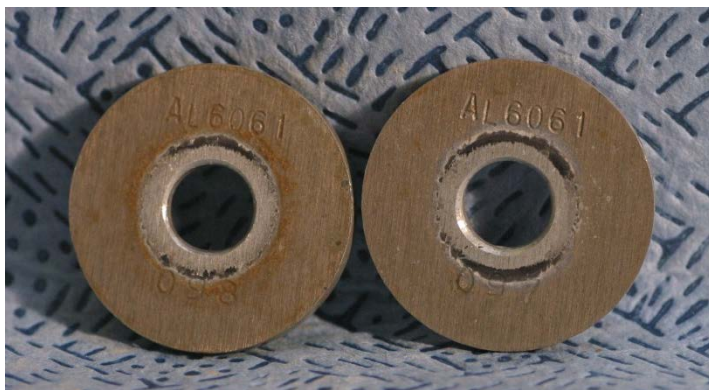
Upward/Downward

As-received from L Baisn

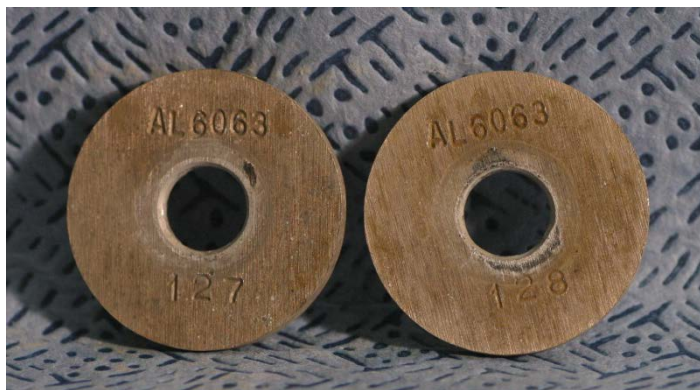
Upward/Downward

As-received from L Baisn

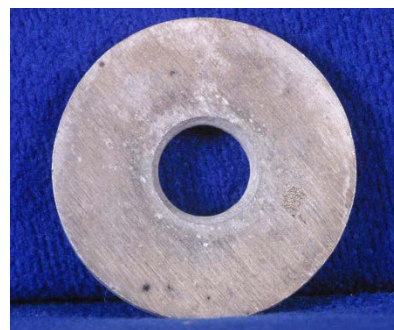
Al 6063 #128

After cleaning in nitric acid solution

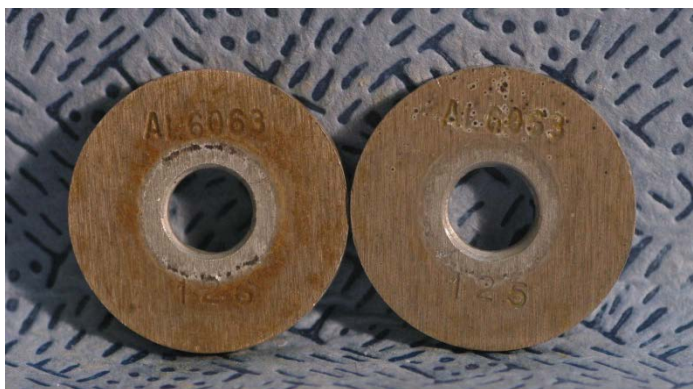
Upward/Downward

As-received from L Baisn

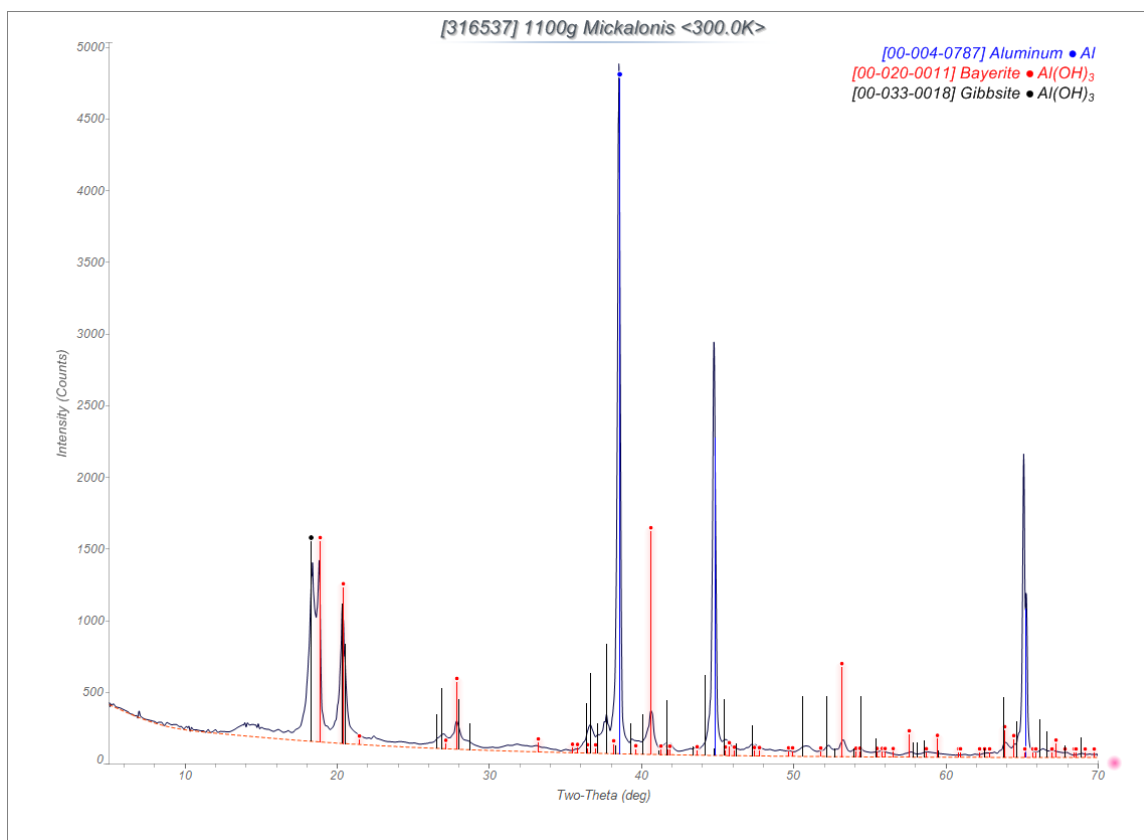
Appendix D XRD Scan of 2014 Aluminum Coupon

For all the coupons, gibbsite ($\gamma\text{-Al(OH)}_3$) and bayerite ($\alpha\text{-Al(OH)}_3$) were identified as the aluminum oxide phases present as shown in Figure 4-3 for 1100-026, which was in the galvanic couple (See Appendix D for a large image of this figure). For the basin pH range and low temperature of operation (i.e. $<77^\circ\text{C}$), a form of aluminum hydroxide (Al(OH)_3) known as nordstandite is predicted to form. Nordstandite can be considered a mixture of gibbsite and bayerite [9]. This result differs from the XRD results for 2006 and 2010 surveillance coupons where bayerite had a greater peak intensity than gibbsite, when it was present. [8, 10]. All oxide XRD peaks for these coupons generally are small compared to those resulting from the aluminum coupon. The 2006 and 2010 surveillance coupons were both dried ahead of performing the XRD which may have impacted the results.

Figure 4-3. X-ray diffraction spectra for Al1100 galvanic coupon #026 downward facing coupon after a 15-year exposure in L Basin

The scan below is same as shown in Figure 4-3.
